Annual Inspection

Pirton Parish Council - Coleman's Close

Inspection Ref: 2901522

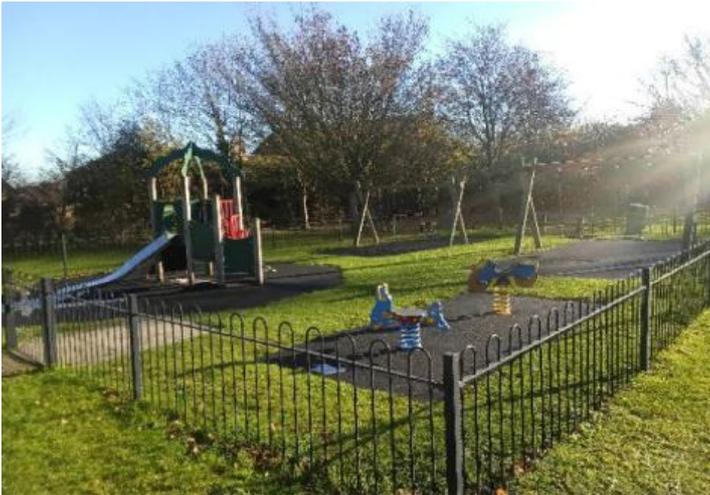
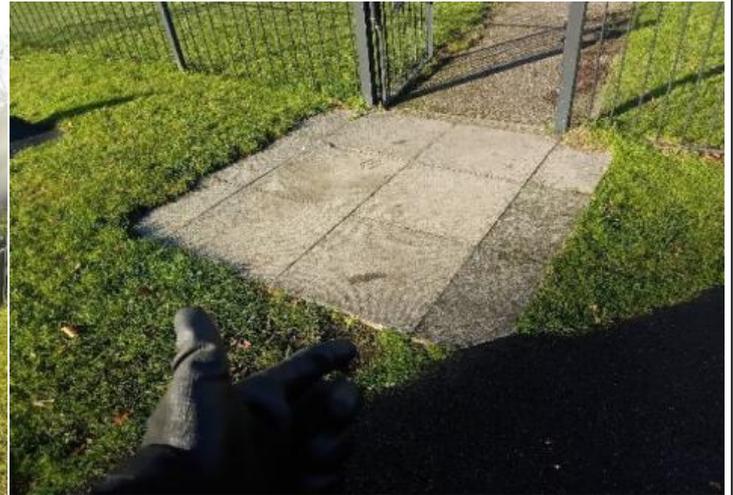
Finding: There are trip hazards at the edges of the surface **Action:** Reinstate surface levels to remove trip hazard

5 - Very Low Risk (Finding 1)

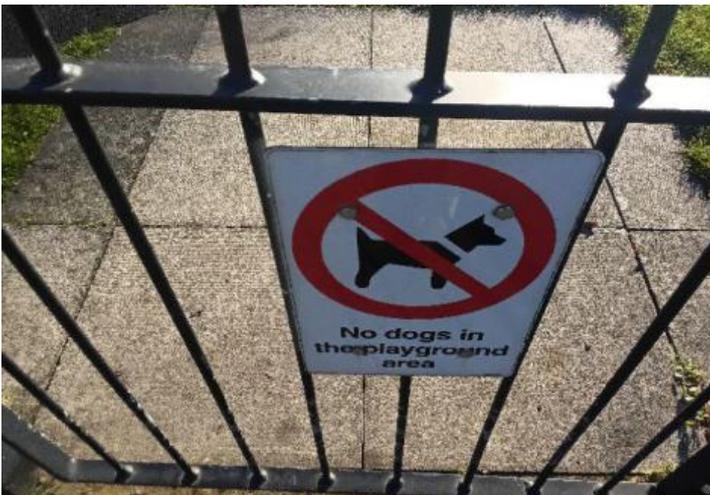
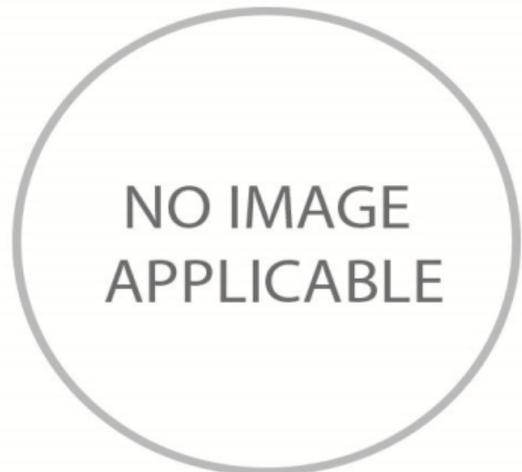
Finding: It is recommended that signage, with information including the site address, contact information for maintenance issues and emergency contact details are provided for the facility **Action:** Provide in accordance with the recommendations

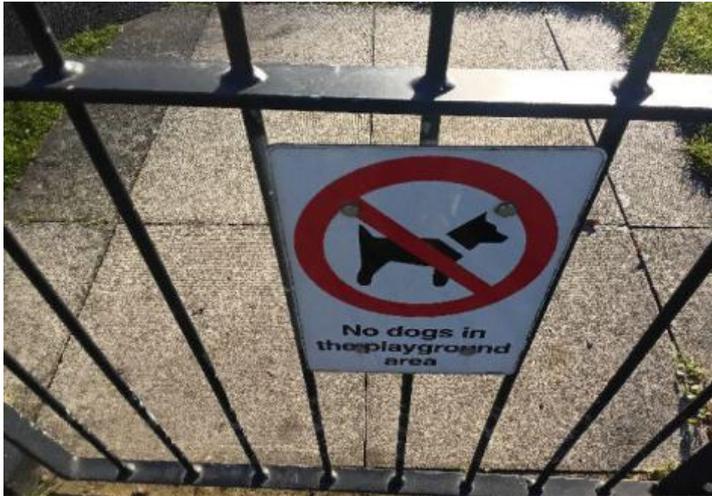
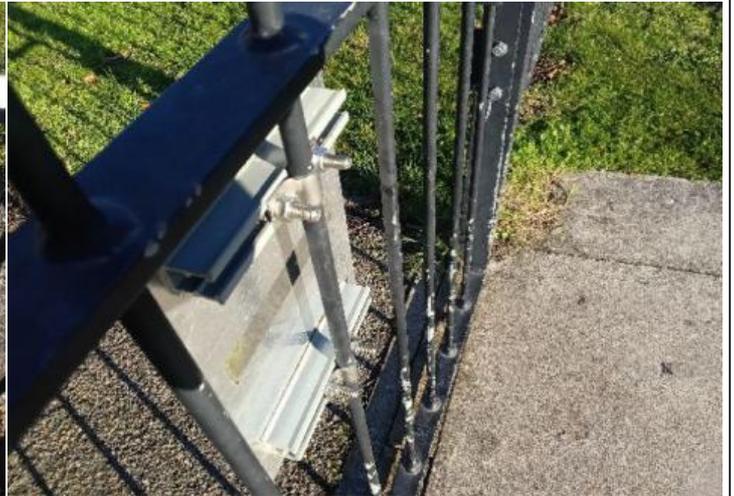
Finding: There are projecting bolt thread(s) present on the rear of sign

Action: Remove excess thread length and deburr or provide cap

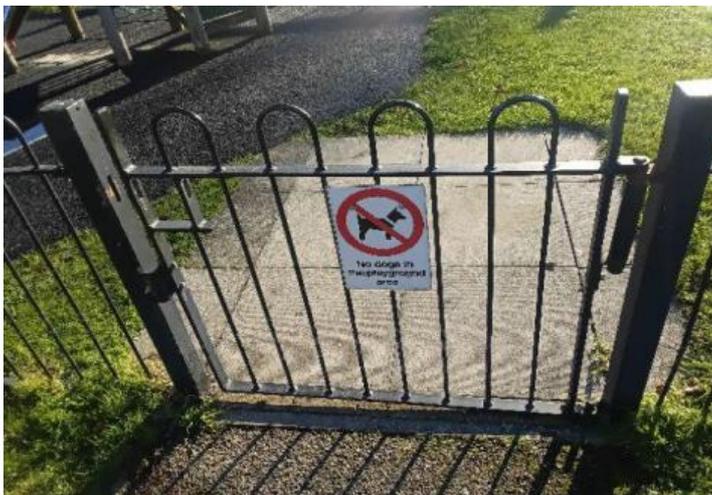
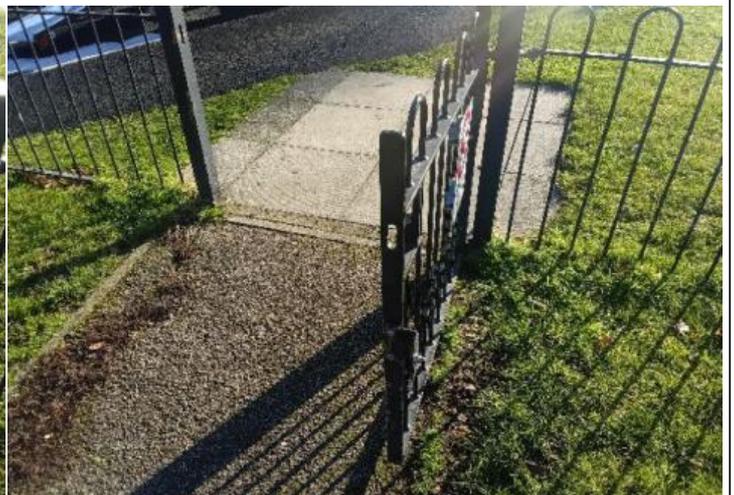
Finding: The gate is not operating correctly

Action: Take effective action to ensure the gate closes between 4 and 8 seconds

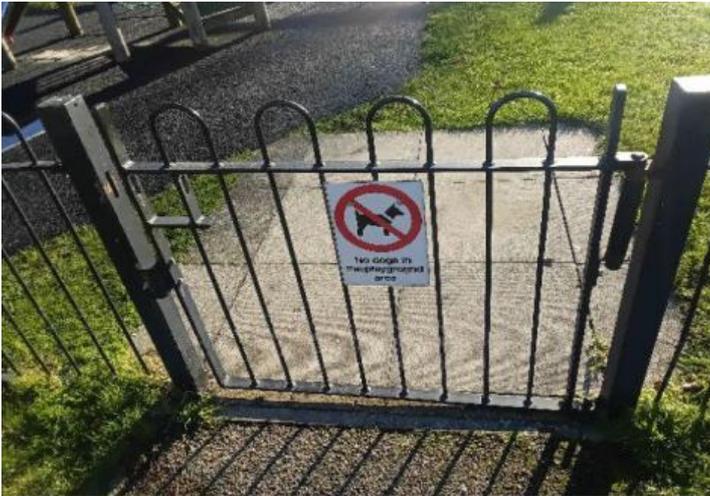
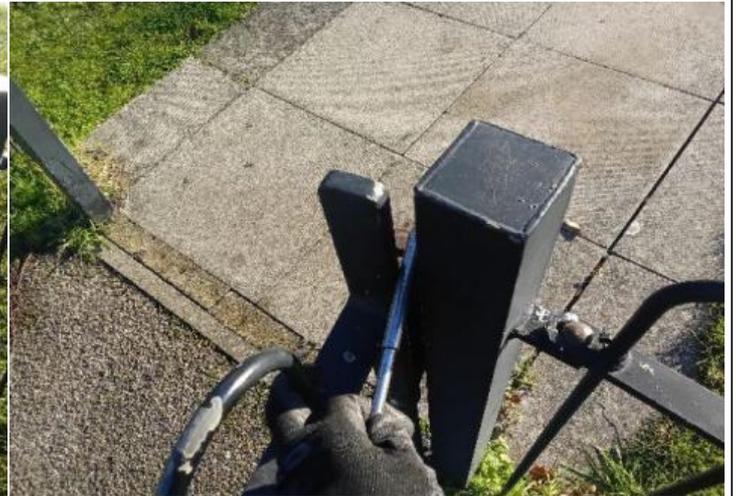
Finding: There are openings that are less than 12mm that could trap or crush fingers

Action: Provide a 12mm gap throughout full range of motion at both sides of gate

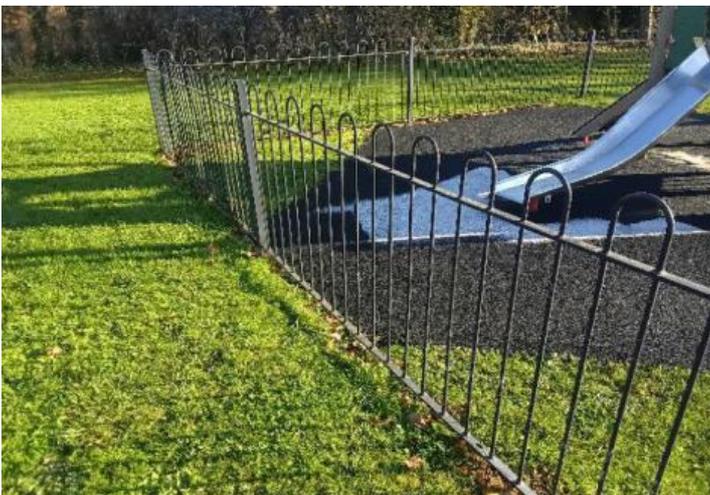
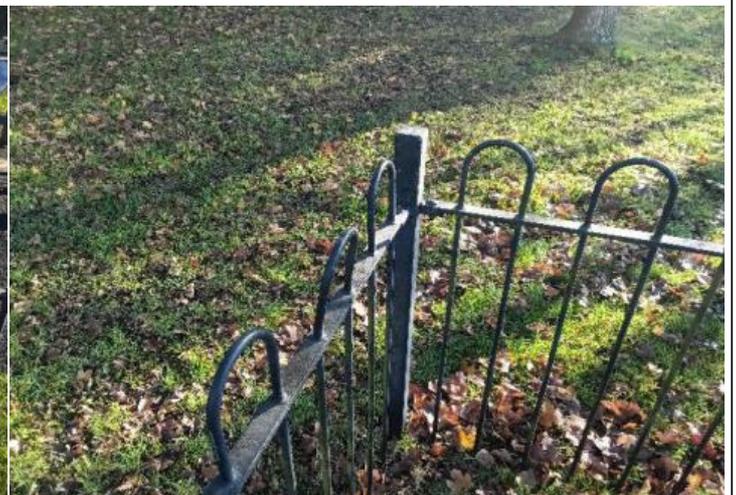
Finding: There is some damage to the fence sections

Action: Monitor for any further deterioration and repair as required

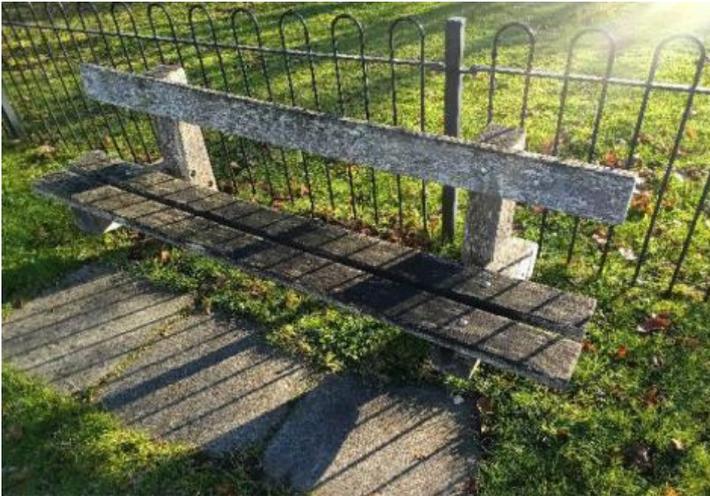
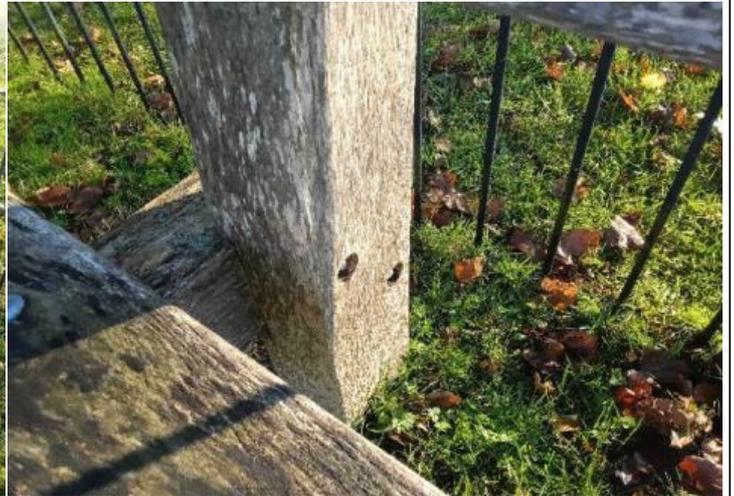
Finding: There is/are bolt cap covers missing or damaged on the bench

Action: Replace missing or damaged bolt cap covers

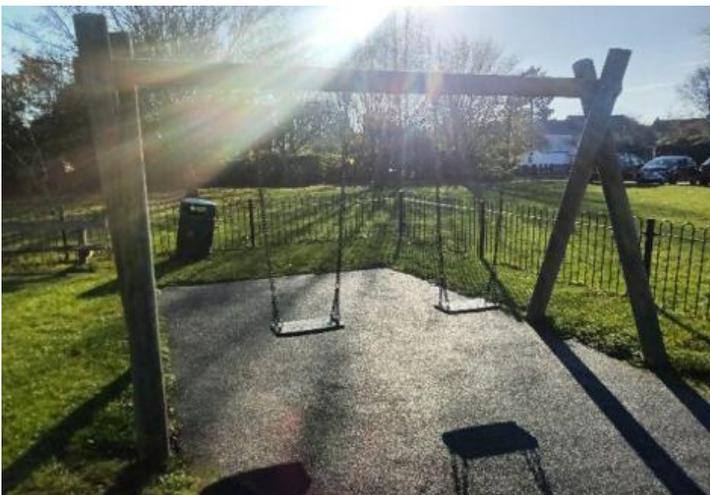
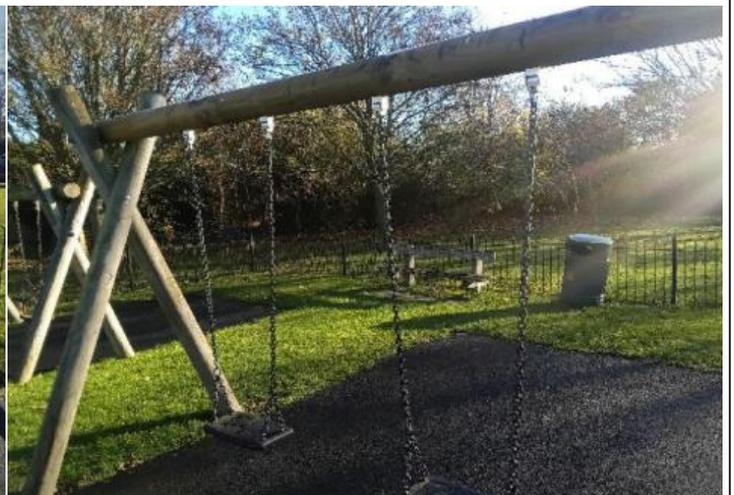
Finding: This design of swing joint has been known to fail on the weld connecting the joint to the threaded stud

Action: We would recommend that the joint be dismantled and checked on a regular basis or consulting with manufacturer on whether a Secondary Safety Device can be fitted

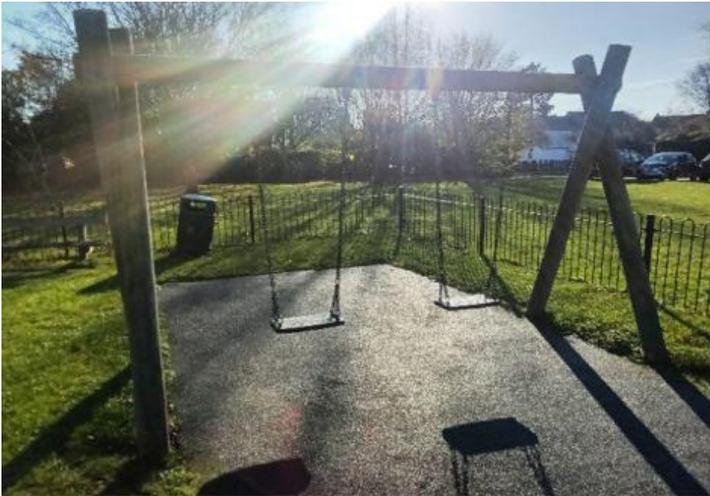
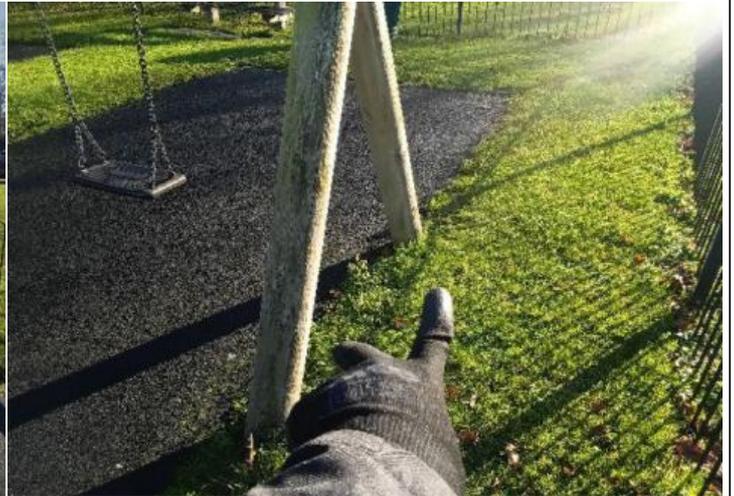
Finding: There is some evidence of rot in 2 timber posts

Action: Monitor for any further deterioration and replace as required

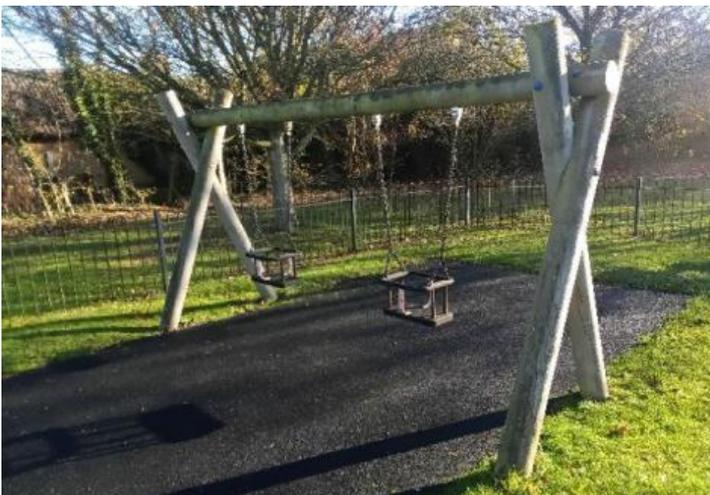
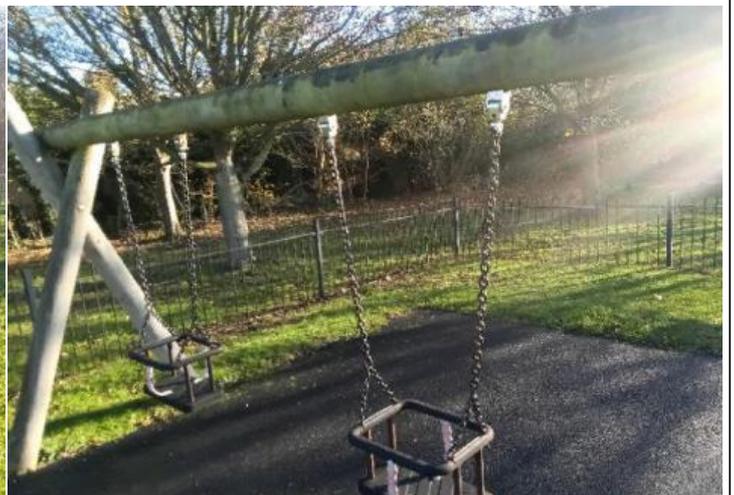
Finding: This design of swing joint has been known to fail on the weld connecting the joint to the threaded stud

Action: We would recommend that the joint be dismantled and checked on a regular basis or consulting with manufacturer on whether a Secondary Safety Device can be fitted

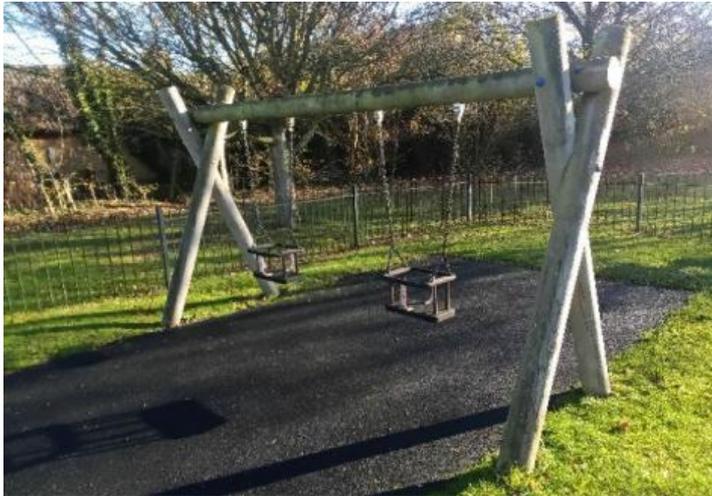
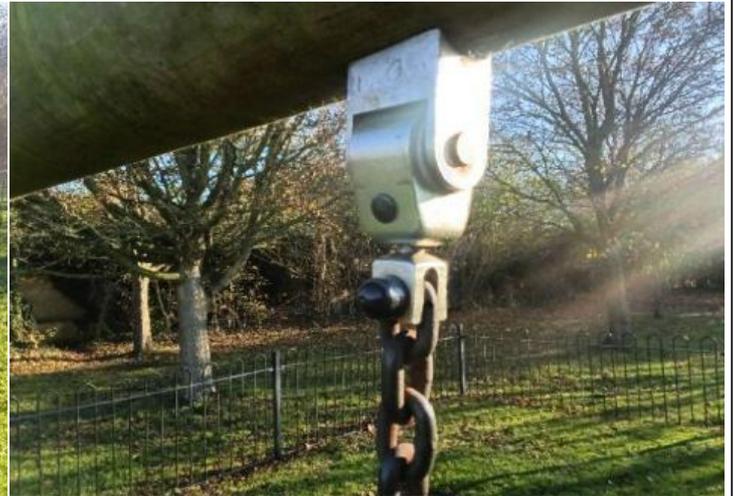
Finding: The swivel joint bushes are worn

Action: Replace worn or missing bushes

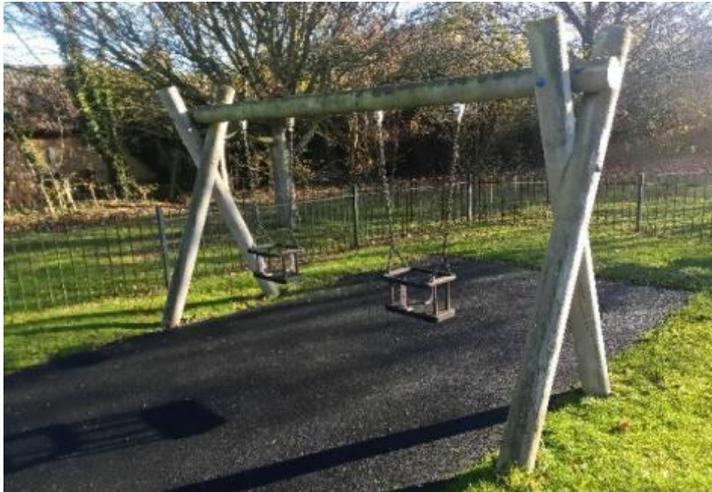
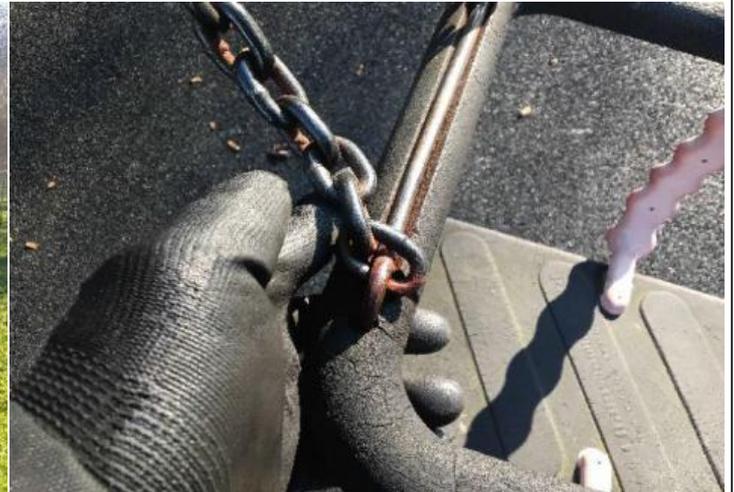
Finding: There is some notable evidence of chain wear

Action: Monitor for any further deterioration and replace when 40% worn

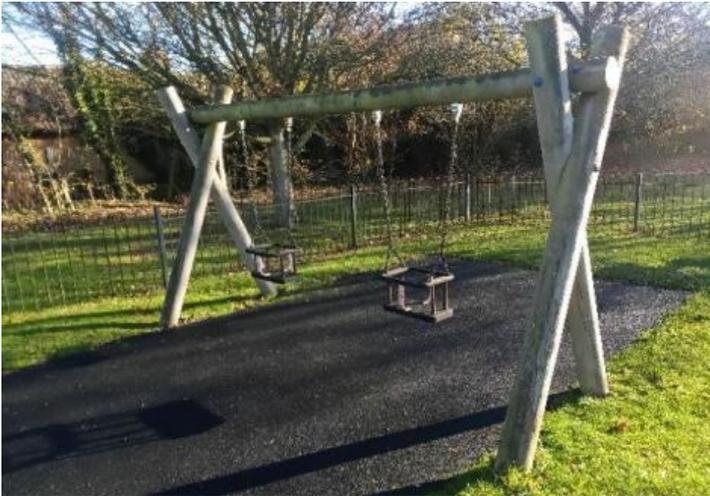
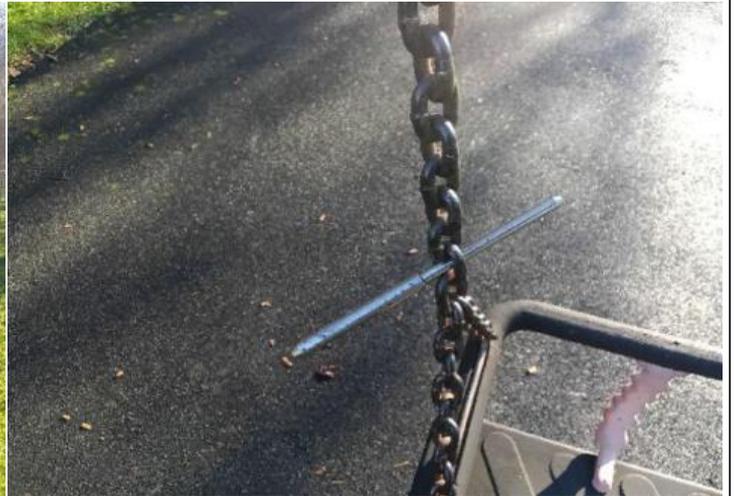
Finding: The chain openings are in excess of the 8.6mm as recommended by BS EN 1176
Action: Monitor - No action given the risk assessment

i 6 - Low Risk (Finding 5)

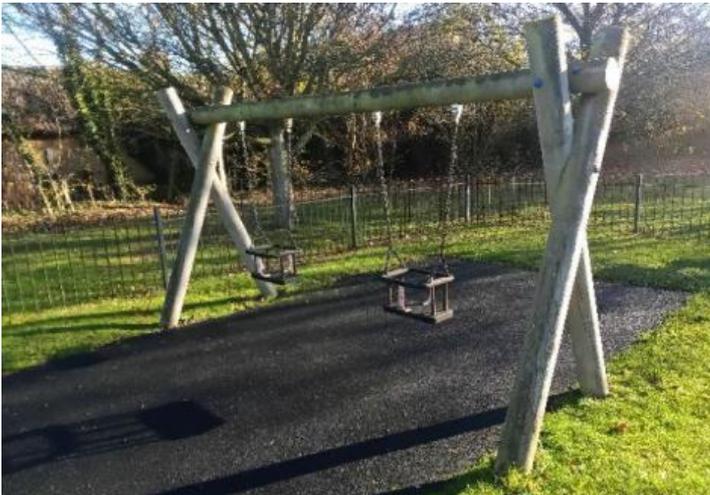
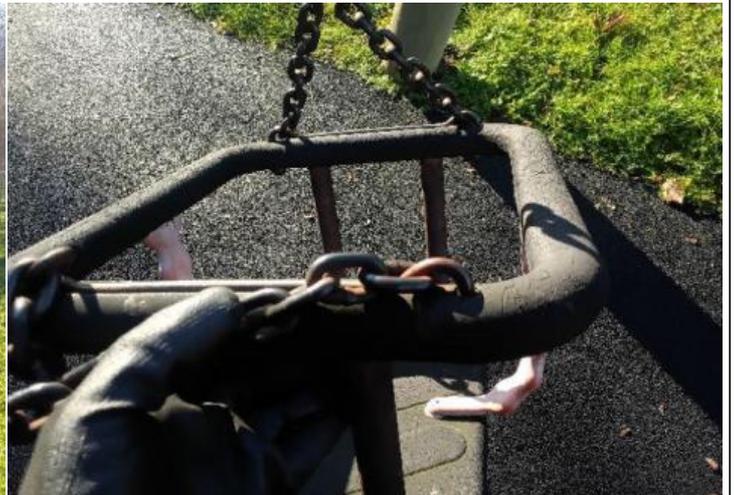
Finding: The swing seat connectors have some wear present
Action: Monitor for further deterioration and replace when 40% worn

i 6 - Low Risk (Finding 6)

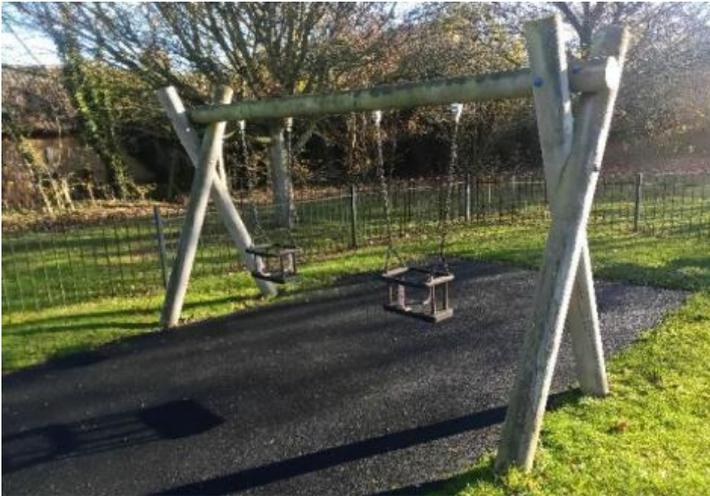
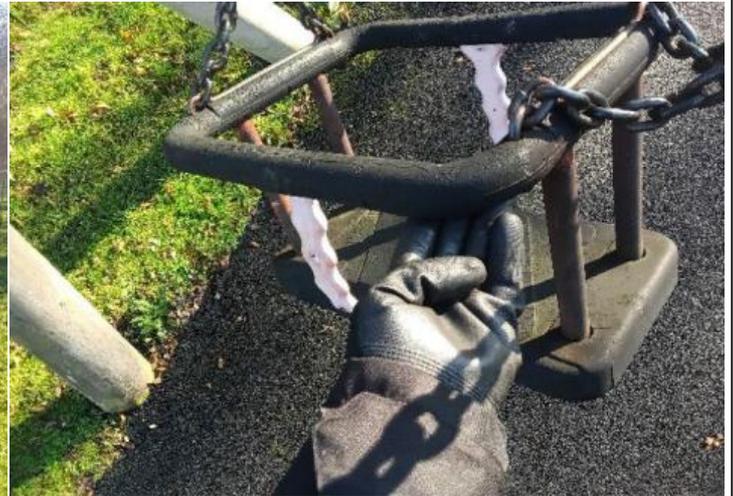
Finding: The seat has minor damage or wear

Action: Monitor for any further deterioration and replace as required

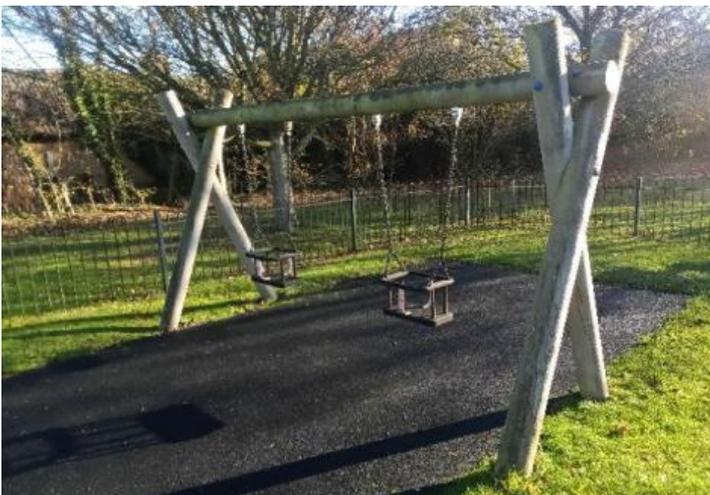
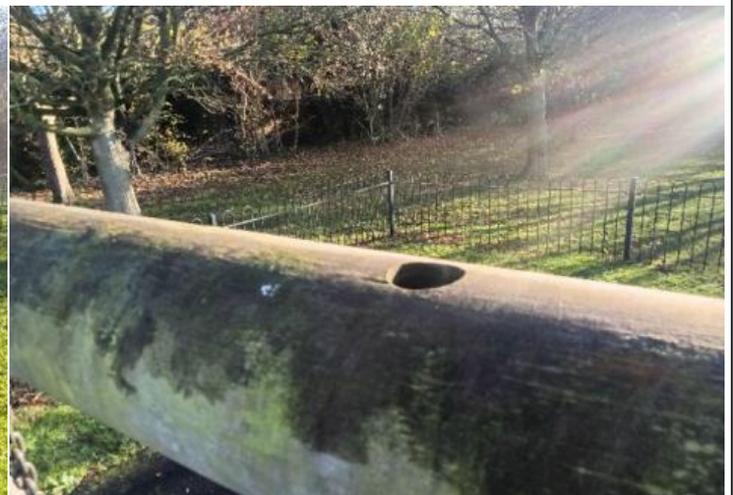
Finding: There is/are bolt cap covers missing or damaged on the framework

Action: Replace missing or damaged bolt cap covers

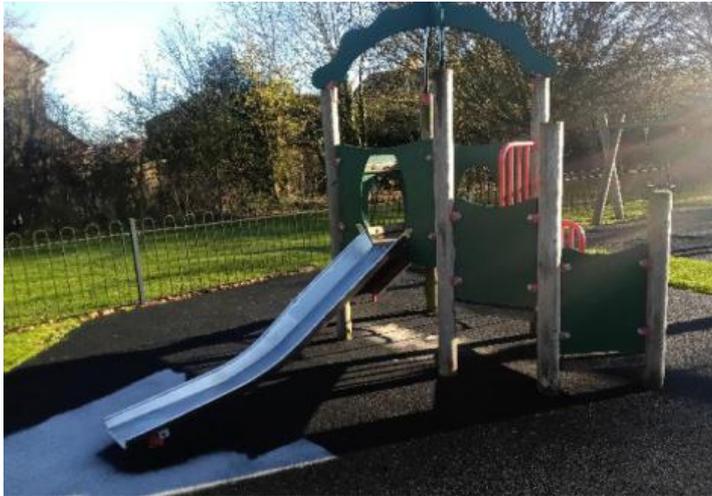
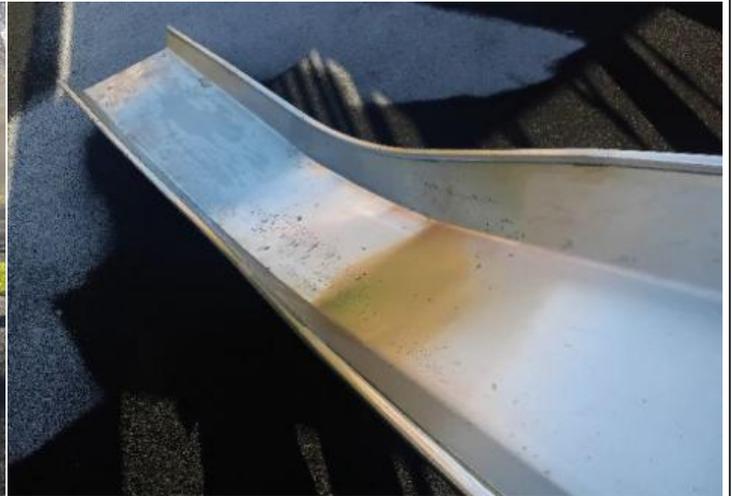
Finding: There are a number of dents in the slide surface

Action: Monitor for any further deterioration and repair as required

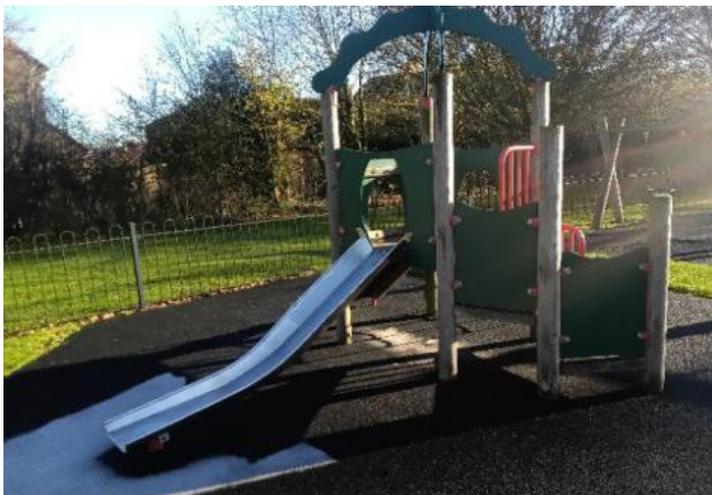
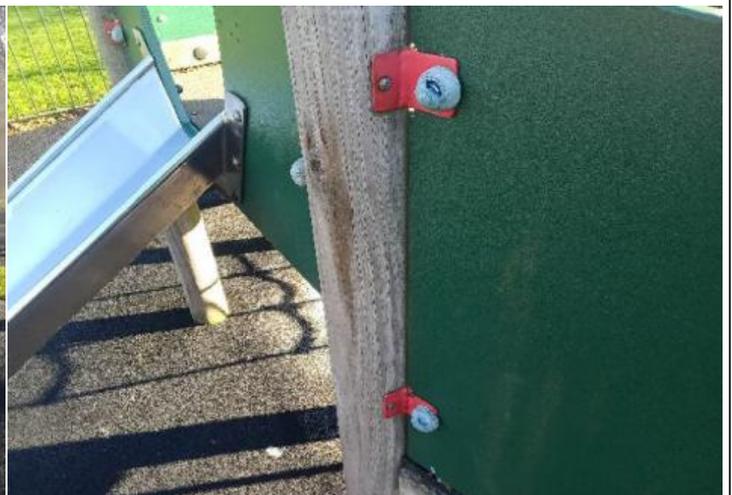
Finding: There is/are bolt cap covers missing or damaged on the framework

Action: Replace missing or damaged bolt cap covers

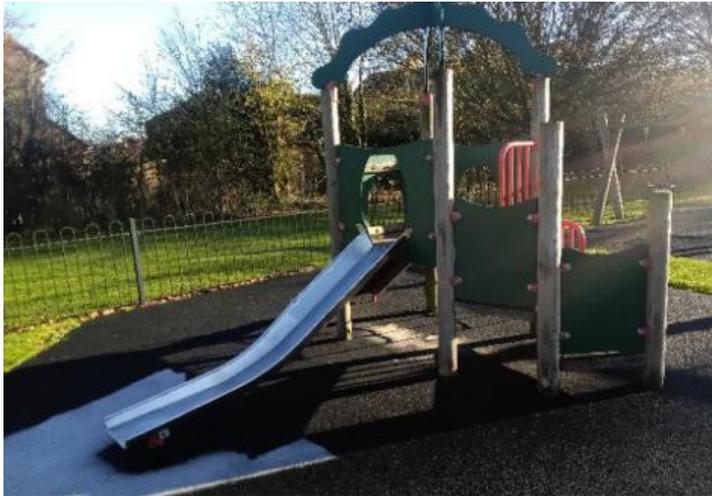
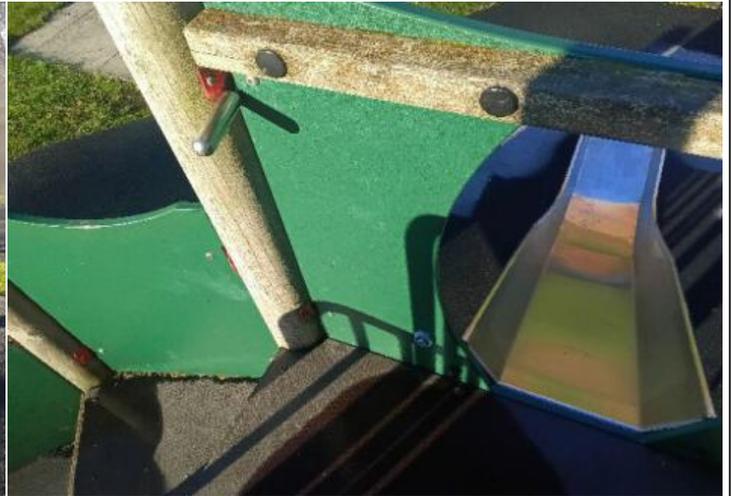
Finding: There is/are finger entrapment/s in the slide barrier and the item fails to meet the requirements of BS EN 1176 Part 1 4.2.7.6 Entrapment of fingers
Action: Monitor - No action given the risk assessment

i 8 - Low Risk (Finding 4)

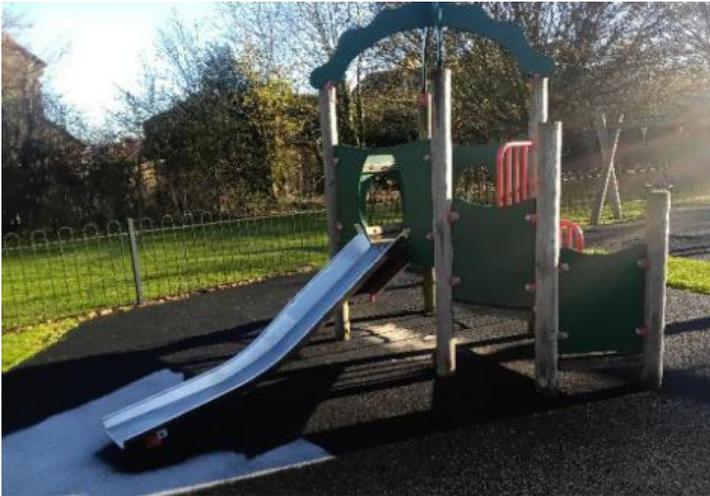
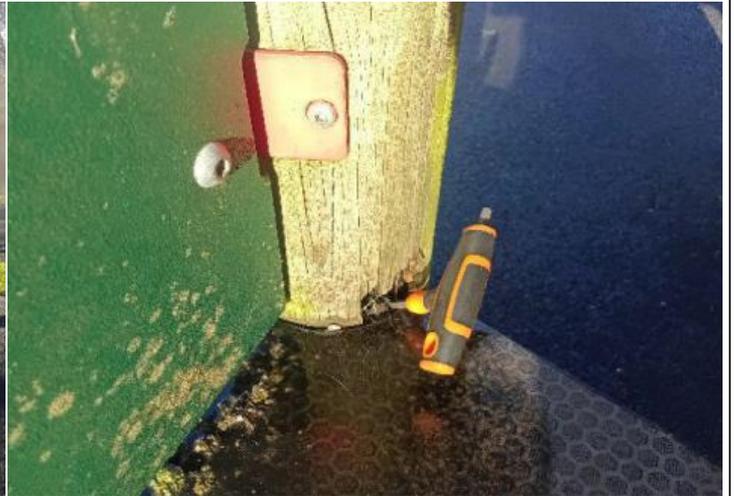
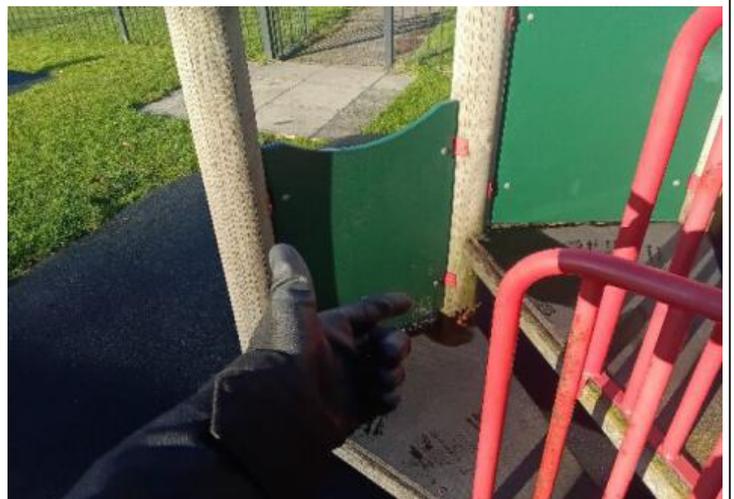
Finding: There are areas or parts of the timber on the structure that have rotted

Action: Replace all affected timbers

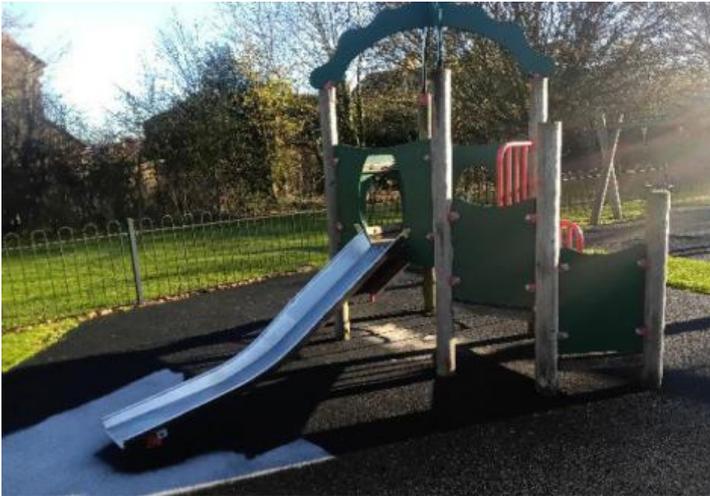
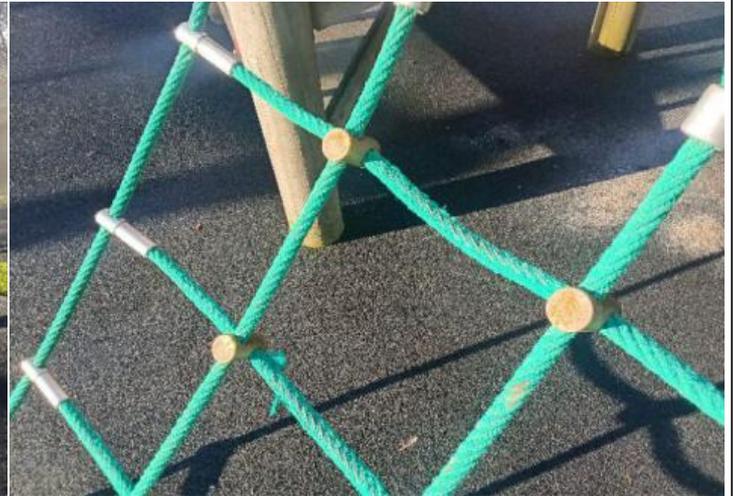
Finding: The ropes/nets are worn/damaged in places

Action: Monitor for any further deterioration and repair or replace as required

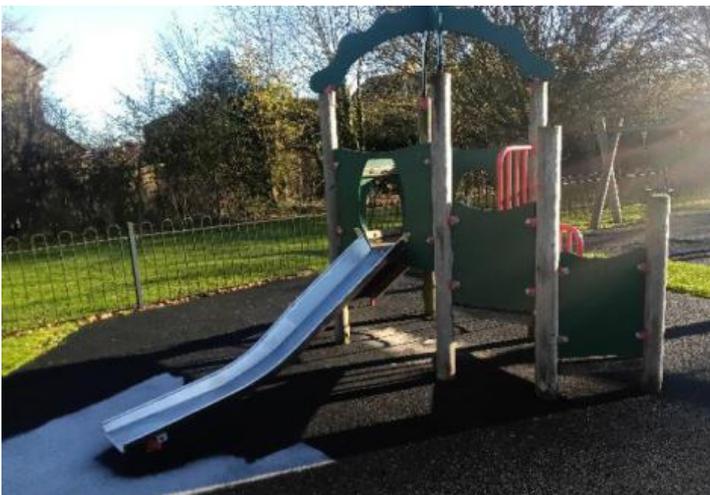
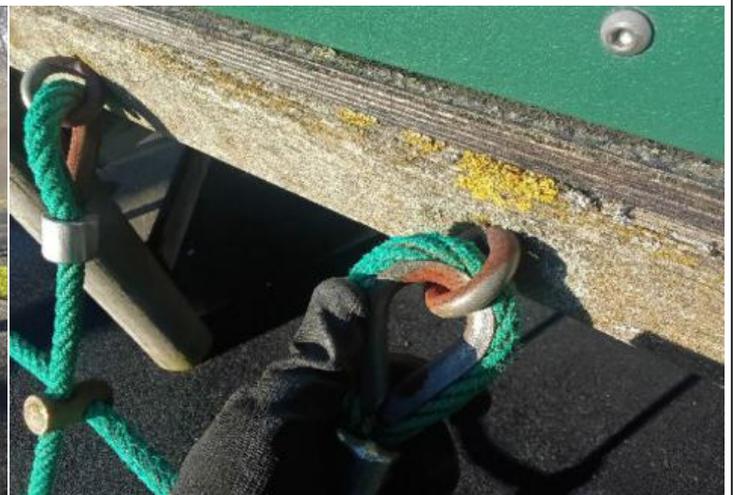
Finding: The connecting lugs are showing signs of wear

Action: Monitor for any further deterioration and replace as required

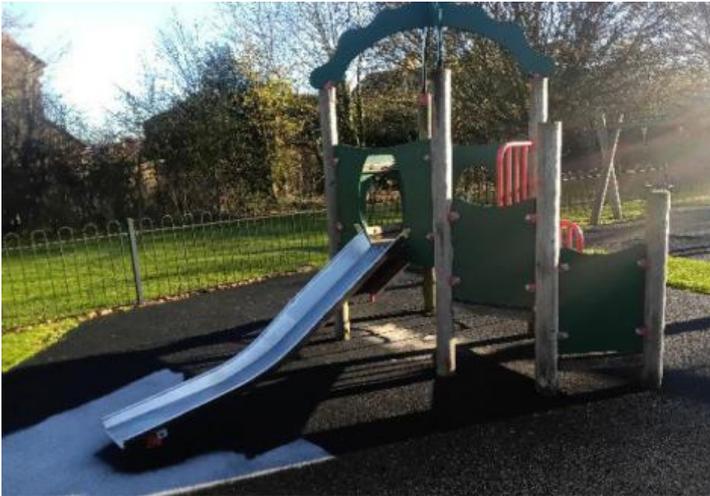
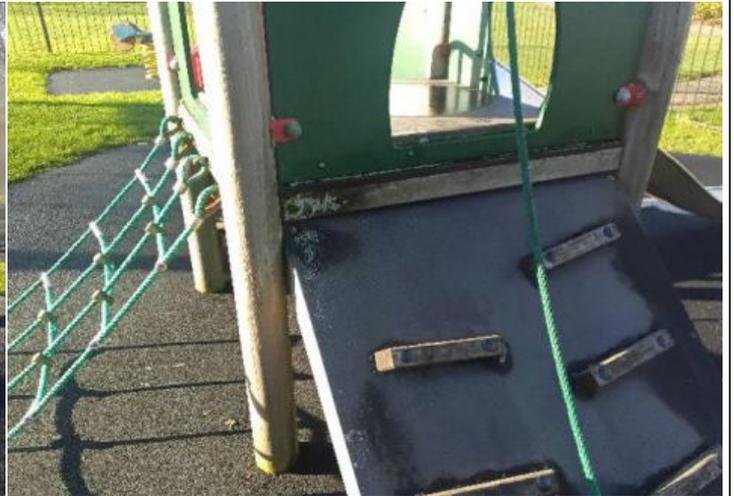
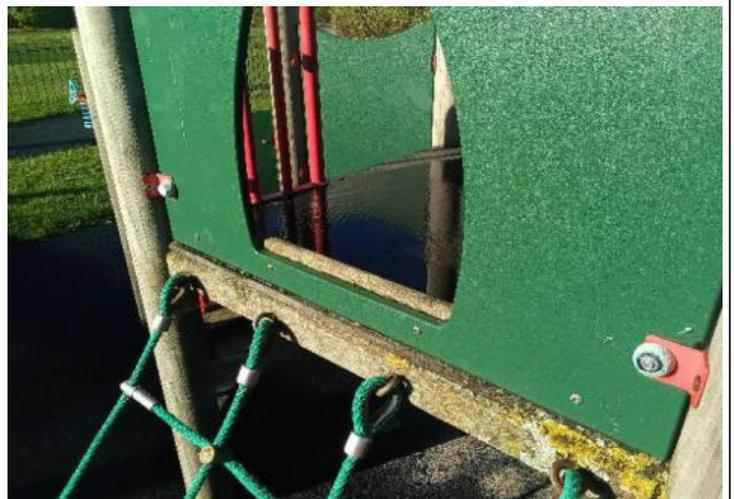
Finding: There is algae or moss on the surface of the multiplay

Action: Clean and treat appropriately

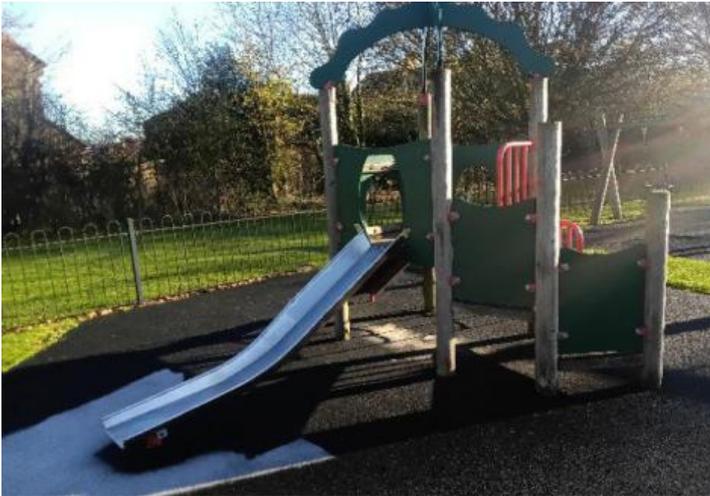
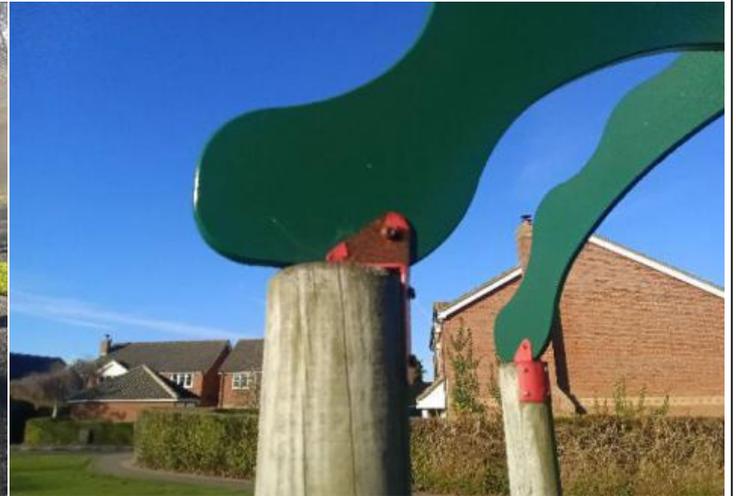
Finding: The paint is flaking off the metalwork

Action: Rub down and re-paint

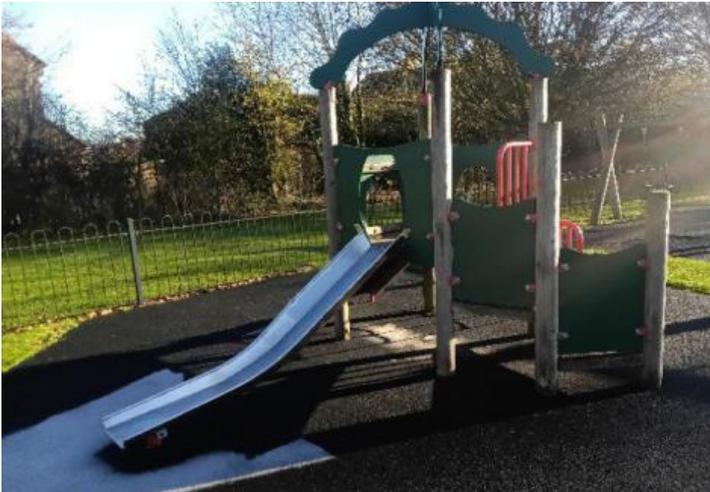
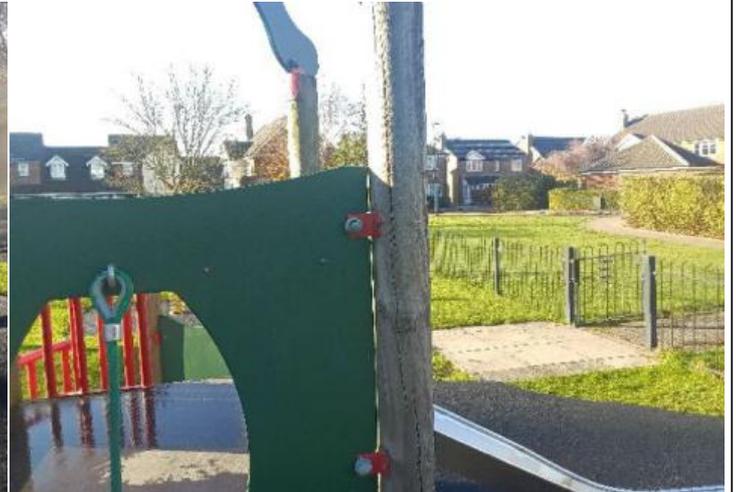
Finding: The timber has a number of splits/shakes or air cracks and this may affect the stability or allow water ingress which will accelerate the rotting process. Timber splits may also create rough / splintering edges.

Action: Monitor, sand down any rough edges and ensure the splits do not cross through fixing points of the structure and/or cause any instability

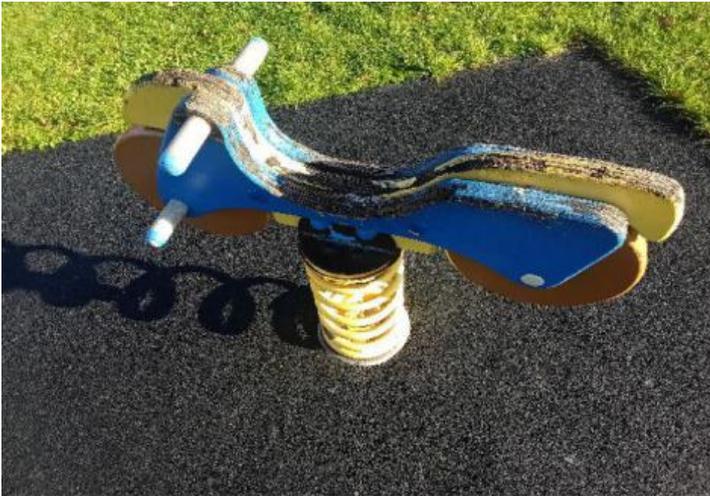
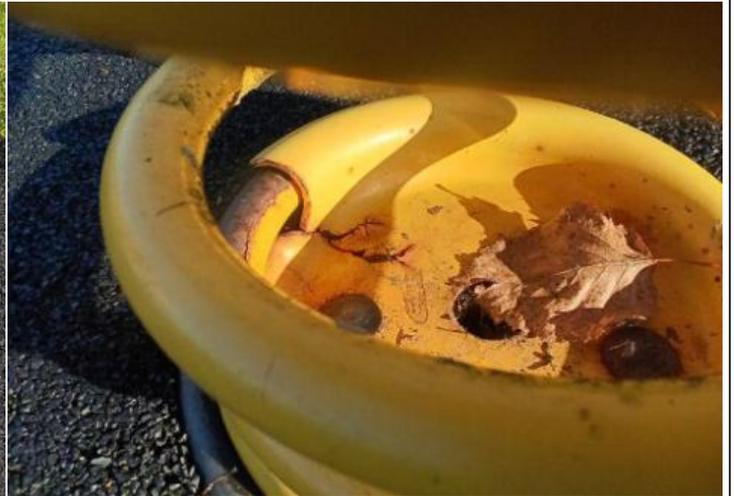
Finding: There is a crack within the baseplate

Action: Replace

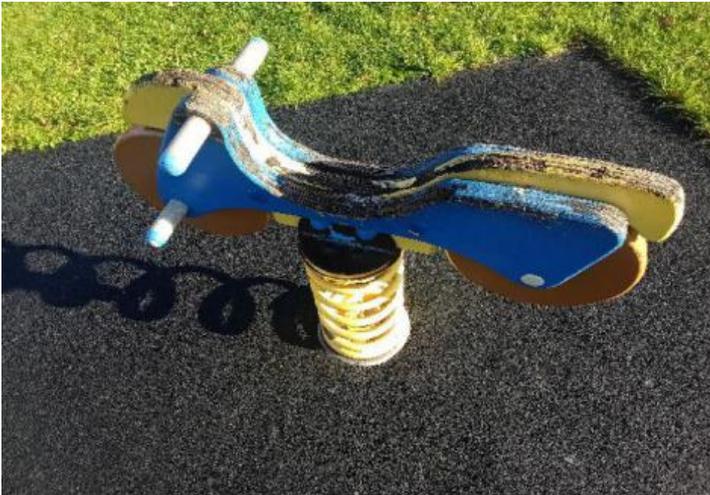
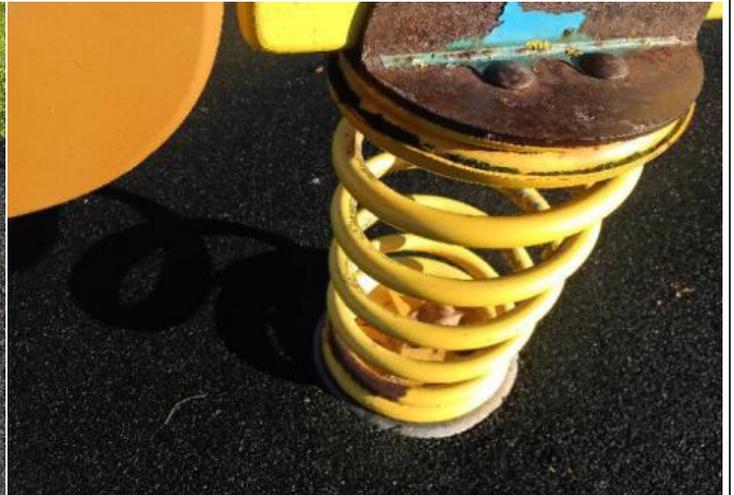
Finding: The paintwork on the spring has been damaged or worn exposing the metal underneath which is rusting

Action: Treat any rusting components and repaint

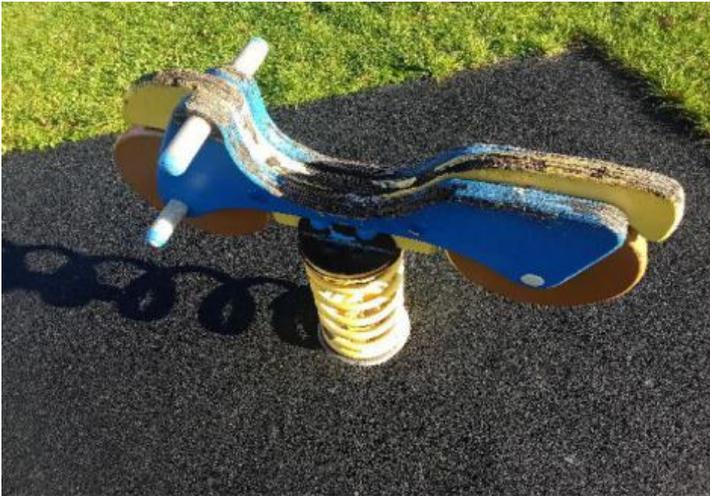
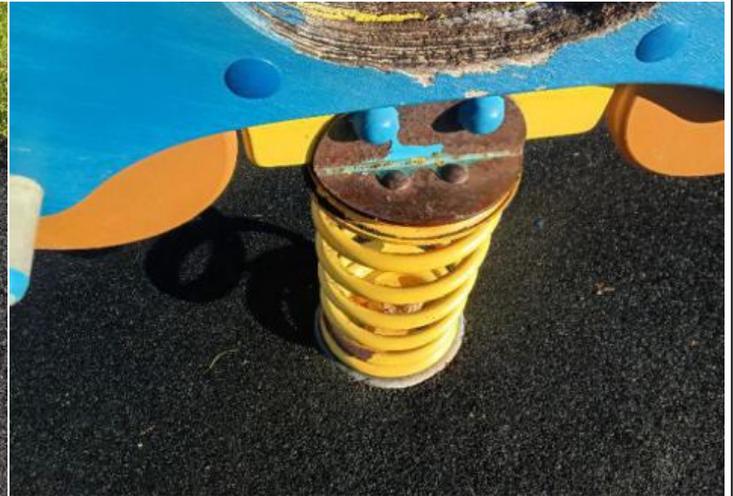
Finding: The spring rotates on the base

Action: Secure spring to prevent rotation

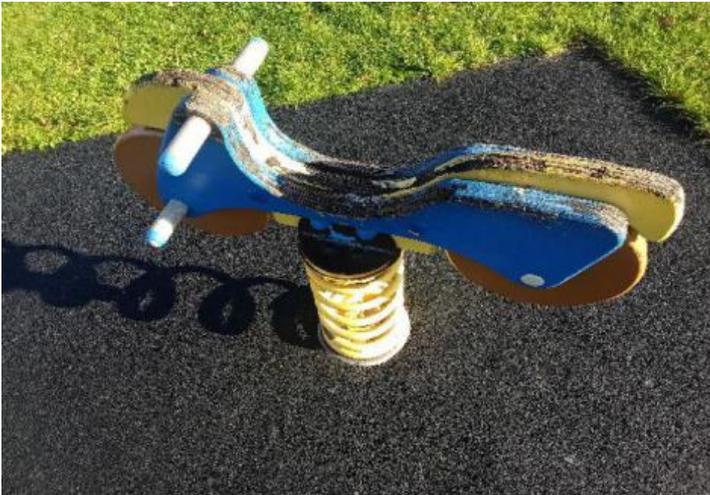
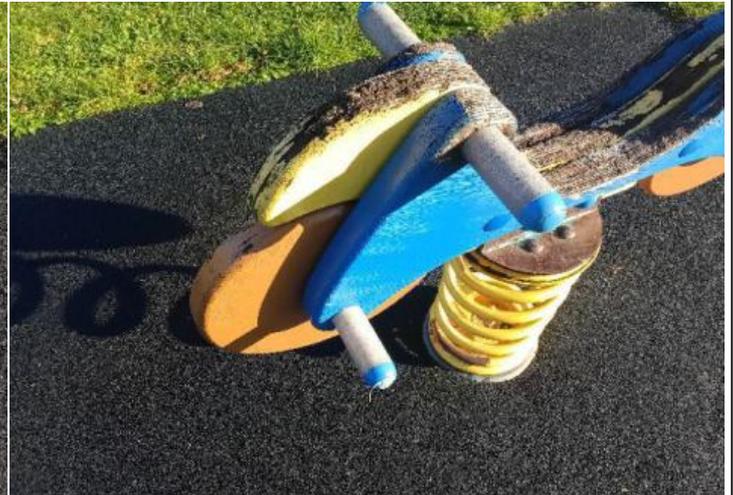
Finding: The end of handgrips and/or footrests have a cross section of less than 15cm² and fail to meet the requirements of BS EN 1176 Part 6

Action: Monitor - No action given the risk assessment
