Annual Inspection

Pirton Parish Council - Coleman's Close

Inspection Ref: 2901522

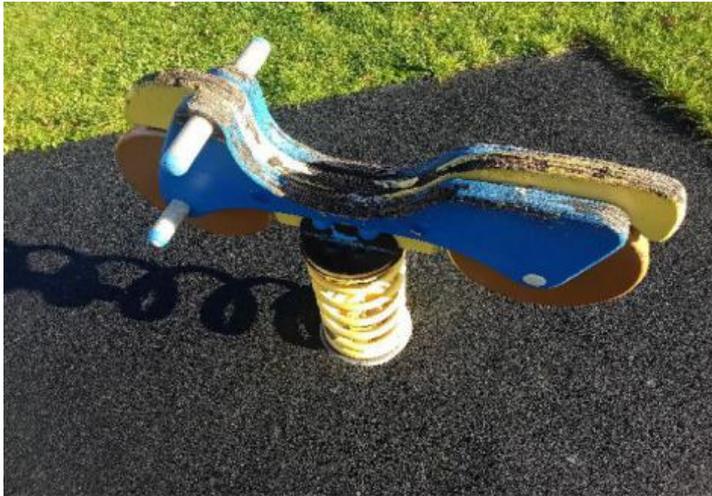
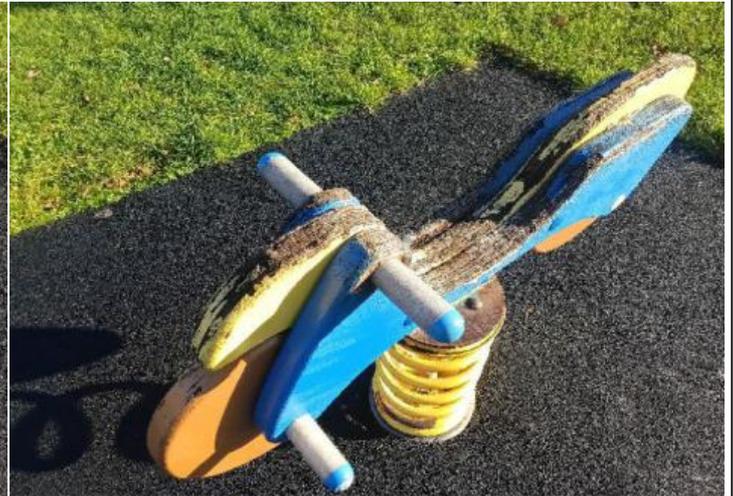
Finding: Parts of the timber are rough or splintered

Action: Remove all rough or sharp edges

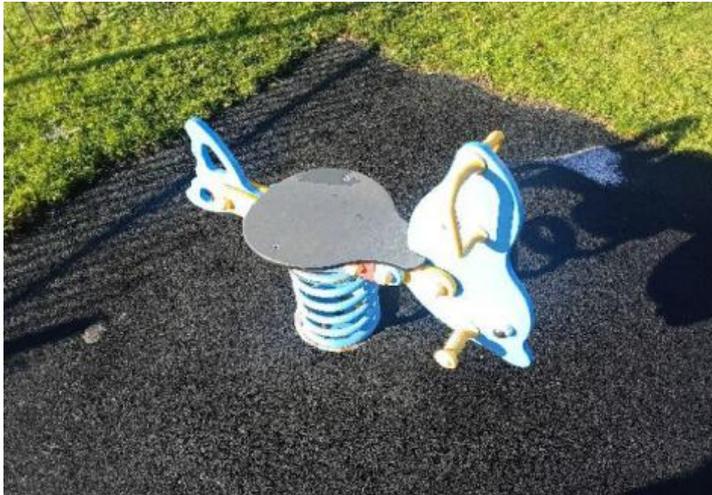
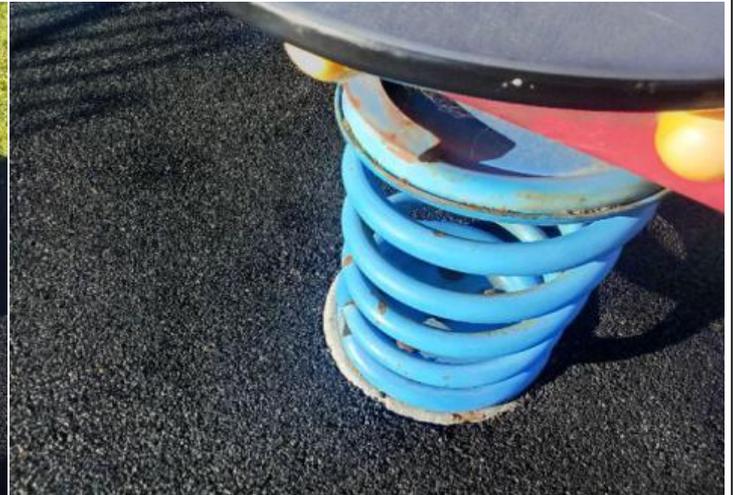
Finding: The paintwork on the spring has been damaged or worn exposing the metal underneath which is rusting

Action: Treat any rusting components and repaint
