the **play inspection** company

Annual Inspection

Pirton Parish Council - Recreation Ground

Walnut Tree Road, North Herts,

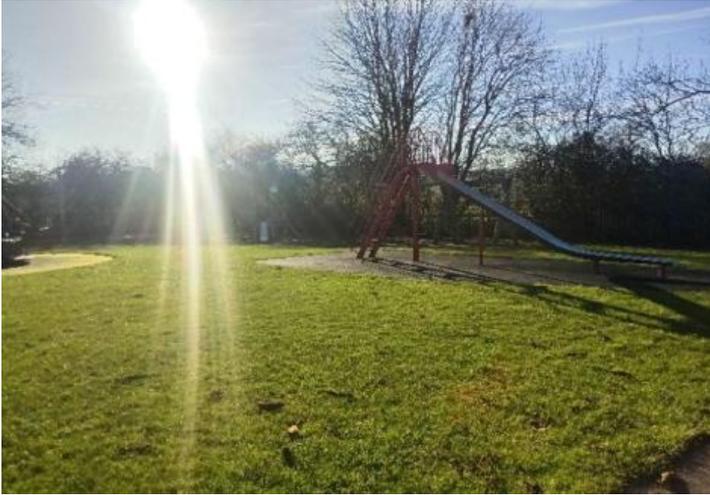
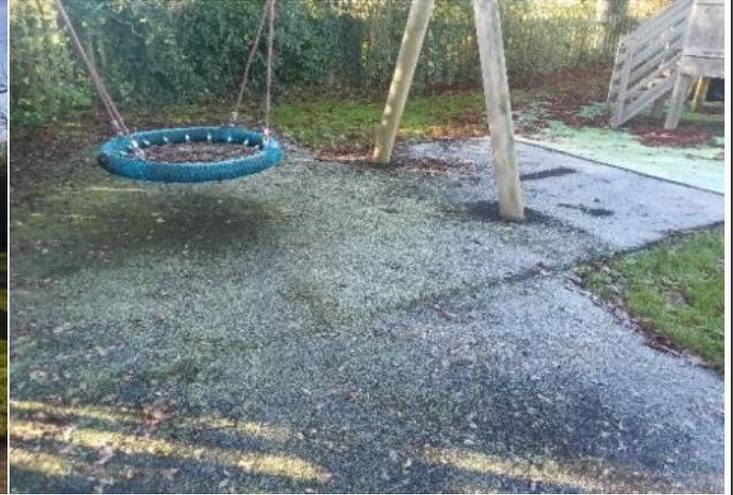
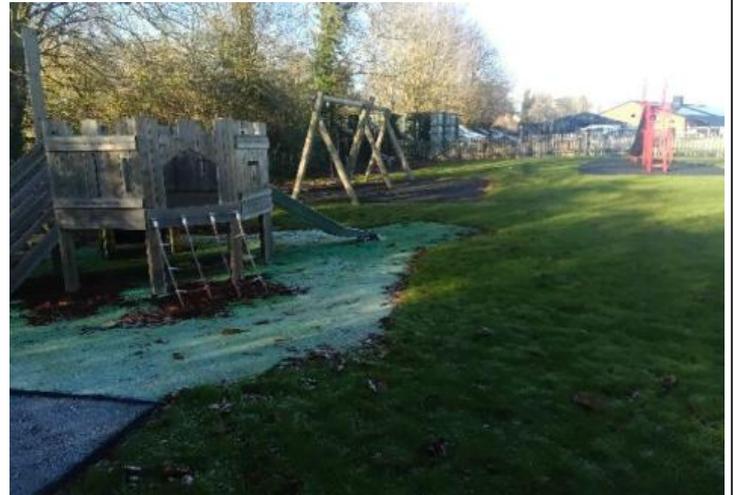
Item: Ancillary Items - Site General
Manufacturer: Owner/Operator

Finding: There is algae, silt or moss growth on the surface resulting in slippery conditions

Action: Clean and treat appropriately

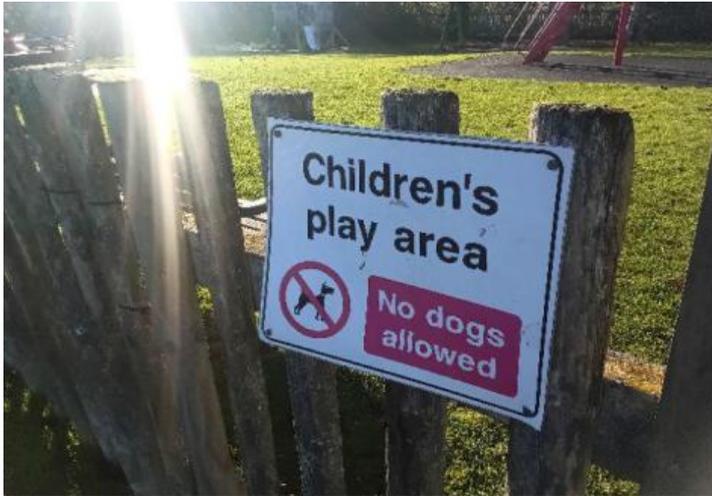
Item: Ancillary Items - Sign
Manufacturer: Not Identified

Finding: It is recommended that signage, with information including the site address, contact information for maintenance issues and emergency contact details are provided for the facility

Action: Provide in accordance with the recommendations

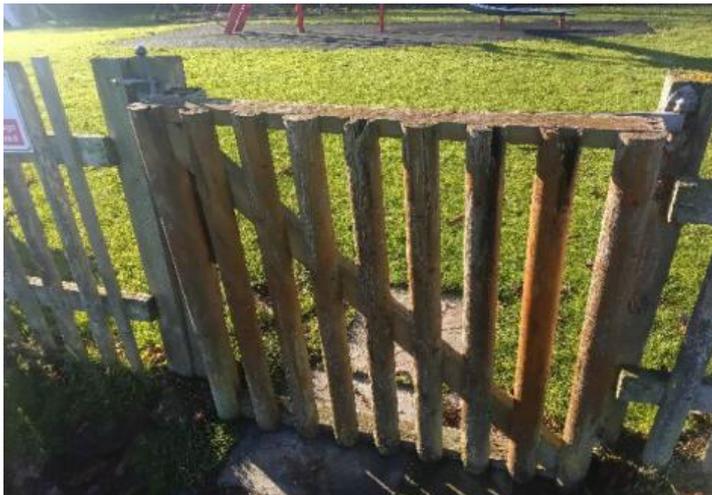
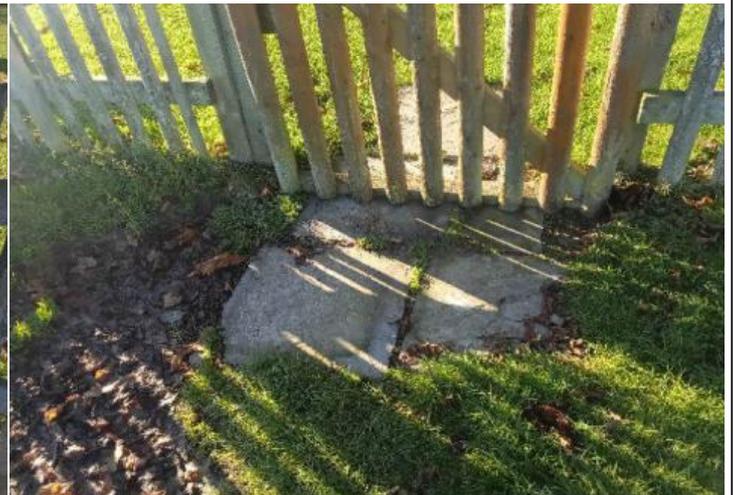
Item: Gates - Gate
Manufacturer: Not Identified

Finding: The area under the gate has eroded leaving uneven areas, or the concrete foundations exposed, resulting in trip hazards at the entrance/exit to the playground

Action: Reinststate to level with surrounding surfaces

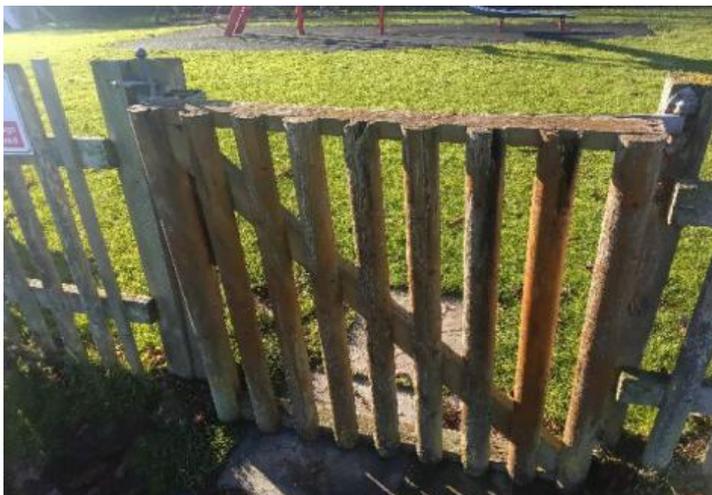
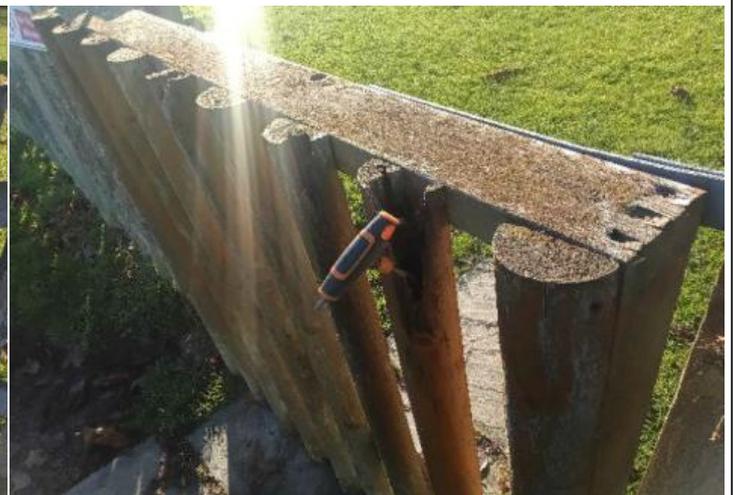
Item: Gates - Gate
Manufacturer: Not Identified

Finding: There are areas or parts of the timber gate that have rotted

Action: Replace gate

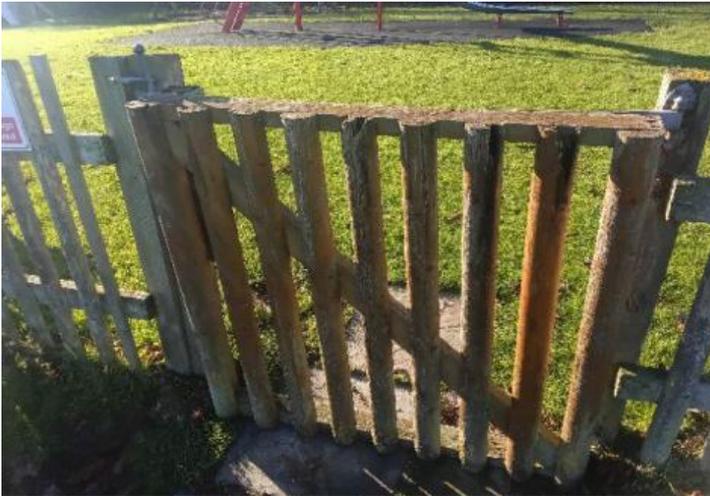
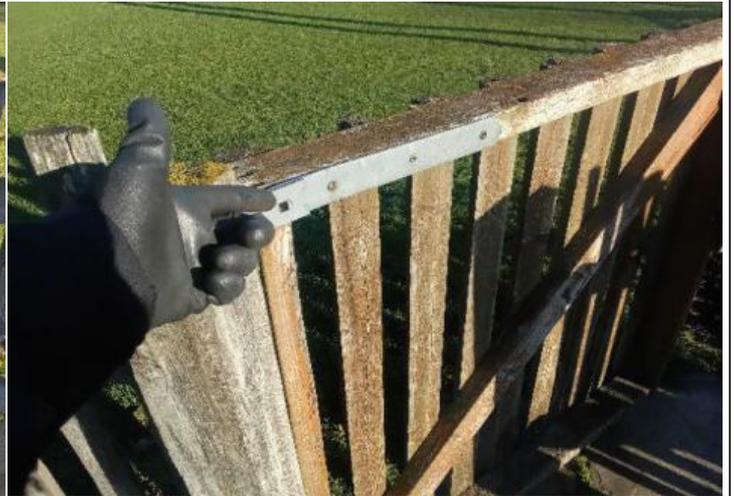
Item: Gates - Gate
Manufacturer: Not Identified

Finding: There is or are fixings missing on the gate

Action: Replace all missing fixings

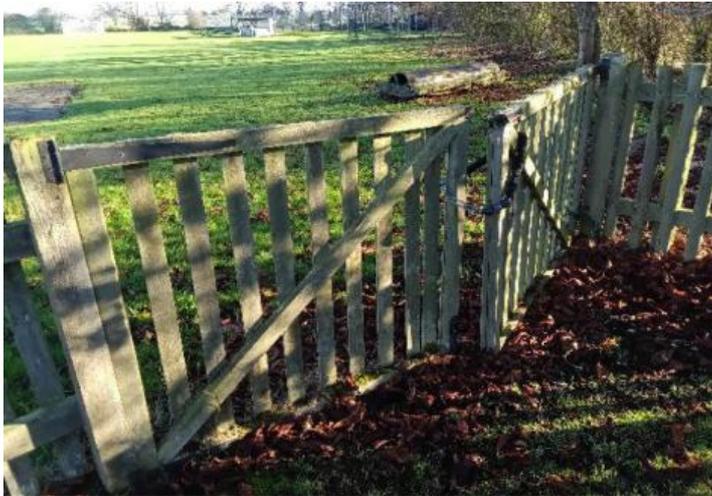
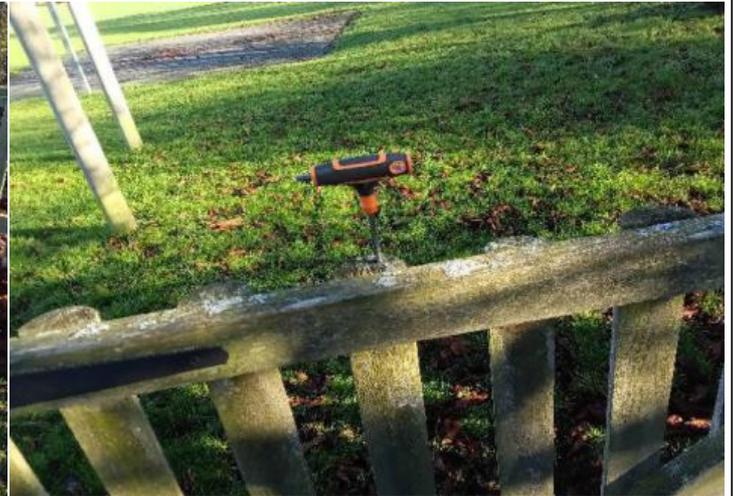
Item: Gates - Gate - Maintenance
Manufacturer: Not Identified

Finding: There is some evidence of rot in the timber gate

Action: Monitor for any further deterioration and replace as required

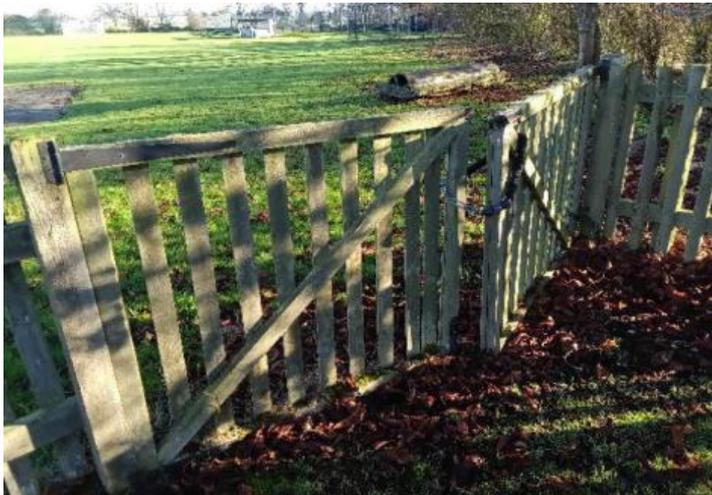
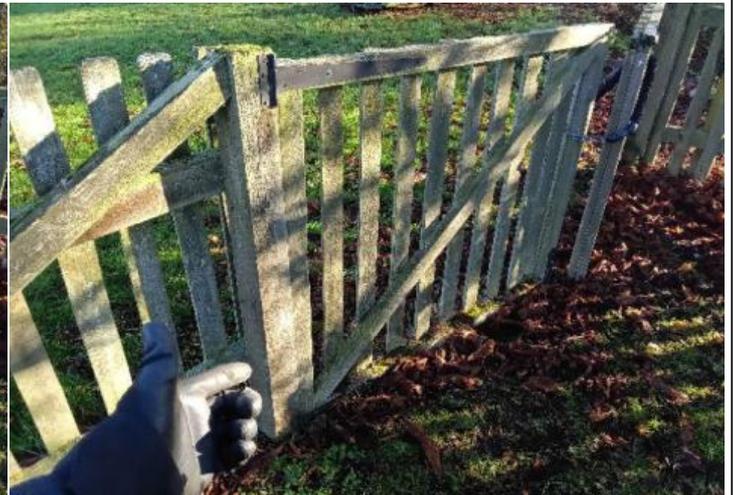
Item: Gates - Gate - Maintenance
Manufacturer: Not Identified

Finding: The gate post is loose

Action: Monitor for any further deterioration and reset as required

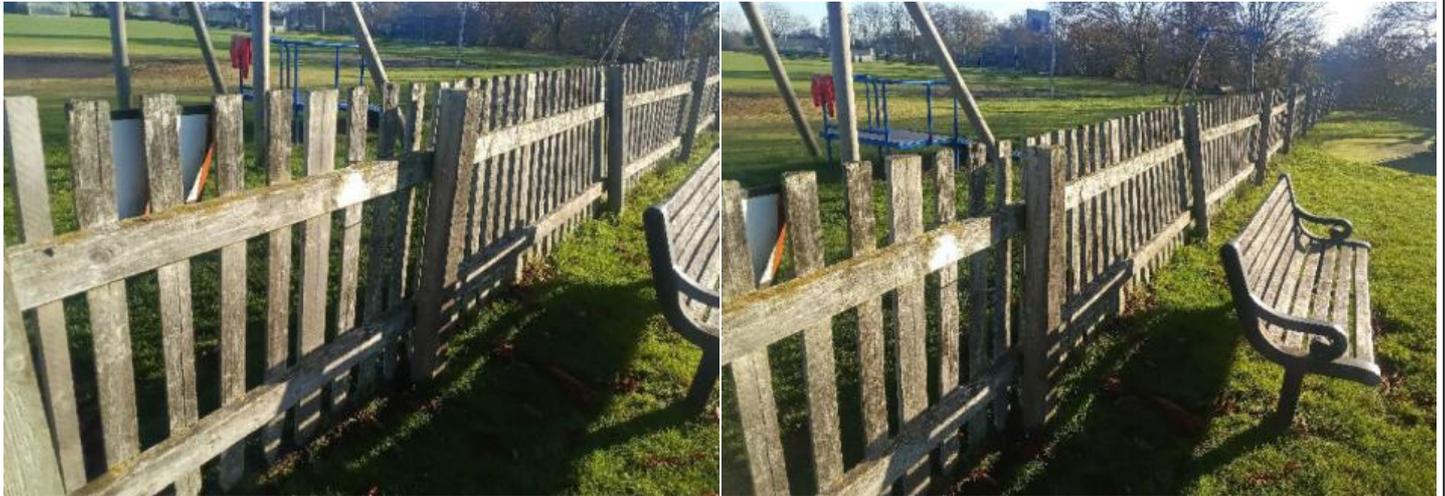
Item: Fences - Fencing - Timber
Manufacturer: Not Identified

Finding: The fence is severely damaged/rotten in places and is leaning in areas

Action: Repair or replace all affected sections

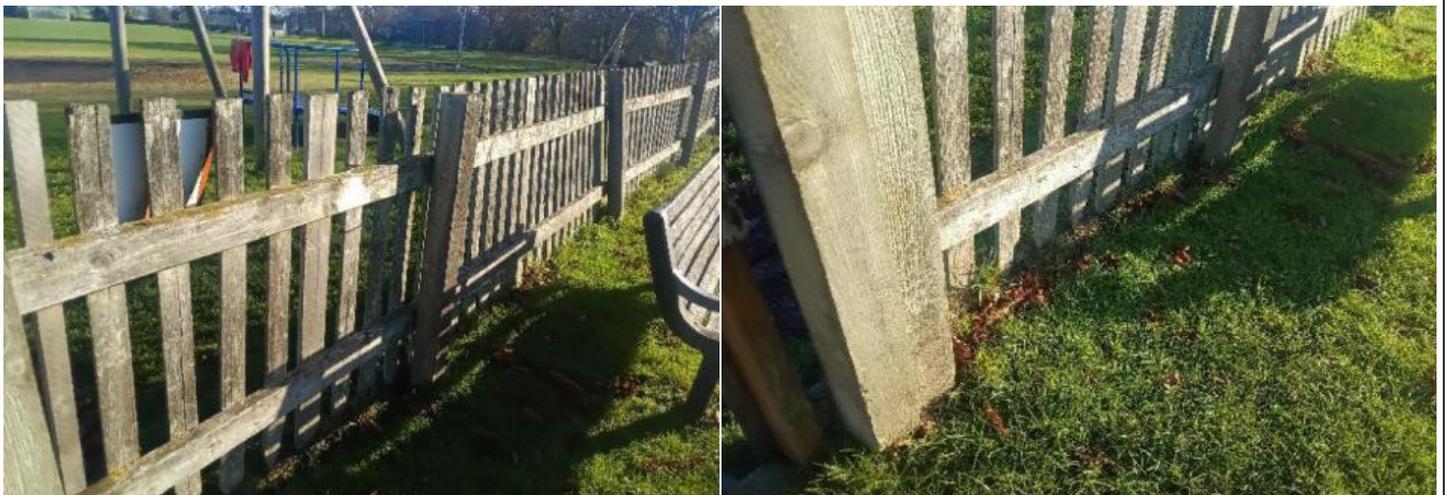
Item: Fences - Fencing - Timber
Manufacturer: Not Identified

Finding: There is some strimmer / machinery damage apparent on the posts, this can penetrate the preservative applied to the timber and accelerate the rotting process

Action: Monitor for any deterioration (rot) and replace as required

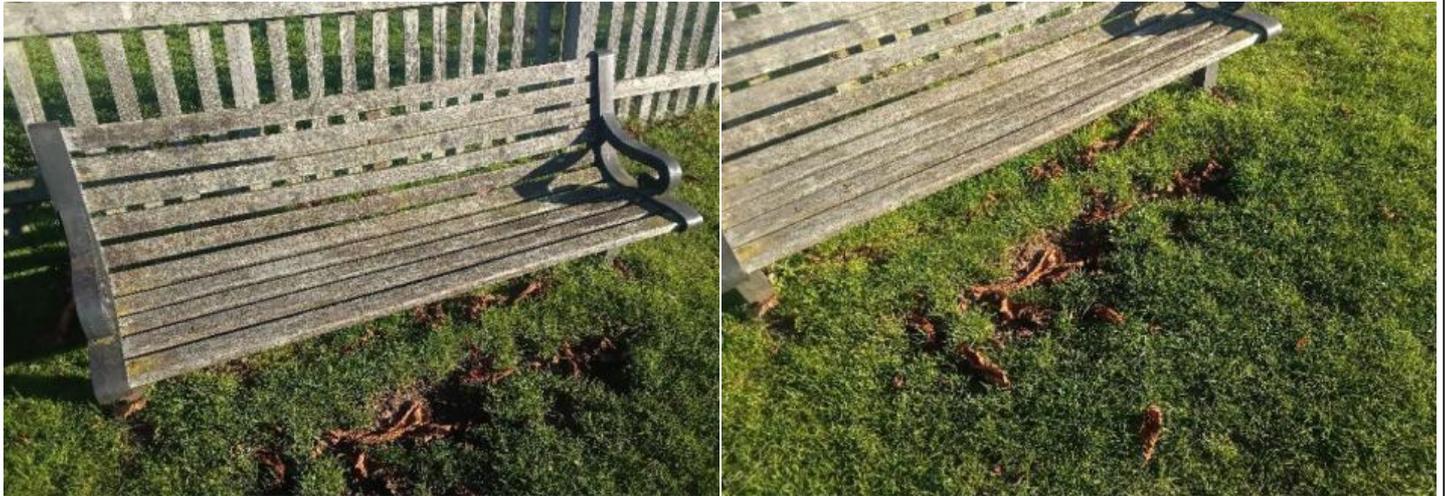
Item: Ancillary Items - Bench
Manufacturer: Not Identified

Finding: The surface has eroded in some areas and may be slippery in wet conditions
Action: Reinststate the surface

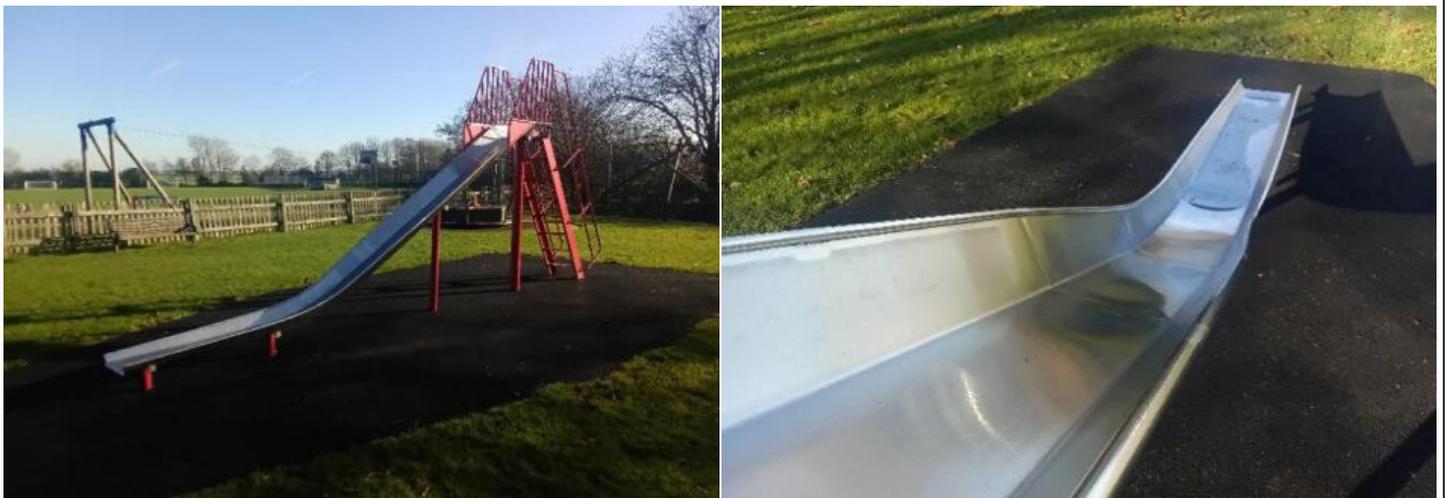
Item: Other - Free Standing Slide
Manufacturer: Not Identified

Finding: There are a number of dents in the slide surface
Action: Monitor for any further deterioration and repair as required

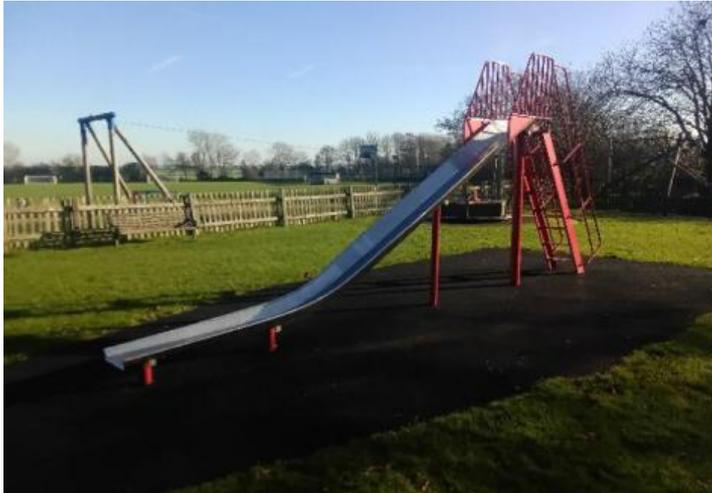
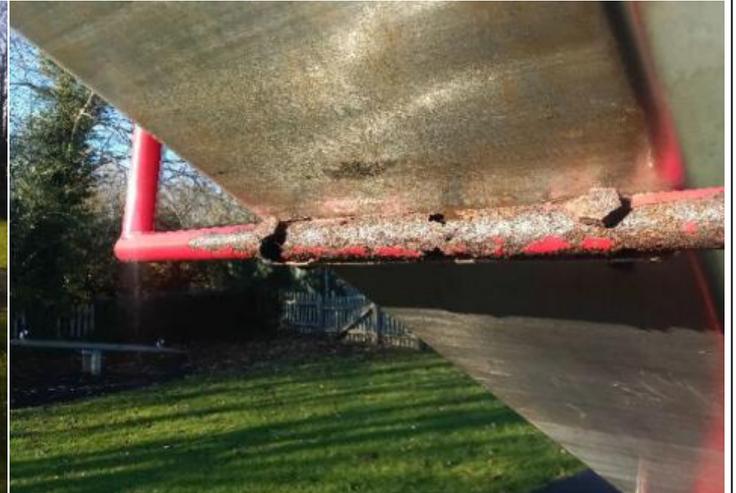
Item: Other - Free Standing Slide
Manufacturer: Not Identified

Finding: Parts of the steel on this freestanding slide have corroded excessively and the metal has perforated in places

Action: Ensure all affected areas are treated and repaired

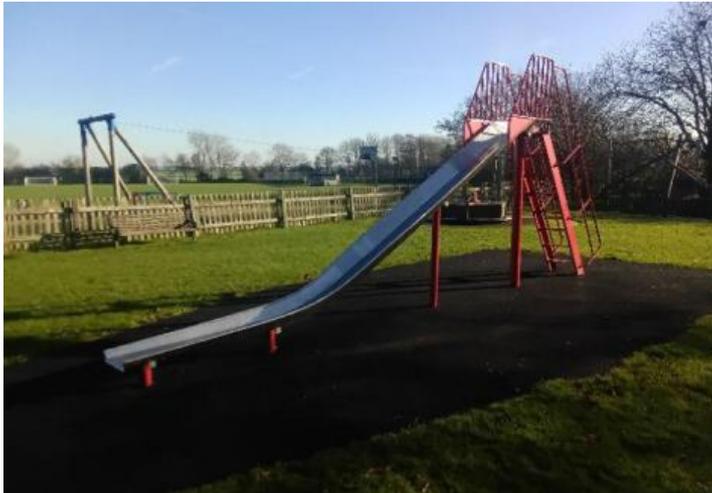
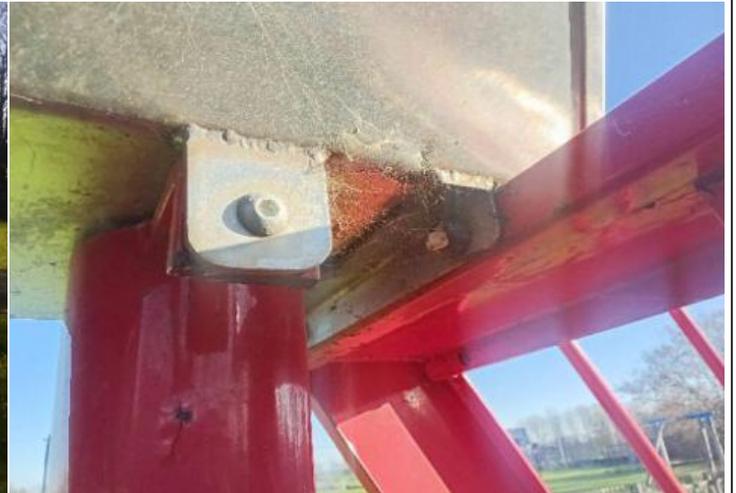
Item: Other - Free Standing Slide
Manufacturer: Not Identified

Finding: The fixings have corroded excessively

Action: Replace all corroded fixings

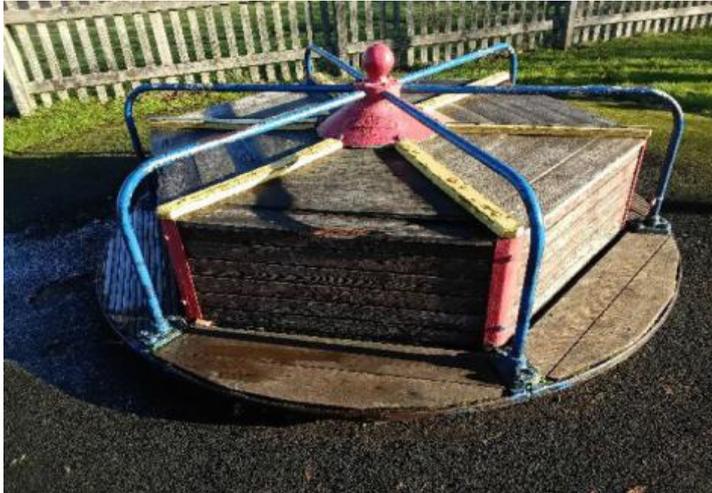
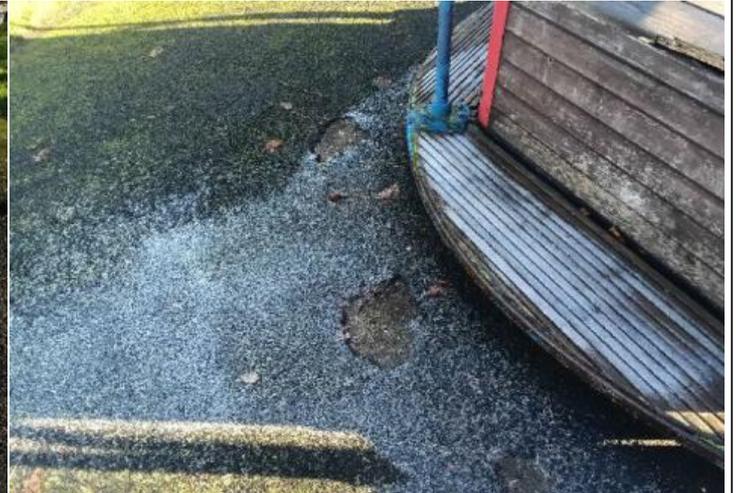
Item: Rotor Play - Roundabout
Manufacturer: Wicksteed Playgrounds

Finding: There is moderate damage to the surface

Action: Repair the damaged areas of surfacing

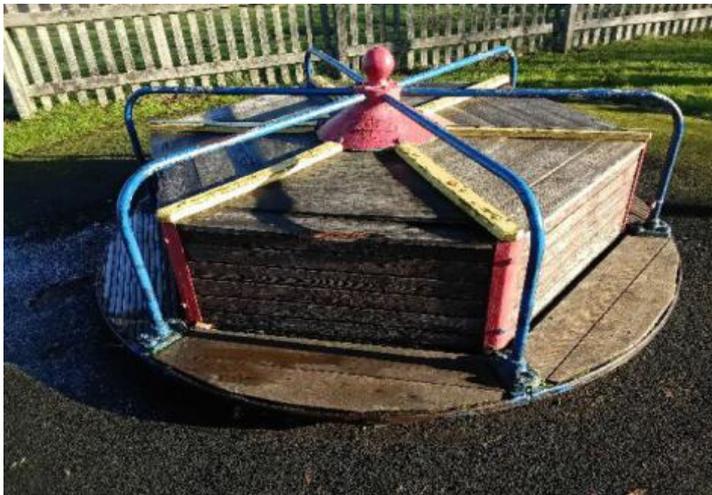
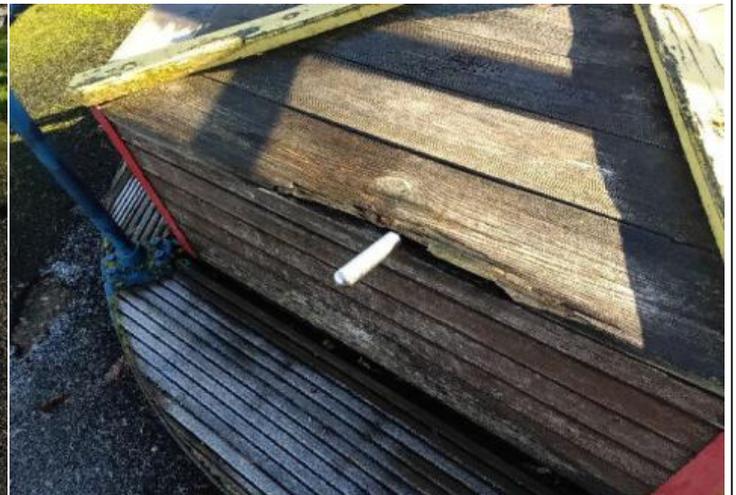
Item: Rotor Play - Roundabout
Manufacturer: Wicksteed Playgrounds

Finding: The timber is rotten creating finger entrapment/s in the roundabout and the item fails to meet the requirements of BS EN 1176 Part 1 4.2.7.6 Entrapment of fingers

Action: Replace timber to remove the entrapment

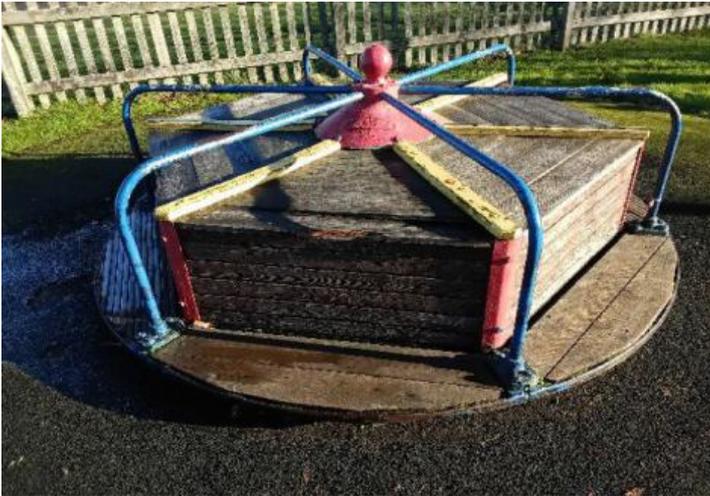
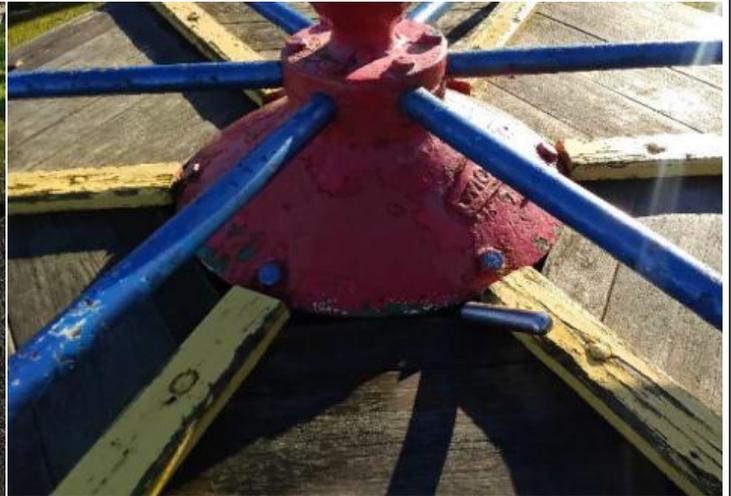
Item: Rotor Play - Roundabout
Manufacturer: Wicksteed Playgrounds

Finding: There is/are finger entrapment/s in the roundabout and the item fails to meet the requirements of BS EN 1176 Part 1 4.2.7.6 Entrapment of fingers
Action: Remove the entrapment

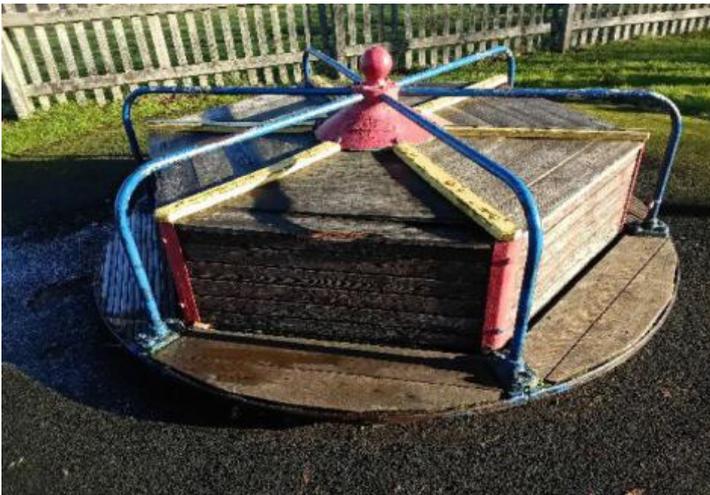
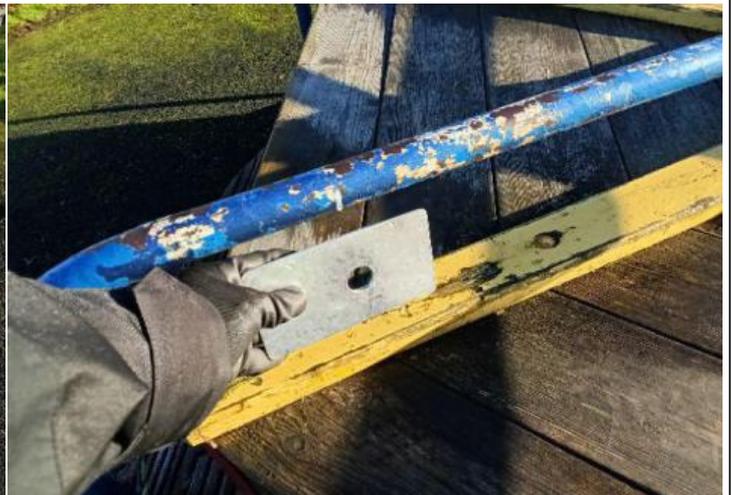
Item: Rotor Play - Roundabout
Manufacturer: Wicksteed Playgrounds

Finding: The item fails to meet the requirements of BS EN 1176 Part 1 4.2.7.2 for head and neck entrapment in the framework
Action: Monitor - No action given the risk assessment

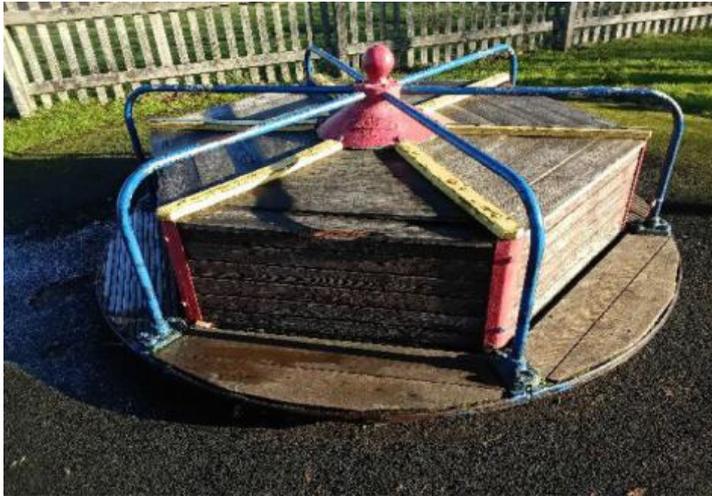
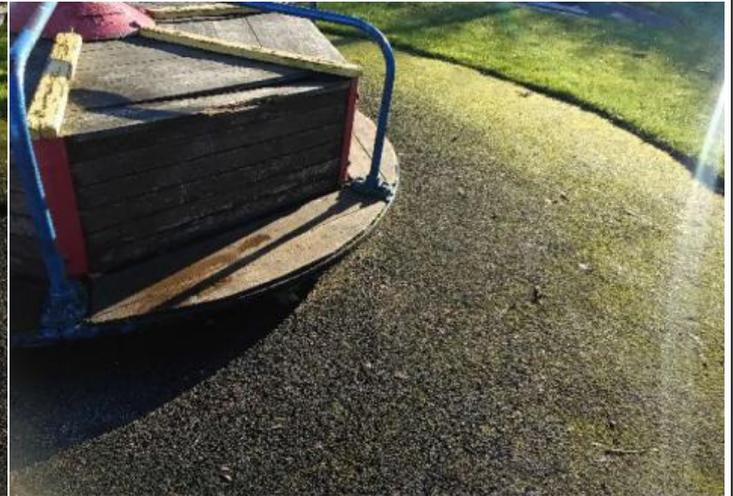
Item: Rotor Play - Roundabout
Manufacturer: Wicksteed Playgrounds

Finding: The safety surface around the area is beginning to wear

Action: Monitor for any further deterioration and repair as required

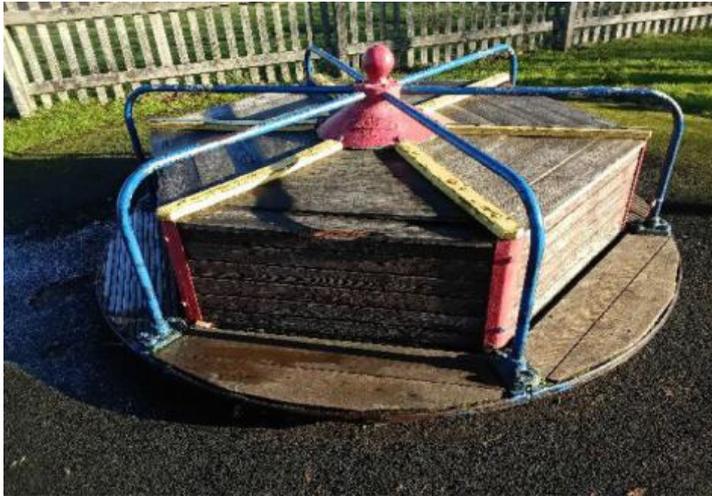
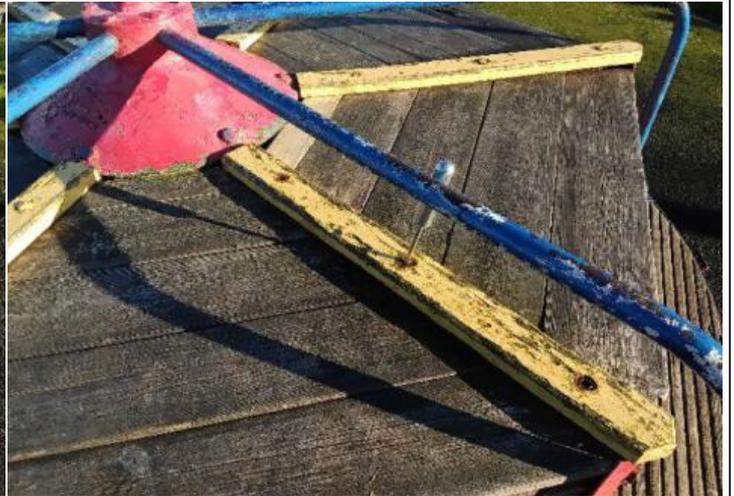
Item: Rotor Play - Roundabout
Manufacturer: Wicksteed Playgrounds

Finding: There are missing fixings creating finger entrapment/s in the framework and the item fails to meet the requirements of BS EN 1176 Part 1 4.2.7.6 Entrapment of fingers

Action: Replace the missing fixings to remove the entrapment

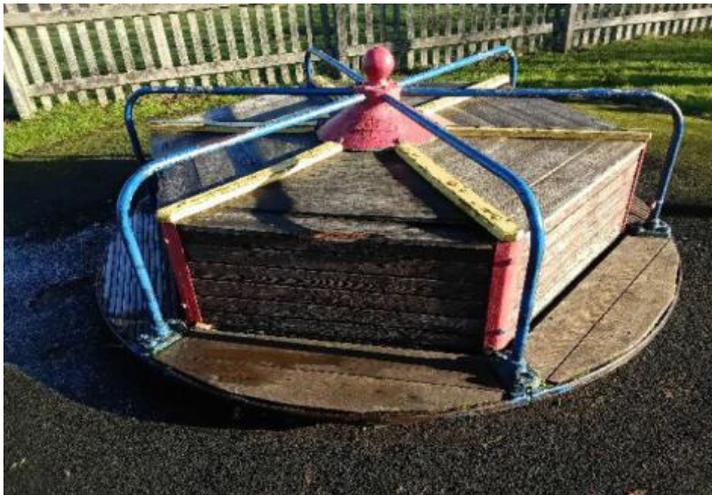
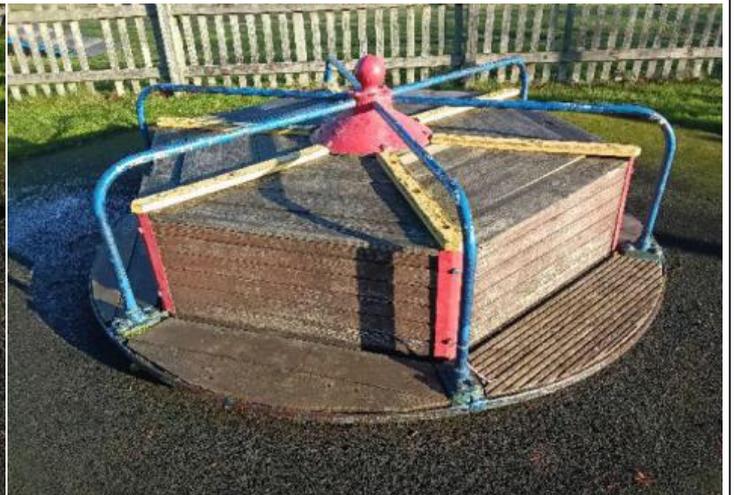
Item: Rotor Play - Roundabout
Manufacturer: Wicksteed Playgrounds

Finding: The bearing is showing signs of wear

Action: Monitor for any further deterioration and replace as required

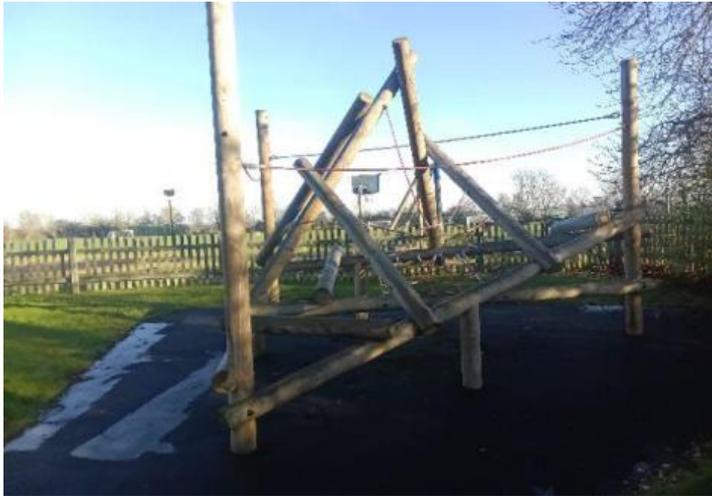
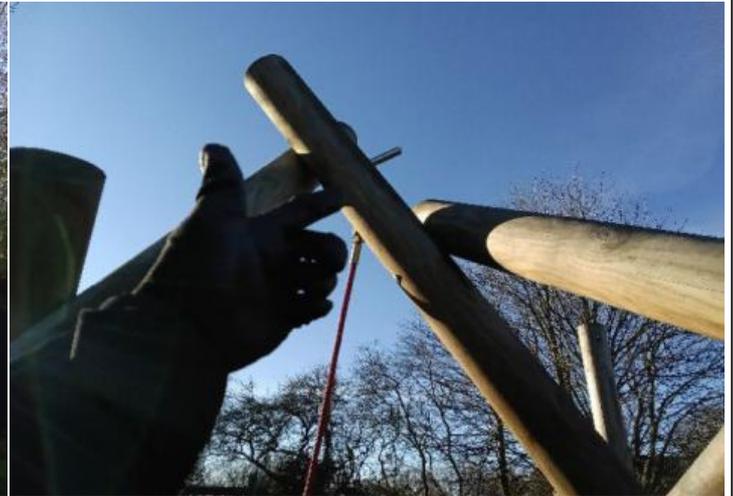
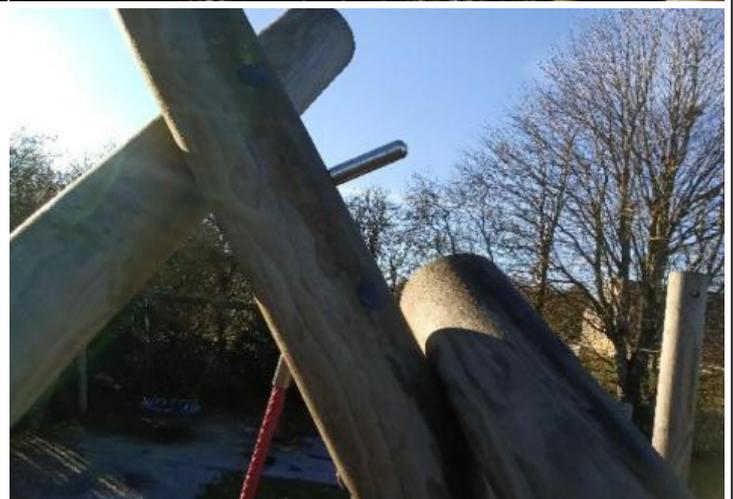
Item: Activity Equipment - Log Climber
Manufacturer: Setter Play

Finding: There is/are finger entrapment/s in the framework and the item fails to meet the requirements of BS EN 1176 Part 1 4.2.7.6 Entrapment of fingers

Action: Provide inserts to remove the entrapment

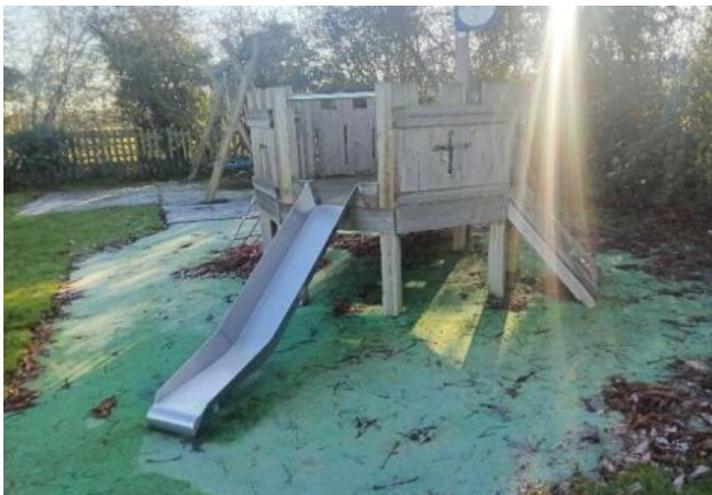
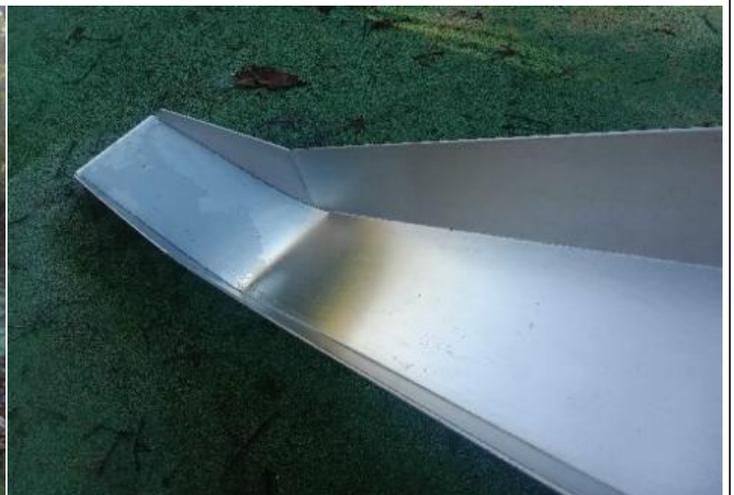
Item: Activity Equipment - Multi Play (Toddler)
Manufacturer: Setter Play

Finding: There are a number of dents in the slide surface

Action: Monitor for any further deterioration and repair as required

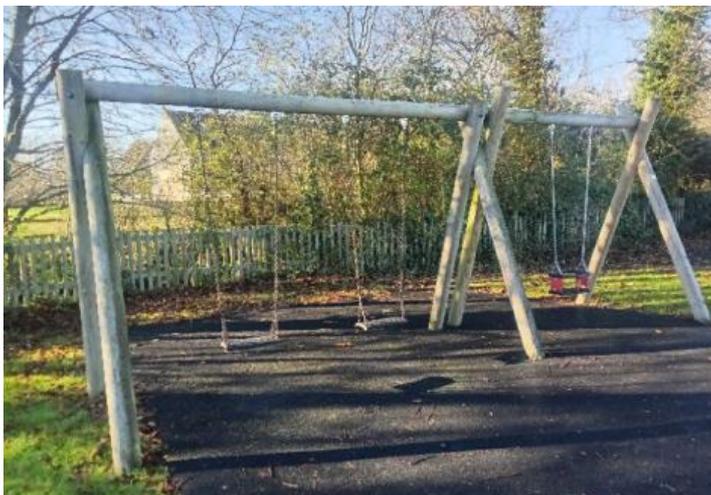
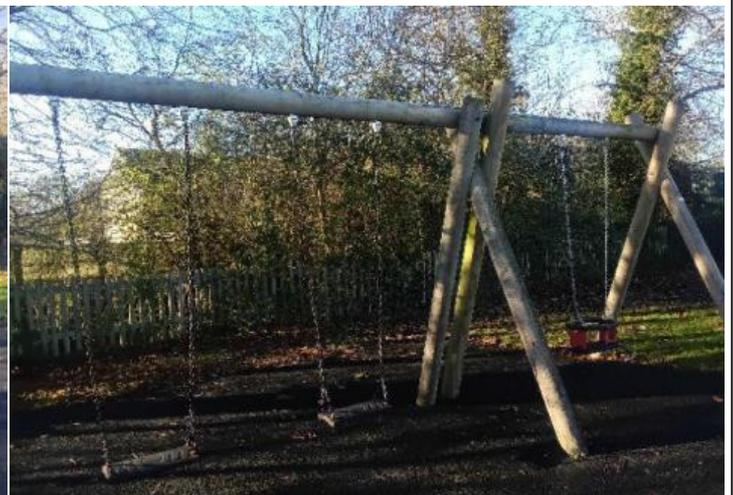
Item: Swings - 2 Bay 2 Flat 1 Cradle Seat
Manufacturer: Setter Play

Finding: This design of swing joint has been known to fail on the weld connecting the joint to the threaded stud

Action: We would recommend that the joint be dismantled and checked on a regular basis or consulting with manufacturer on whether a Secondary Safety Device can be fitted

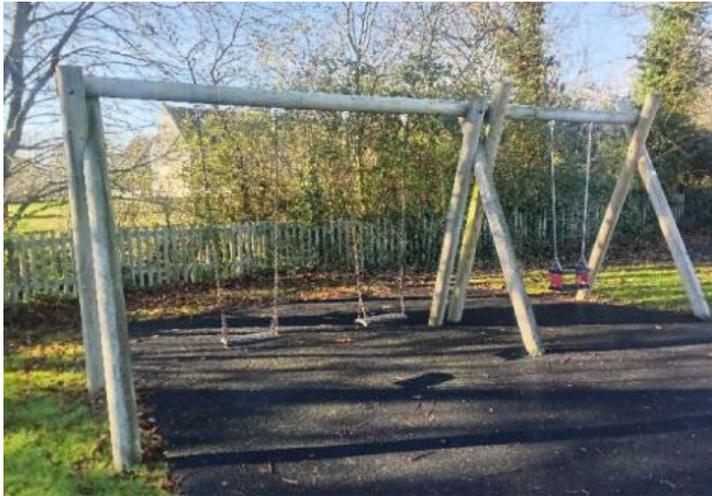
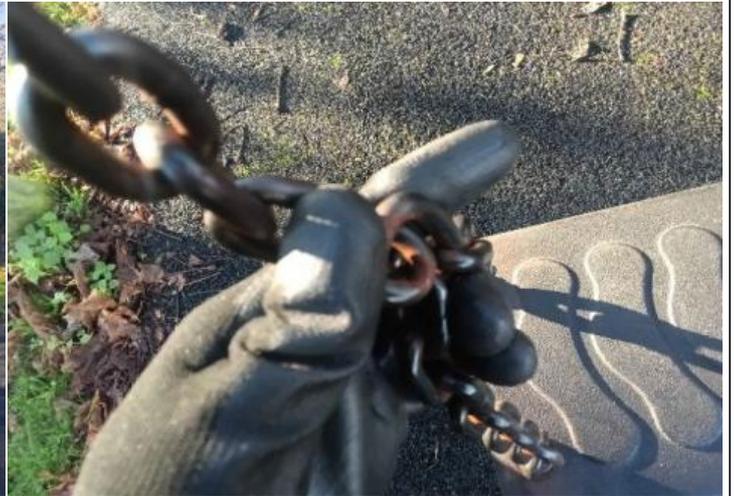
Item: Swings - 2 Bay 2 Flat 1 Cradle Seat
Manufacturer: Setter Play

Finding: There is some notable evidence of chain wear

Action: Monitor for any further deterioration and replace when 40% worn

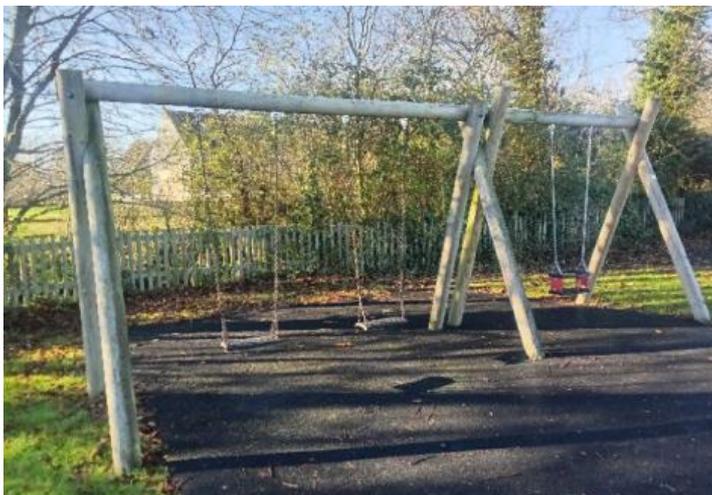
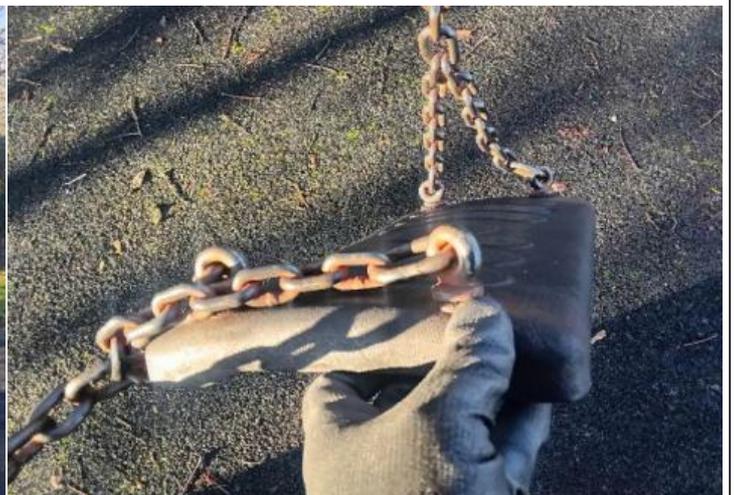
Item: Swings - 2 Bay 2 Flat 1 Cradle Seat
Manufacturer: Setter Play

Finding: The swing seat connectors have some wear present

Action: Monitor for further deterioration and replace when 40% worn

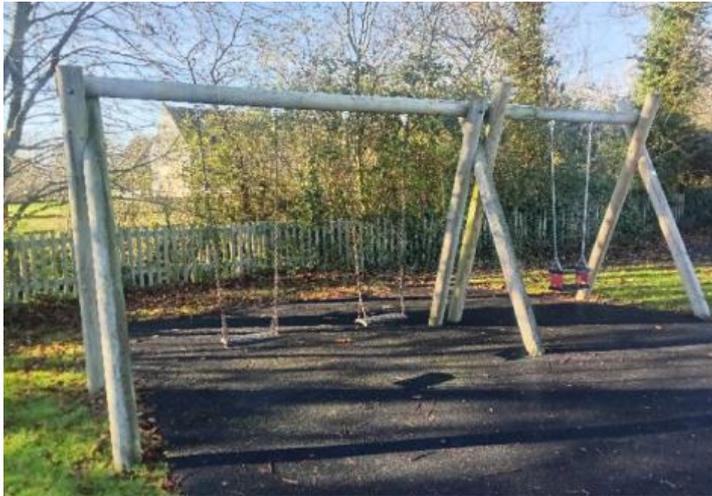
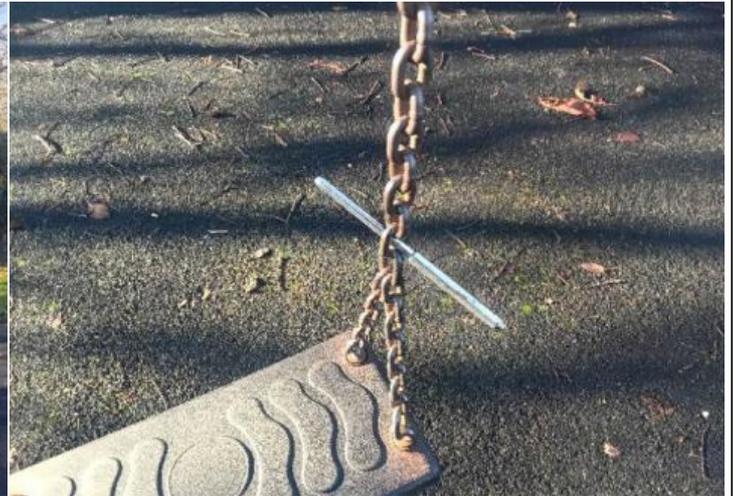
Item: Swings - 2 Bay 2 Flat 1 Cradle Seat
Manufacturer: Setter Play

Finding: The chain openings are in excess of the 8.6mm as recommended by BS EN 1176
Action: Monitor - No action given the risk assessment

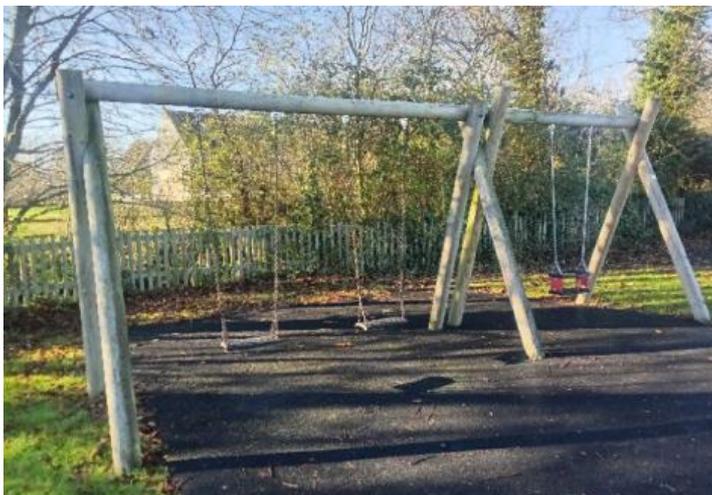
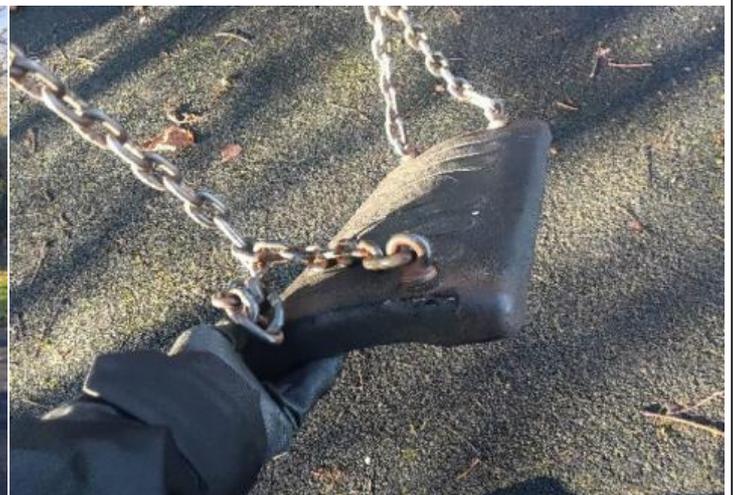
Item: Swings - 2 Bay 2 Flat 1 Cradle Seat
Manufacturer: Setter Play

Finding: The seat has minor damage or wear
Action: Monitor for any further deterioration and replace as required

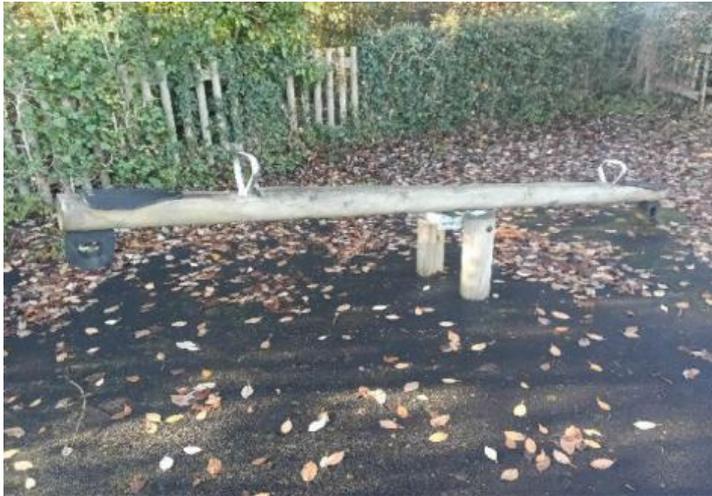
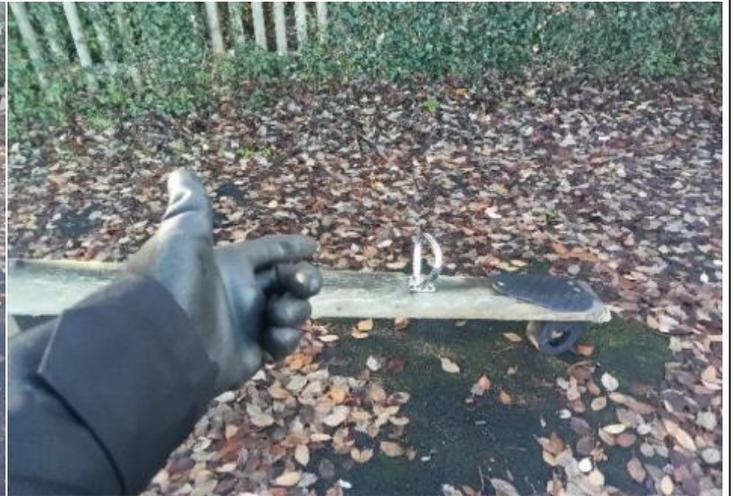
Item: Rocking Equipment - See Saw
Manufacturer: Setter Play

Finding: The surface has subsided in some areas

Action: Monitor for any further deterioration and repair as required

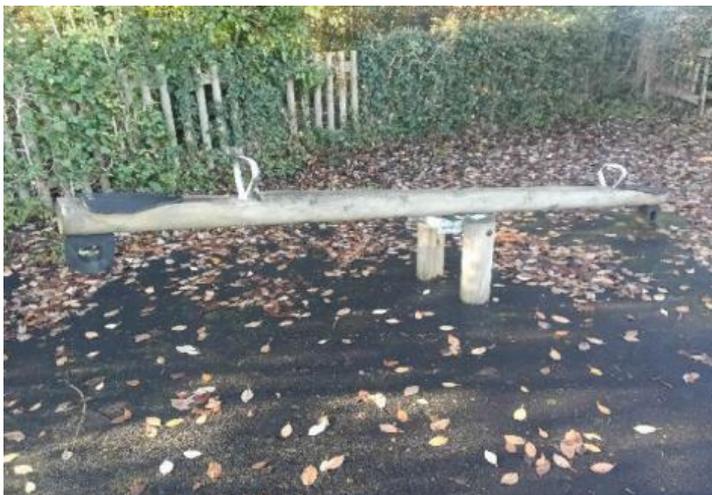
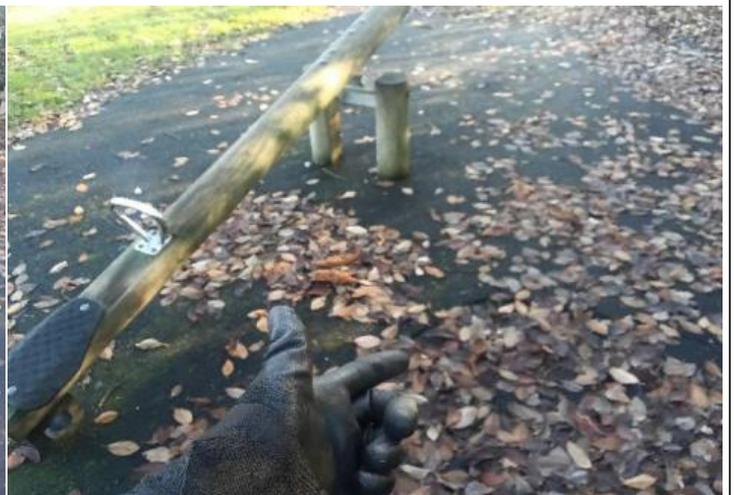
Item: Rocking Equipment - See Saw
Manufacturer: Setter Play

Finding: There is moderate damage to the surface

Action: Repair the damaged areas of surfacing
