the **play inspection** company

Annual Inspection

Pirton Parish Council - Recreation Ground

Walnut Tree Road, North Herts,

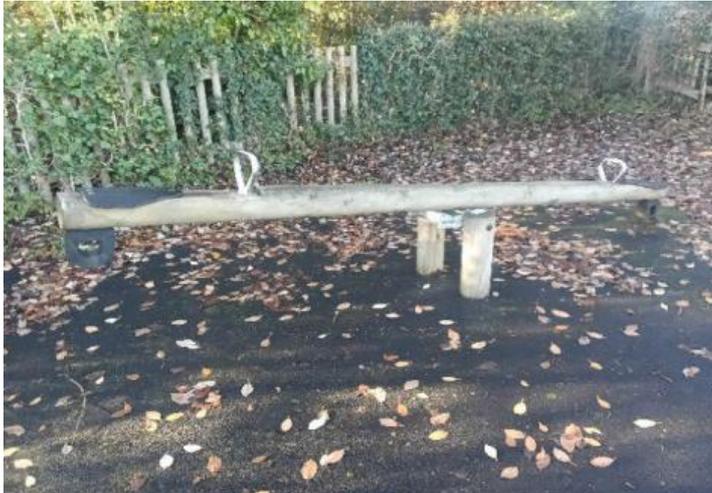
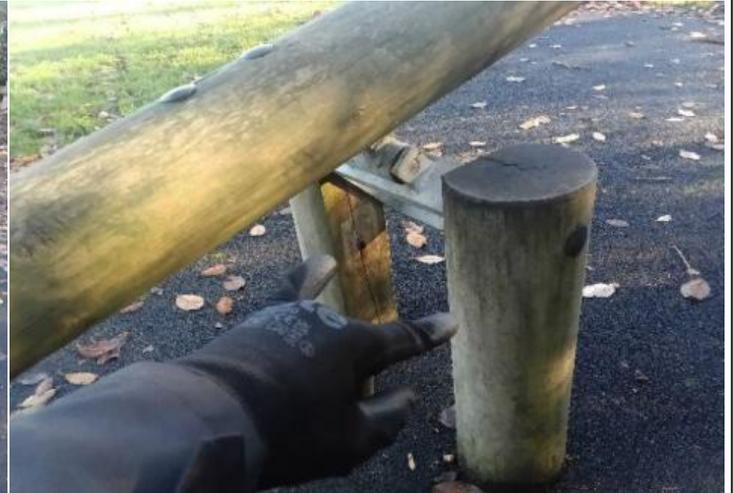
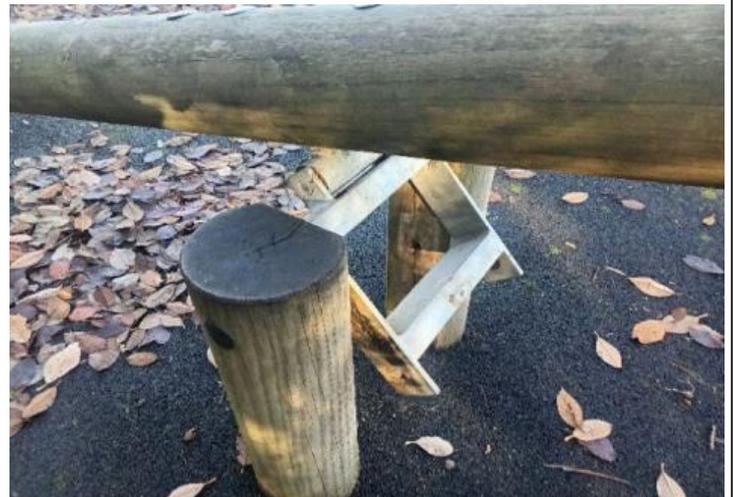
Item: Rocking Equipment - See Saw
Manufacturer: Setter Play

Finding: There are fixings missing on the see saw pivot
(Client Notified)

Action: Replace all missing fixings

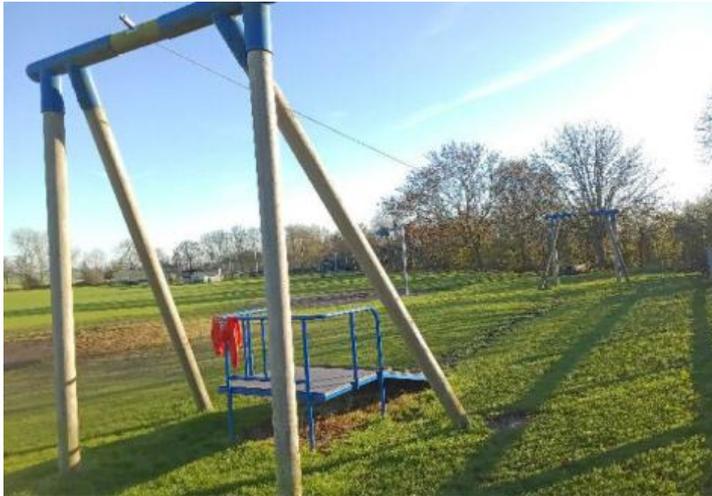
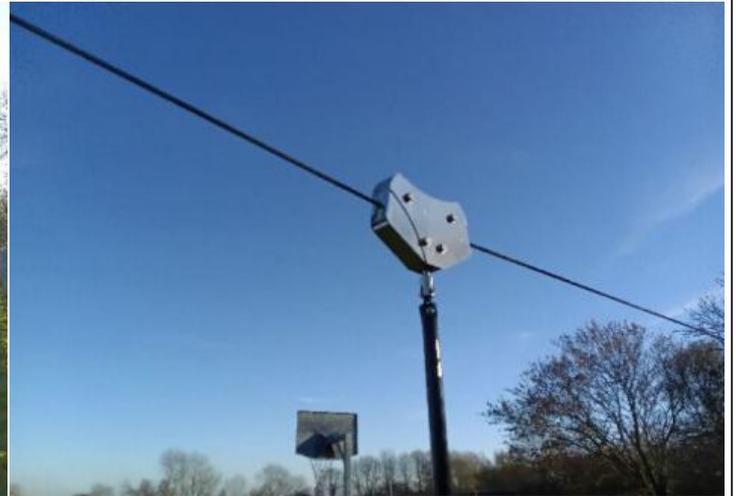
Item: Other - Cable Runway
Manufacturer: Not Identified

Finding: We have completed a visual inspection of the suspension links, cable and fixing points from ground level, however it is not possible to fully inspect these areas without either hiring equipment to gain access or removing the cable and suspension and inspecting at ground level. We recommend that the main cable and fixing security is thoroughly inspected at least in accordance with the manufacturers recommendations to check for wear, damage, security or internal rusting; this will help to ensure the continued safe use of the equipment

Action: Inspect in accordance with the manufacturers recommendations

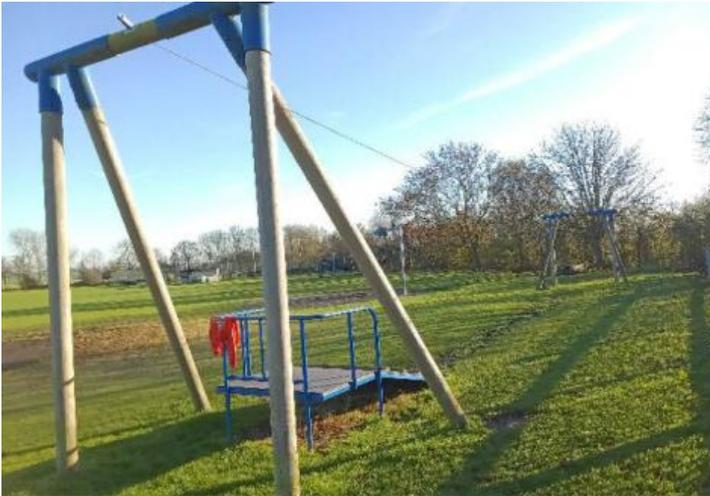
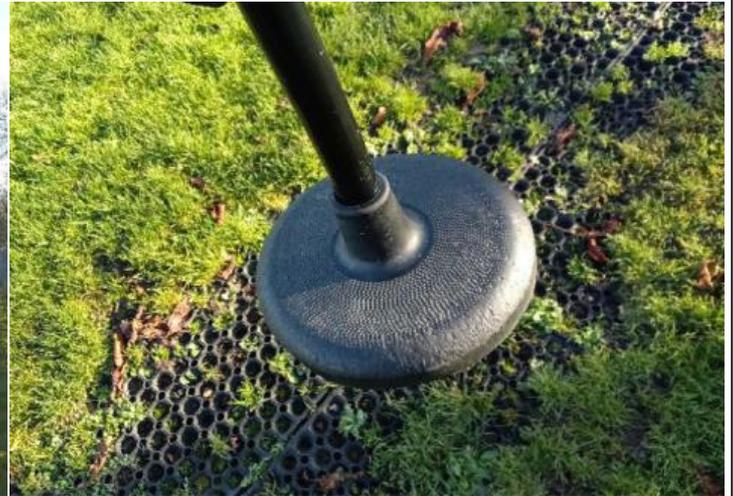
Item: Other - Cable Runway
Manufacturer: Not Identified

Finding: The seat connection cannot be inspected without dismantling the seat

Action: Dismantle the seat to inspect the seat connection for wear

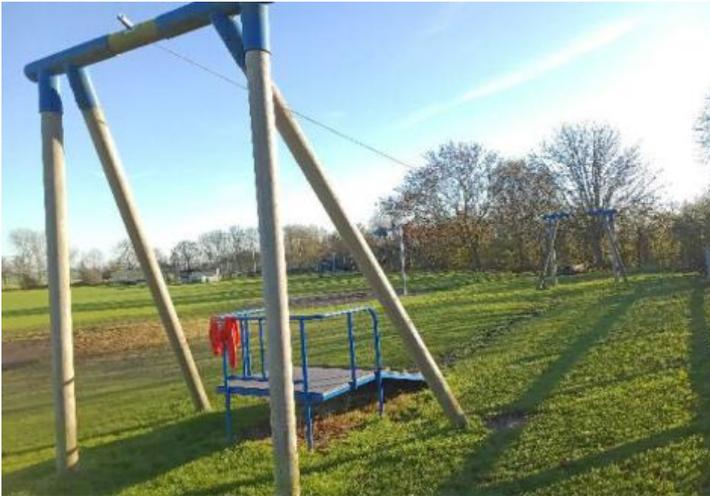
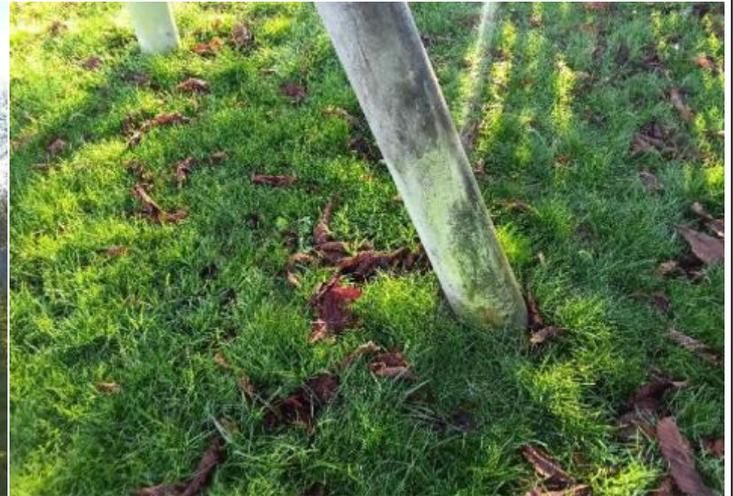
Item: Other - Cable Runway
Manufacturer: Not Identified

Finding: There is some strimmer / machinery damage apparent on the posts, this can penetrate the preservative applied to the timber and accelerate the rotting process

Action: Monitor for any deterioration (rot) and replace as required

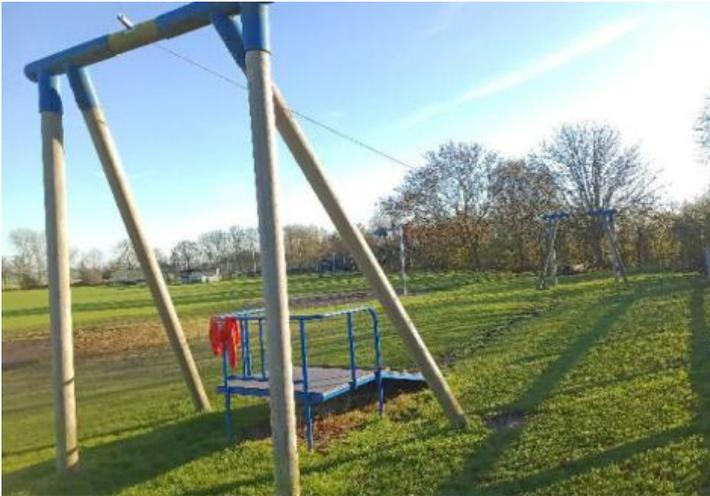
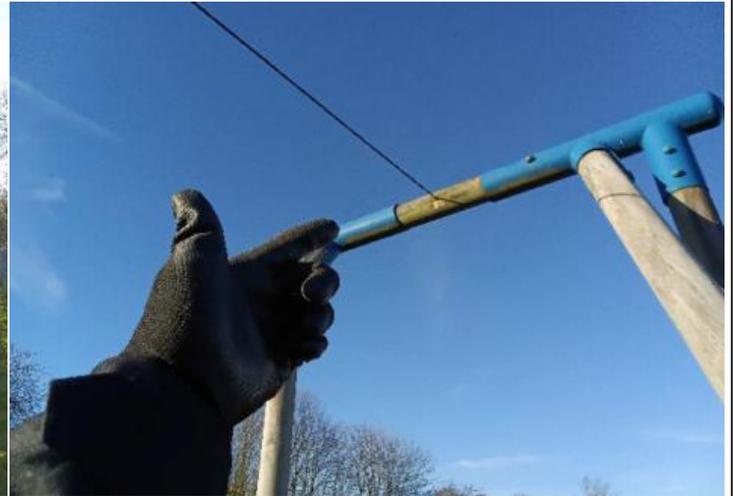
Item: Other - Cable Runway
Manufacturer: Not Identified

Finding: There is or are fixings missing on the framework

Action: Replace all missing fixings

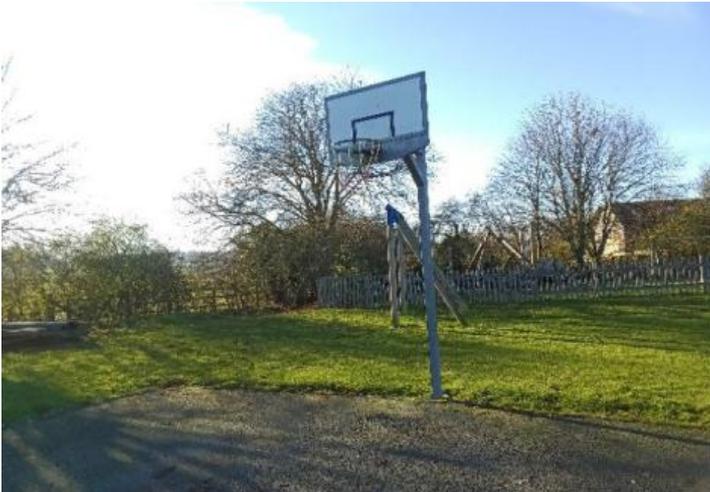
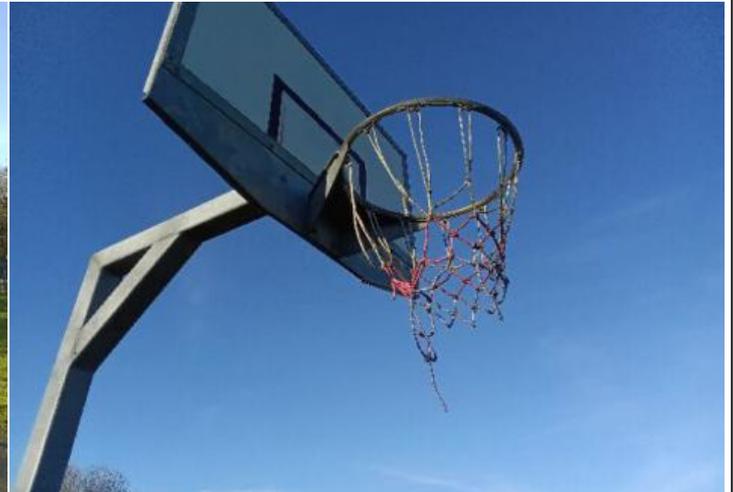
Item: Multi Use Games Area - Basketball Post
Manufacturer: Carr

Finding: The net is damaged and requires removal / replacement

Action: Replace

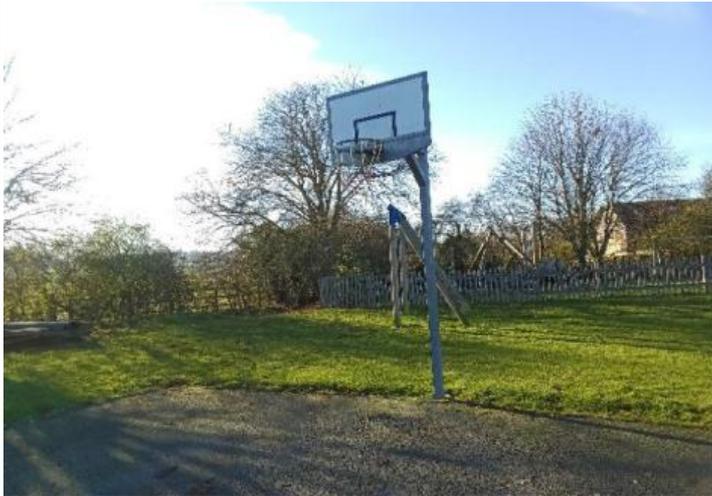
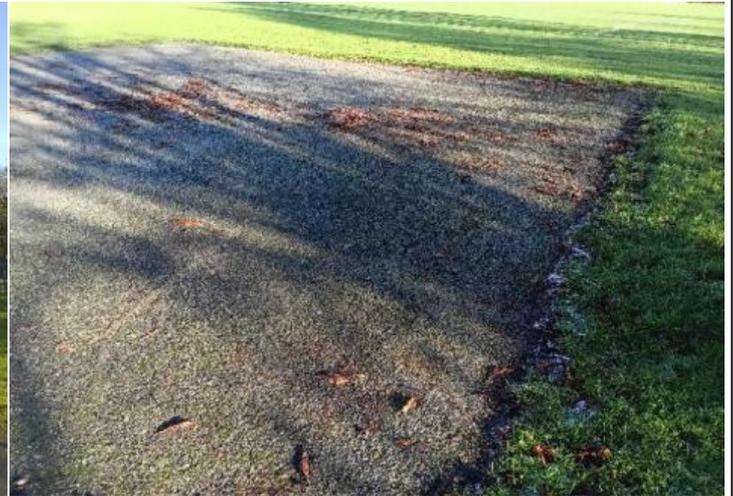
Item: Multi Use Games Area - Basketball Post
Manufacturer: Carr

Finding: There is algae, silt or moss growth on the surface resulting in slippery conditions

Action: Clean and treat appropriately
