Annual Inspection

Pirton Parish Council - Coleman's Close

Inspection Ref: 2901522

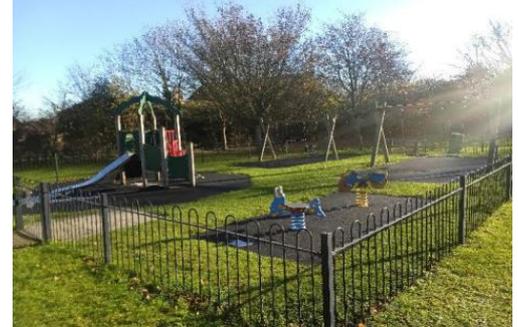
Item: Site General
Manufacturer: Owner/Operator
Surface Type: N/A
Item Quantity: 1
Equipment Compliance: N/A
Surface Area Compliance: N/A

There are trip hazards at the edges of the surface - Reinststate surface levels to remove trip hazard

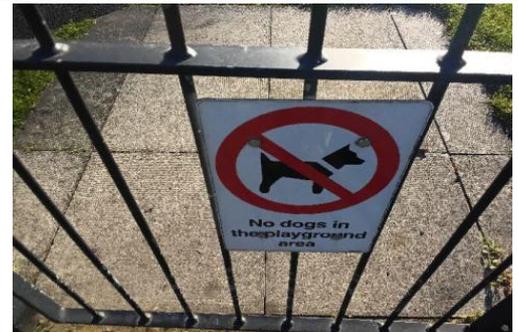
Item: Sign
Manufacturer: Not Identified
Surface Type: N/A
Item Quantity: 1
Equipment Compliance: N/A
Surface Area Compliance: N/A

It is recommended that signage, with information including the site address, contact information for maintenance issues and emergency contact details are provided for the facility - Provide in accordance with the recommendations

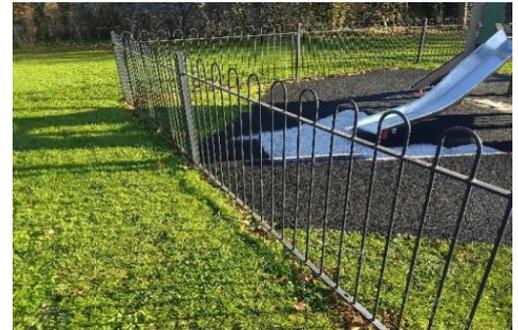
Item: Fence - Bow Top
Manufacturer: Not Identified
Surface Type: Grass
Item Quantity: 1
Equipment Compliance: N/A
Surface Area Compliance: N/A

There is some damage to the fence sections - Monitor for any further deterioration and repair as required

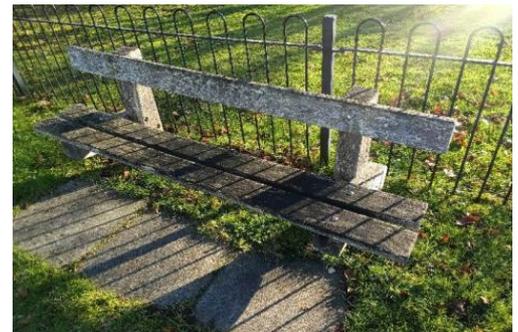
Item: Bench
Manufacturer: Not Identified
Surface Type: Grass
Item Quantity: 1
Equipment Compliance: N/A
Surface Area Compliance: N/A

There is/are bolt cap covers missing or damaged on the bench - Replace missing or damaged bolt cap covers

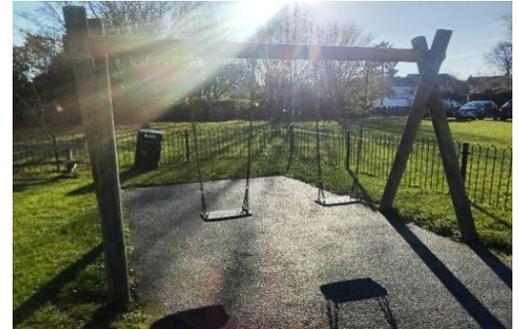
Item: 1 Bay 2 Seat (Flat)
Manufacturer: Playdale Playgrounds Ltd
Surface Type: Wet Pour
Item Quantity: 1
Equipment Compliance: Yes
Surface Area Compliance: Yes

This design of swing joint has been known to fail on the weld connecting the joint to the threaded stud - We would recommend that the joint be dismantled and checked on a regular basis or consulting with manufacturer on whether a Secondary Safety Device can be fitted

There is some evidence of rot in 2 timber posts - Monitor for any further deterioration and replace as required

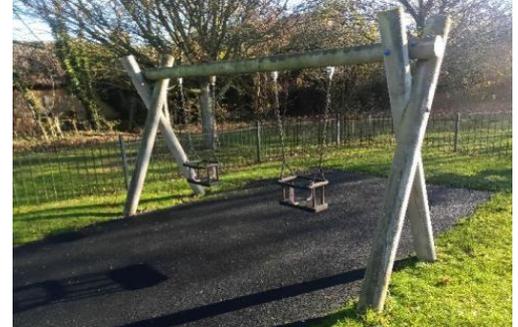
Item: 1 Bay 2 Seat (Cradle)
Manufacturer: Playdale Playgrounds Ltd
Surface Type: Wet Pour
Item Quantity: 1
Equipment Compliance: No
Surface Area Compliance: Yes

This design of swing joint has been known to fail on the weld connecting the joint to the threaded stud - We would recommend that the joint be dismantled and checked on a regular basis or consulting with manufacturer on whether a Secondary Safety Device can be fitted

The swivel joint bushes are worn - Replace worn or missing bushes

There is some notable evidence of chain wear - Monitor for any further deterioration and replace when 40% worn

The chain openings are in excess of the 8.6mm as recommended by BS EN 1176 - Monitor - No action given the risk assessment

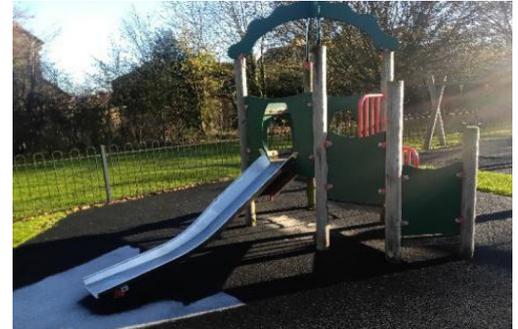
Item: Multi Play (Junior)
Manufacturer: Playdale Playgrounds Ltd
Surface Type: Wet Pour
Item Quantity: 1
Equipment Compliance: No
Surface Area Compliance: Yes

There are a number of dents in the slide surface - Monitor for any further deterioration and repair as required
