the **play inspection** company

Annual Inspection

Pirton Parish Council - Recreation Ground

Walnut Tree Road, North Herts,

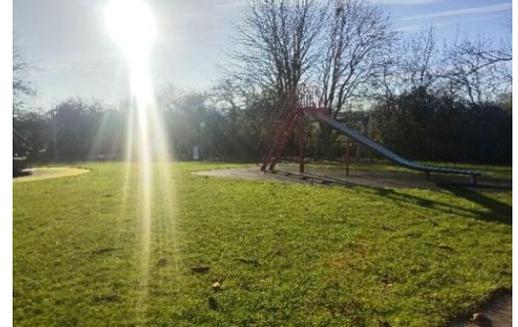
Item: Site General
Manufacturer: Owner/Operator
Surface Type: N/A
Item Quantity: 1
Equipment Compliance: N/A
Surface Area Compliance: N/A

There is algae, silt or moss growth on the surface resulting in slippery conditions - Clean and treat appropriately

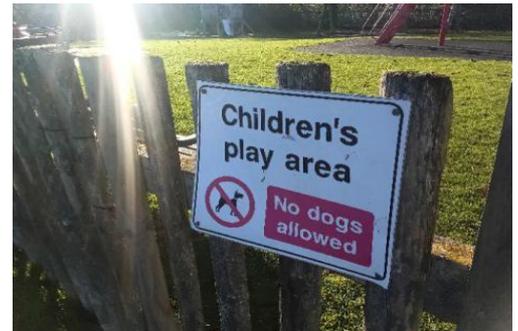
Item: Sign
Manufacturer: Not Identified
Surface Type: N/A
Item Quantity: 1
Equipment Compliance: N/A
Surface Area Compliance: N/A

It is recommended that signage, with information including the site address, contact information for maintenance issues and emergency contact details are provided for the facility - Provide in accordance with the recommendations

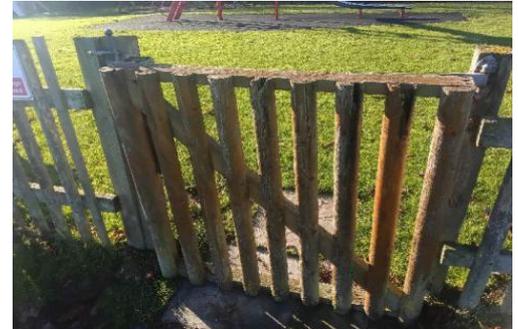
Item: Gate
Manufacturer: Not Identified
Surface Type: Paving Slabs
Item Quantity: 1
Equipment Compliance: N/A
Surface Area Compliance: N/A

The area under the gate has eroded leaving uneven areas, or the concrete foundations exposed, resulting in trip hazards at the entrance/exit to the playground - Reinstate to level with surrounding surfaces

There are areas or parts of the timber gate that have rotted - Replace gate

There is or are fixings missing on the gate - Replace all missing fixings

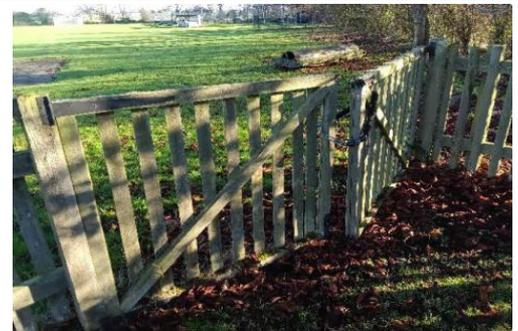
Item: Gate - Maintenance
Manufacturer: Not Identified
Surface Type: Grass
Item Quantity: 1
Equipment Compliance: N/A
Surface Area Compliance: N/A

There is some evidence of rot in the timber gate - Monitor for any further deterioration and replace as required

The gate post is loose - Monitor for any further deterioration and reset as required

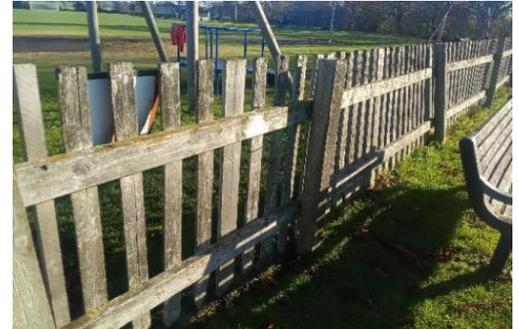
Item: Fencing - Timber
Manufacturer: Not Identified
Surface Type: Grass
Item Quantity: 1
Equipment Compliance: N/A
Surface Area Compliance: N/A

The fence is severely damaged/rotten in places and is leaning in areas - Repair or replace all affected sections

There is some strimmer / machinery damage apparent on the posts, this can penetrate the preservative applied to the timber and accelerate the rotting process - Monitor for any deterioration (rot) and replace as required

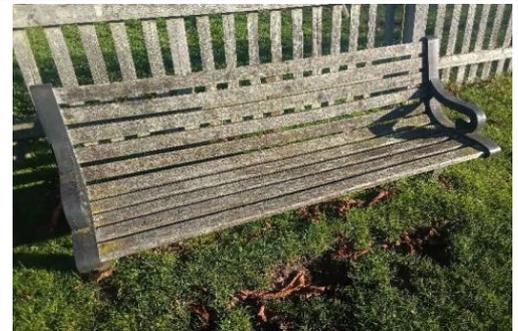
Item: Bench
Manufacturer: Not Identified
Surface Type: Grass
Item Quantity: 1
Equipment Compliance: N/A
Surface Area Compliance: N/A

The surface has eroded in some areas and may be slippery in wet conditions - Reinstate the surface

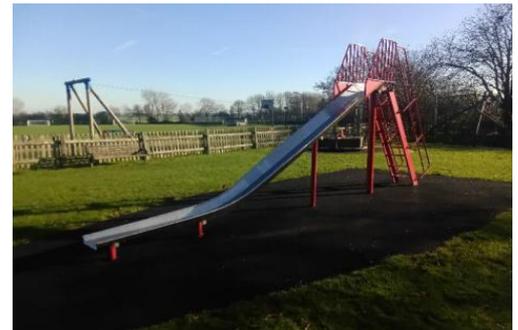
Item: Free Standing Slide
Manufacturer: Not Identified
Surface Type: Wet Pour
Item Quantity: 1
Equipment Compliance: Yes
Surface Area Compliance: Yes

There are a number of dents in the slide surface - Monitor for any further deterioration and repair as required

Parts of the steel on this freestanding slide have corroded excessively and the metal has perforated in places - Ensure all affected areas are treated and repaired

The fixings have corroded excessively - Replace all corroded fixings

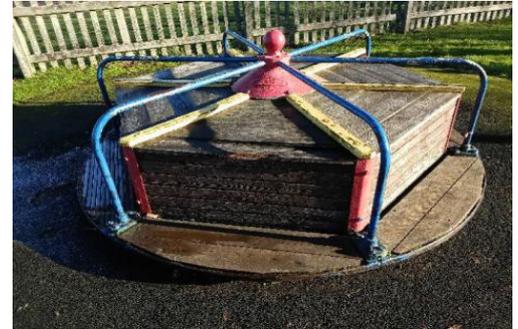
Item: Roundabout
Manufacturer: Wicksteed Playgrounds
Surface Type: Wet Pour
Item Quantity: 1
Equipment Compliance: No
Surface Area Compliance: Yes

There is moderate damage to the surface - Repair the damaged areas of surfacing

The timber is rotten creating finger entrapment/s in the roundabout and the item fails to meet the requirements of BS EN 1176 Part 1 4.2.7.6 Entrapment of fingers - Replace timber to remove the entrapment

There is/are finger entrapment/s in the roundabout and the item fails to meet the requirements of BS EN 1176 Part 1 4.2.7.6 Entrapment of fingers - Remove the entrapment

The item fails to meet the requirements of BS EN 1176 Part 1 4.2.7.2 for head and neck entrapment in the framework - Monitor - No action given the risk assessment

The safety surface around the area is beginning to wear - Monitor for any further deterioration and repair as required

There are missing fixings creating finger entrapment/s in the framework and the item fails to meet the requirements of BS EN 1176 Part 1 4.2.7.6 Entrapment of fingers - Replace the missing fixings to remove the entrapment

The bearing is showing signs of wear - Monitor for any further deterioration and replace as required

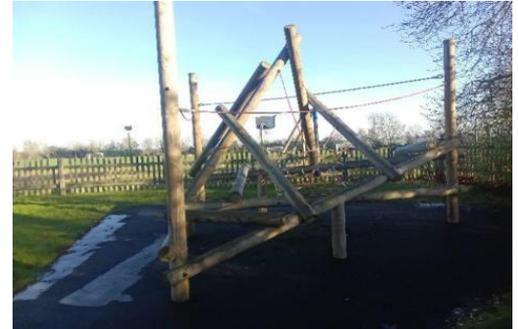
Item: Log Climber
Manufacturer: Setter Play
Surface Type: Wet Pour
Item Quantity: 1
Equipment Compliance: No
Surface Area Compliance: Yes

Parts of the timber are rough or splintered - Remove all rough or sharp edges

There is/are finger entrapment/s in the framework and the item fails to meet the requirements of BS EN 1176 Part 1 4.2.7.6 Entrapment of fingers - Provide inserts to remove the entrapment

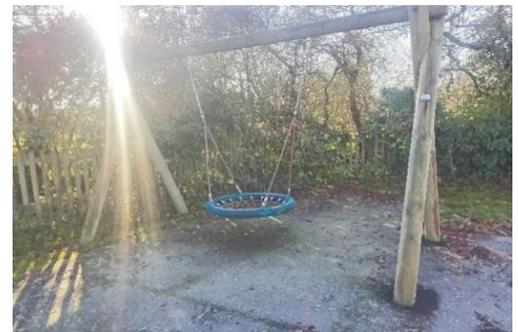
Item: Basket Swing - Type 1
Manufacturer: Setter Play
Surface Type: Wet Pour
Item Quantity: 1
Equipment Compliance: Yes
Surface Area Compliance: Yes

The tree canopy overhangs the equipment and is less than 2.0m away - Lift tree canopy to ensure a minimum clearance of 2.0m from the equipment

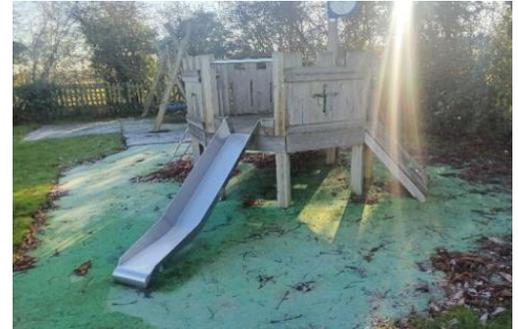
Item: Multi Play (Toddler)
Manufacturer: Setter Play
Surface Type: Wet Pour
Item Quantity: 1
Equipment Compliance: Yes
Surface Area Compliance: Yes

There are a number of dents in the slide surface - Monitor for any further deterioration and repair as required

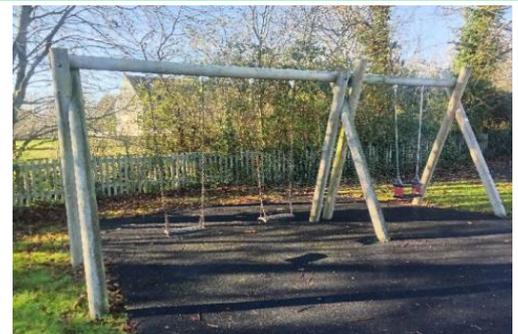
Item: 2 Bay 2 Flat 1 Cradle Seat
Manufacturer: Setter Play
Surface Type: Wet Pour
Item Quantity: 1
Equipment Compliance: No
Surface Area Compliance: Yes

This design of swing joint has been known to fail on the weld connecting the joint to the threaded stud - We would recommend that the joint be dismantled and checked on a regular basis or consulting with manufacturer on whether a Secondary Safety Device can be fitted

There is some notable evidence of chain wear - Monitor for any further deterioration and replace when 40% worn

The swing seat connectors have some wear present - Monitor for further deterioration and replace when 40% worn

The chain openings are in excess of the 8.6mm as recommended by BS EN 1176 - Monitor - No action given the risk assessment

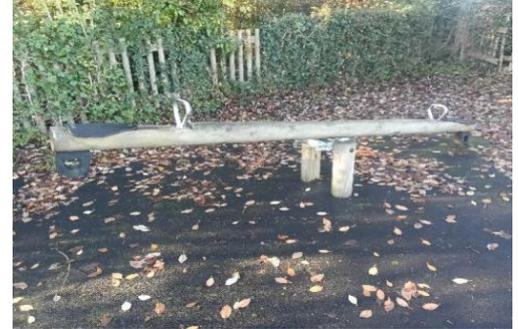
Item: See Saw
Manufacturer: Setter Play
Surface Type: Wet Pour
Item Quantity: 1
Equipment Compliance: Yes
Surface Area Compliance: Yes

The surface has subsided in some areas - Monitor for any further deterioration and repair as required

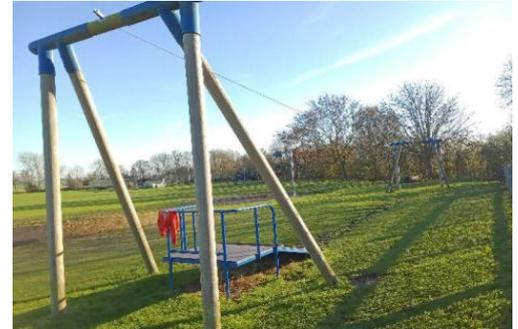
Item: Cable Runway
Manufacturer: Not Identified
Surface Type: Grass Matrix Tiles
Item Quantity: 1
Equipment Compliance: No
Surface Area Compliance: Yes

We have completed a visual inspection of the suspension links, cable and fixing points from ground level, however it is not possible to fully inspect these areas without either hiring equipment to gain access or removing the cable and suspension and inspecting at ground level. We recommend that the main cable and fixing security is thoroughly inspected at least in accordance with the manufacturers recommendations to check for wear, damage, security or internal rusting; this will help to ensure the continued safe use of the equipment - Inspect in accordance with the manufacturers recommendations

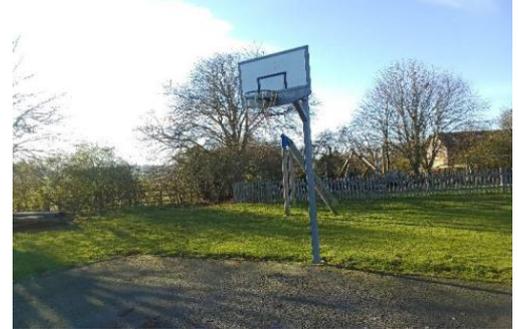
Item: Basketball Post
Manufacturer: Carr
Surface Type: Tarmac
Item Part Number:
Item Quantity: 1
Equipment Compliance: Yes
Surface Area Compliance: N/A
Total Findings: 3

The net is damaged and requires removal / replacement - Replace

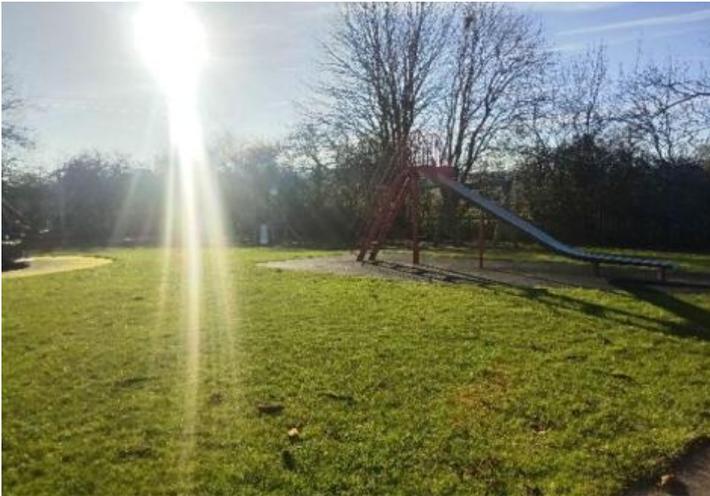
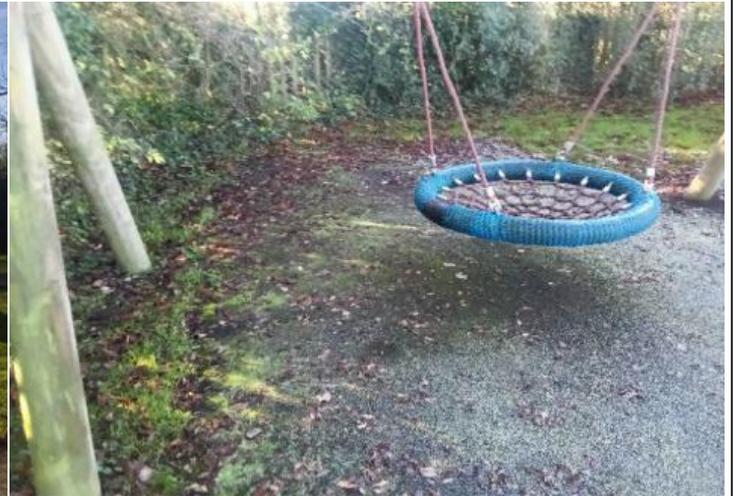
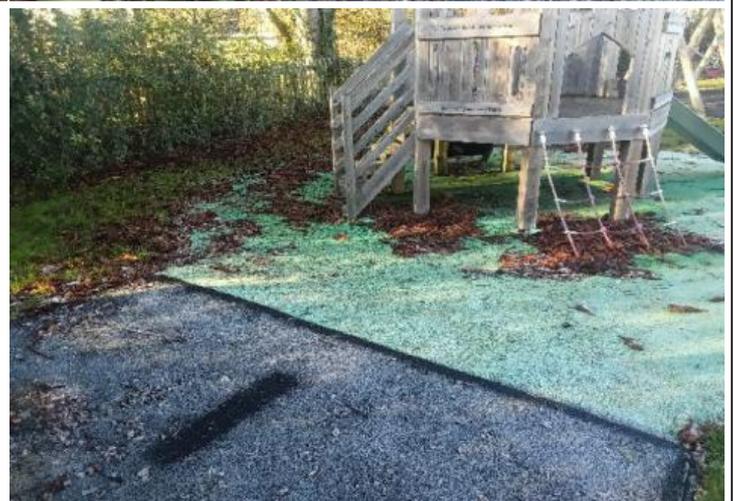
Item: Ancillary Items - Site General
Manufacturer: Owner/Operator

Finding: There is some tree debris on the surfacing

Action: Remove and maintain

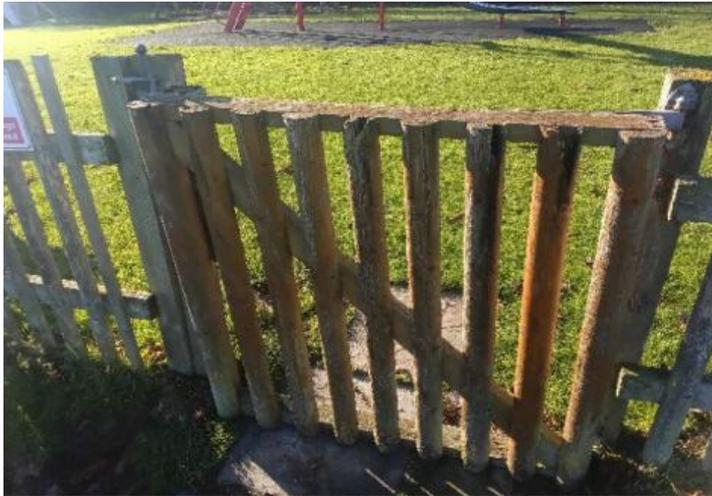
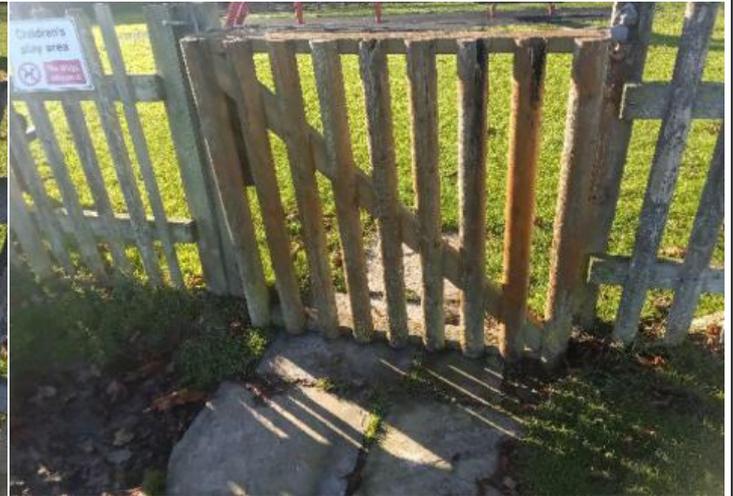
Item: Gates - Gate
Manufacturer: Not Identified

Finding: The gate is snagging on the surrounding surface preventing it from closing correctly

Action: Carry out remedial works to ensure the gate closes correctly

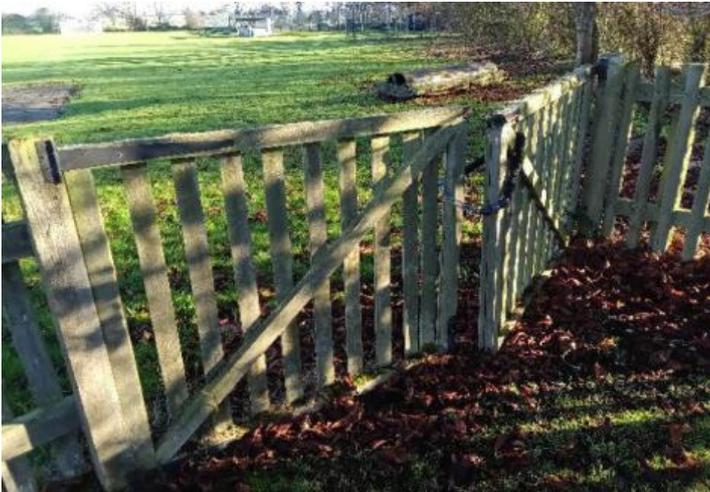
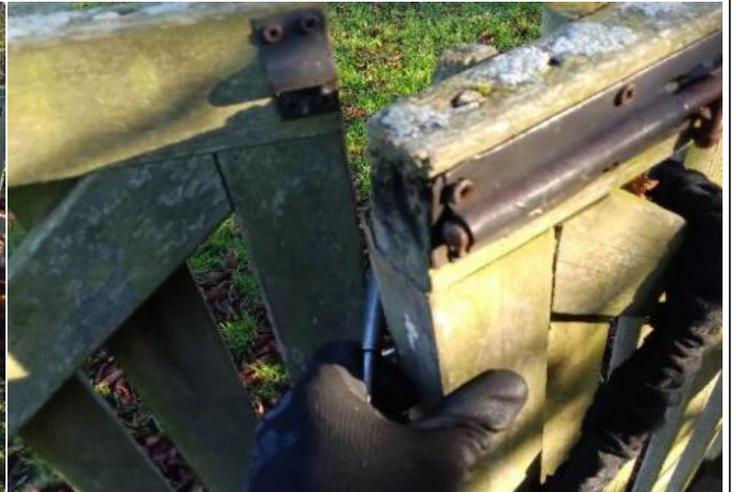
Item: Gates - Gate - Maintenance
Manufacturer: Not Identified

Finding: There are openings that are less than 12mm that could trap or crush fingers

Action: Provide a 12mm gap throughout full range of motion at both sides of gate

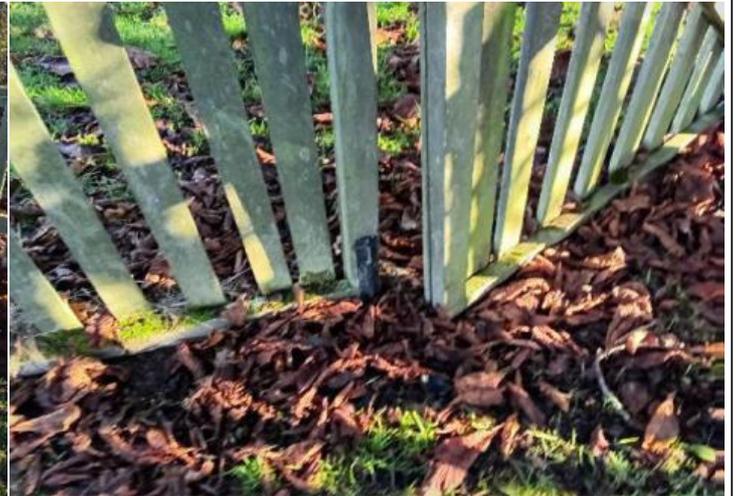
Item: Gates - Gate - Maintenance
Manufacturer: Not Identified

Finding: The gate has no drop bolt sleeves and/or drop bolts fitted

Action: Provide drop bolt sleeves and/or drop bolts

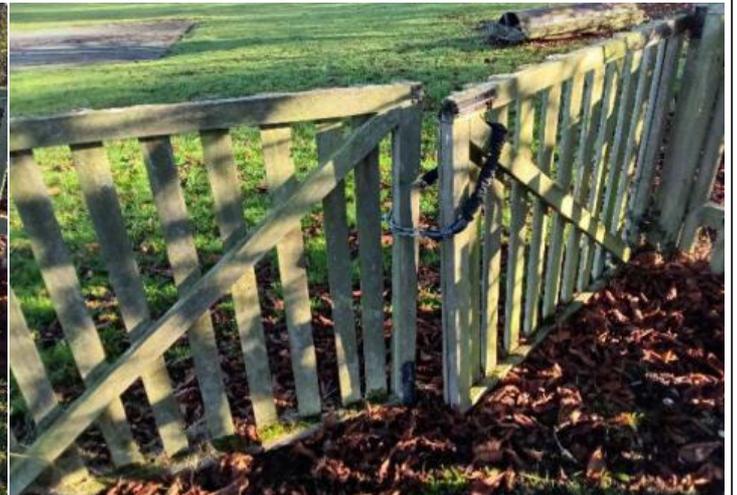
Item: Gates - Gate - Maintenance
Manufacturer: Not Identified

Finding: The gate is snagging on the surrounding surface preventing it from closing correctly

Action: Carry out remedial works to ensure the gate closes correctly

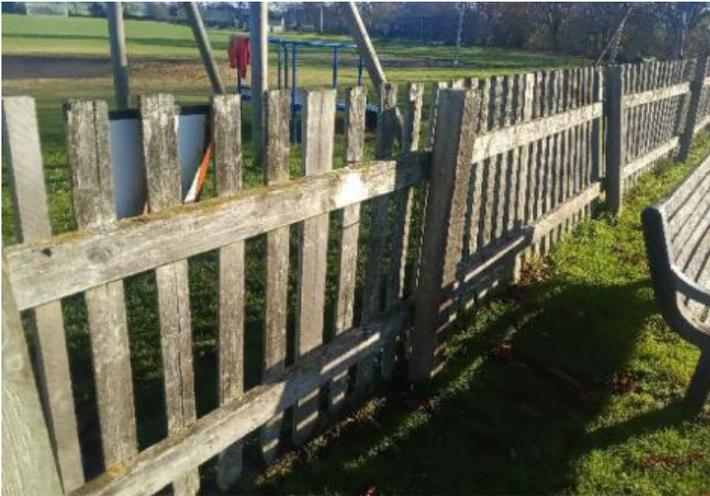
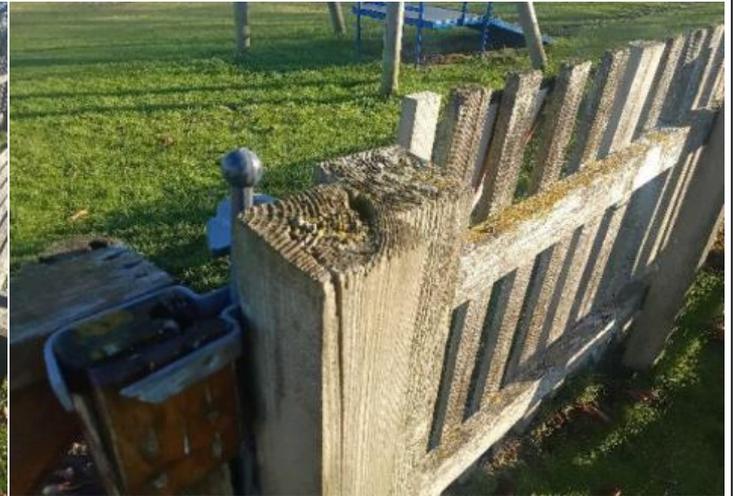
Item: Fences - Fencing - Timber
Manufacturer: Not Identified

Finding: Parts of the timber are rough or splintered

Action: Remove all rough or sharp edges

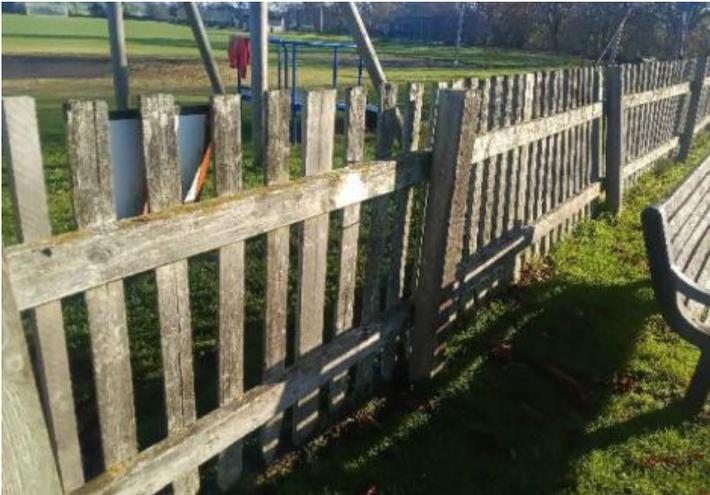
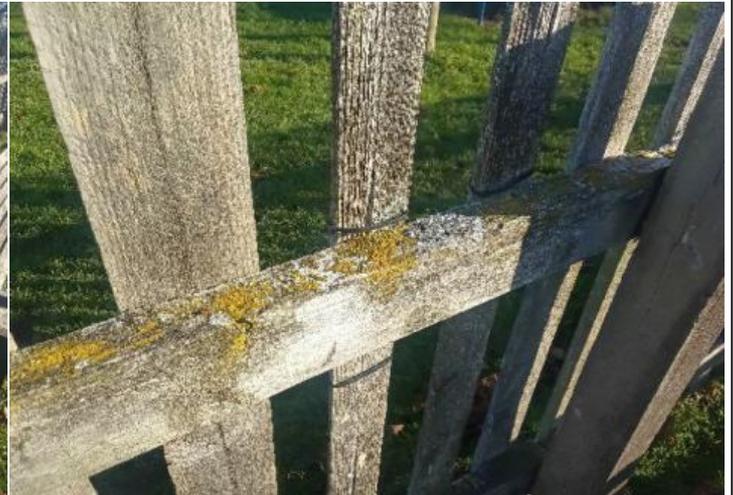
Item: Fences - Fencing - Timber
Manufacturer: Not Identified

Finding: Cable ties are present and there are sharp projecting ends

Action: Remove

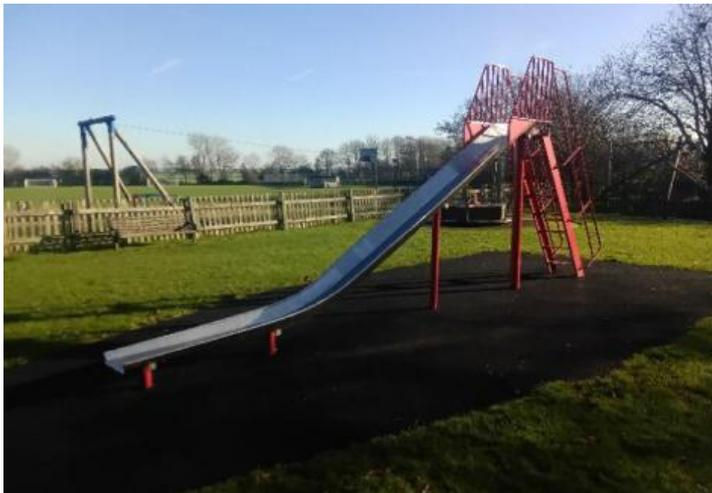
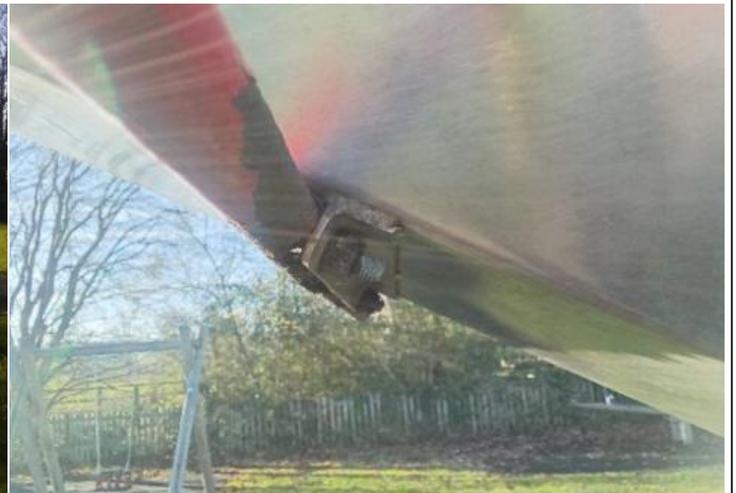
Item: Other - Free Standing Slide
Manufacturer: Not Identified

Finding: There are projecting bolt thread(s) present

Action: Remove excess thread length and deburr or provide cap

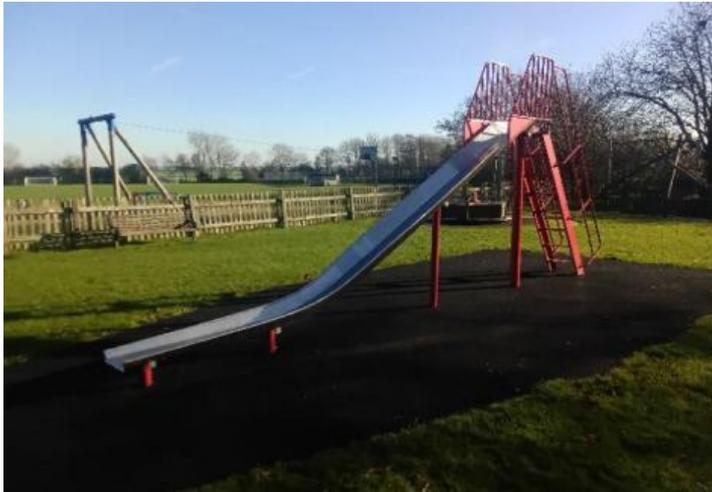
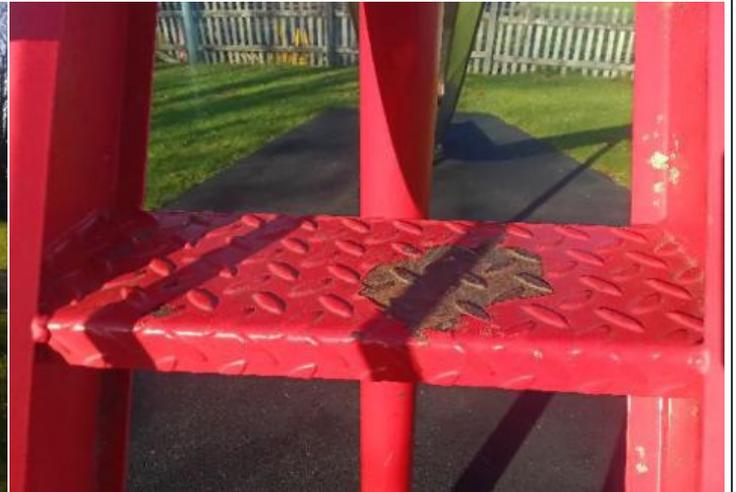
Item: Other - Free Standing Slide
Manufacturer: Not Identified

Finding: The paint is flaking off the metalwork

Action: Rub down and re-paint

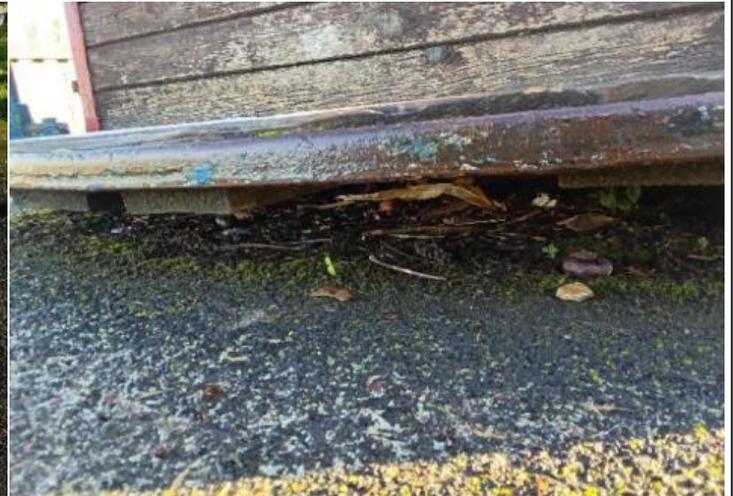
Item: Rotor Play - Roundabout
Manufacturer: Wicksteed Playgrounds

Finding: The ground clearance is not maintained under the roundabout for 300mm without deviations as required by BS EN 1176 Part 5 Clause 5.2.3

Action: Monitor - No action given the risk assessment

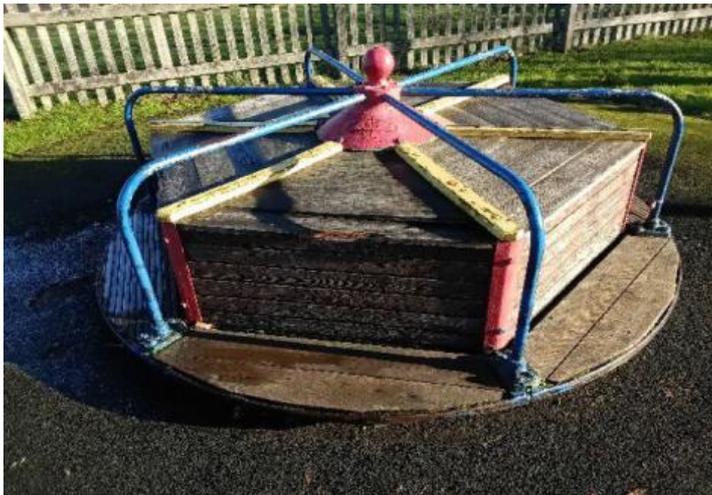
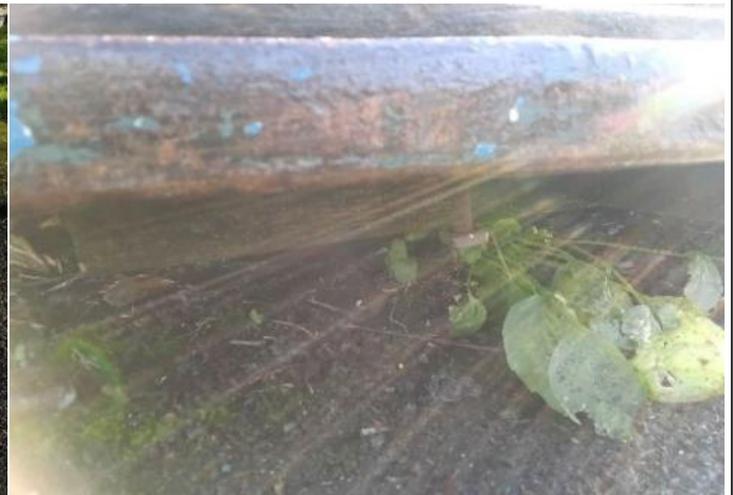
Item: Rotor Play - Roundabout
Manufacturer: Wicksteed Playgrounds

Finding: There are projecting bolt thread(s) present on the roundabout underside

Action: Remove excess thread length and deburr or provide cap

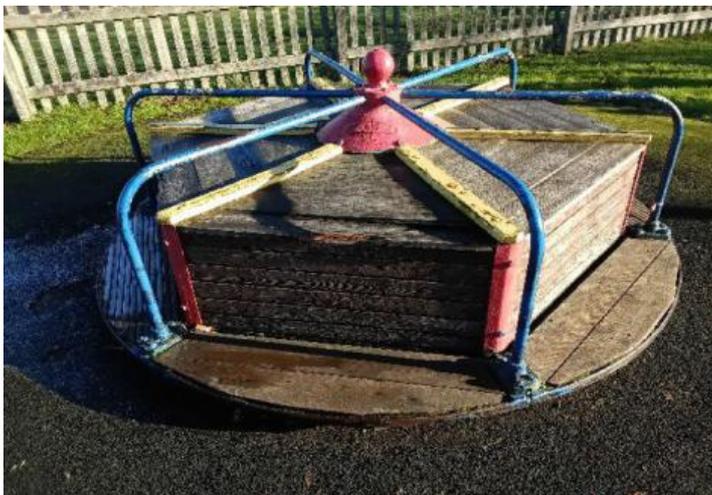
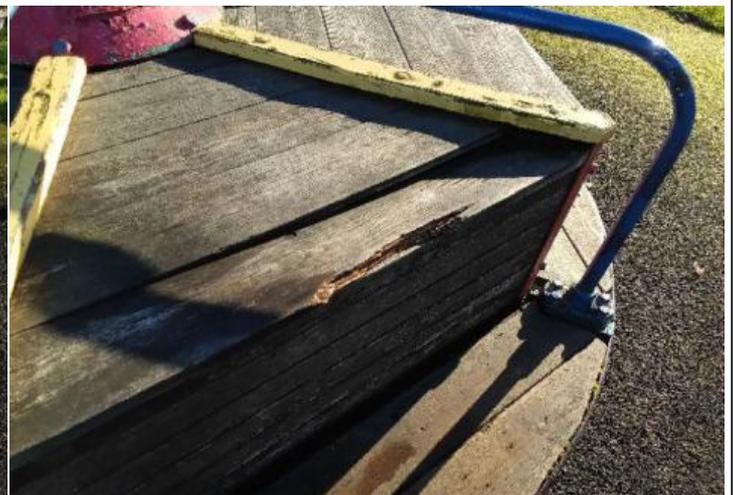
Item: Rotor Play - Roundabout
Manufacturer: Wicksteed Playgrounds

Finding: Parts of the timber are rough or splintered

Action: Remove all rough or sharp edges

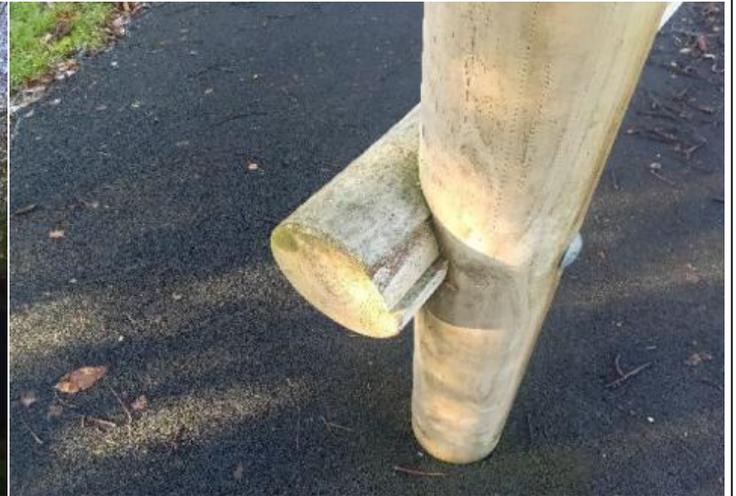
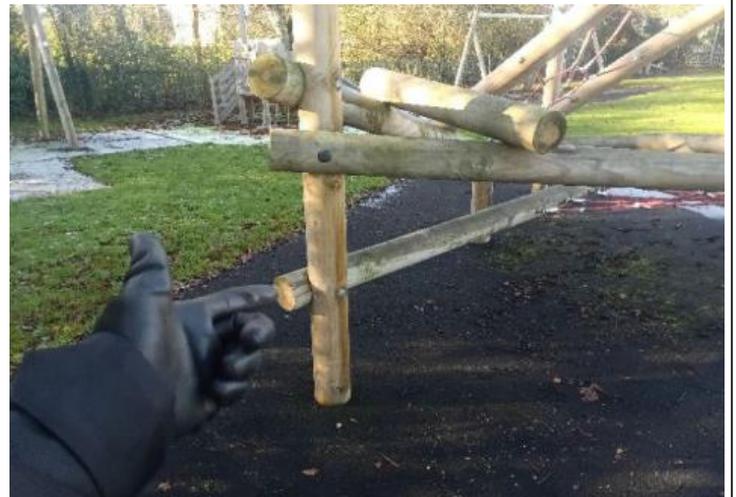
Item: Activity Equipment - Log Climber
Manufacturer: Setter Play

Finding: Parts of the timber are rough or splintered

Action: Remove all rough or sharp edges

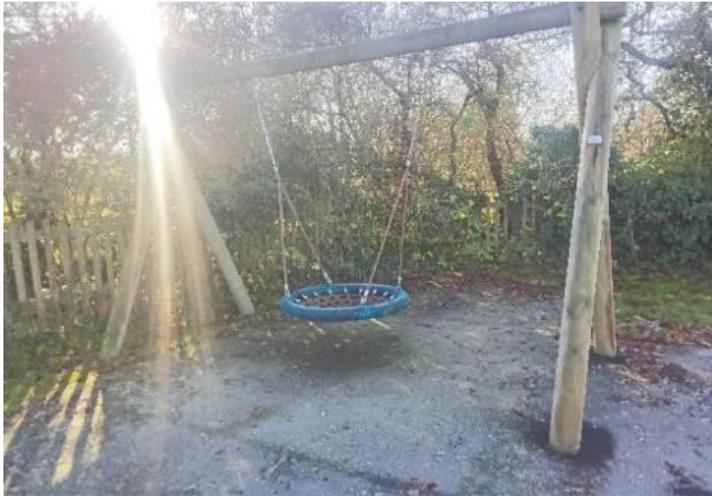
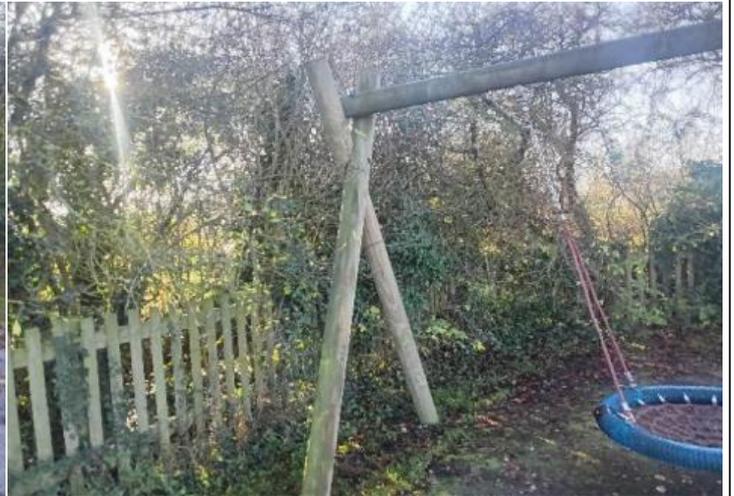
Item: Swings - Basket Swing - Type 1
Manufacturer: Setter Play

Finding: The tree canopy overhangs the equipment and is less than 2.0m away

Action: Lift tree canopy to ensure a minimum clearance of 2.0m from the equipment

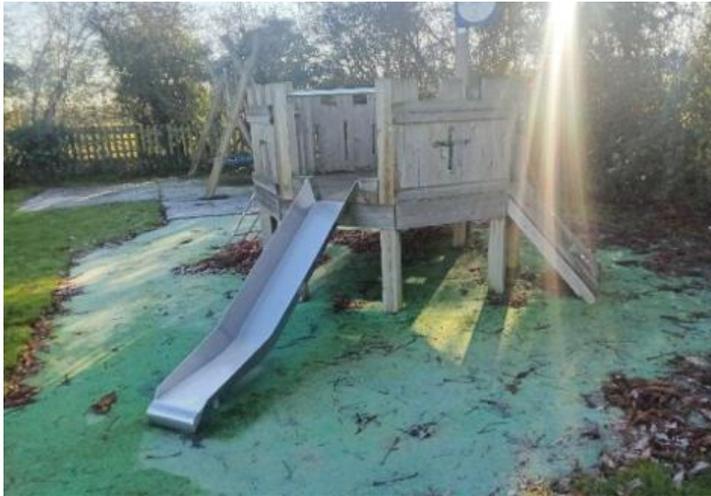
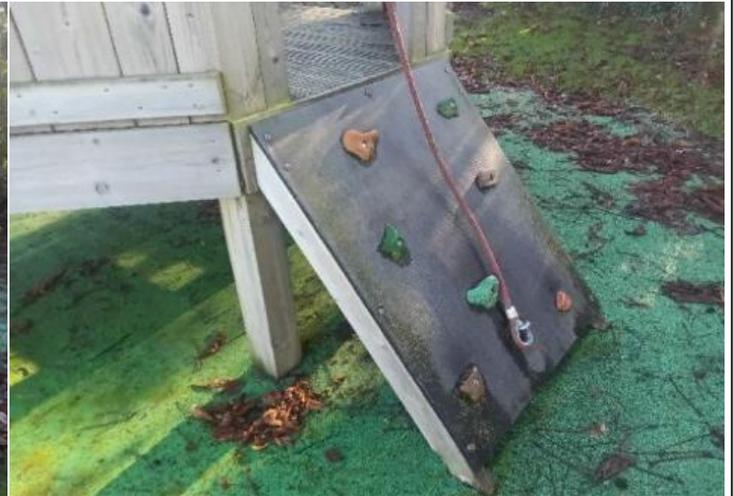
Item: Activity Equipment - Multi Play (Toddler)
Manufacturer: Setter Play

Finding: There is algae or moss on the surface of the multiplay

Action: Clean and treat appropriately

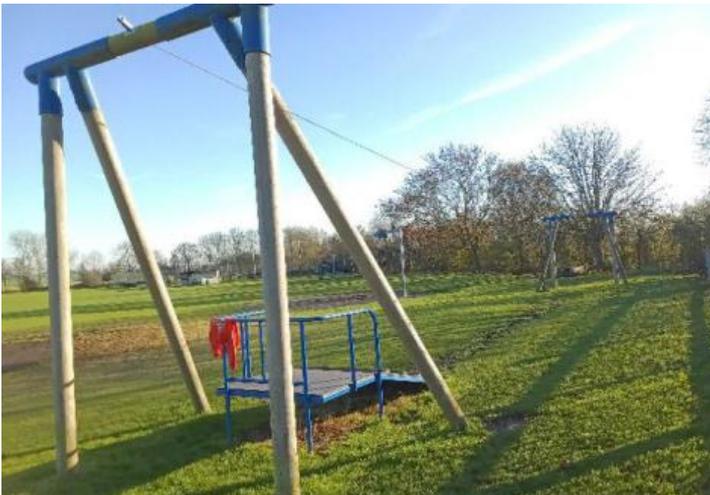
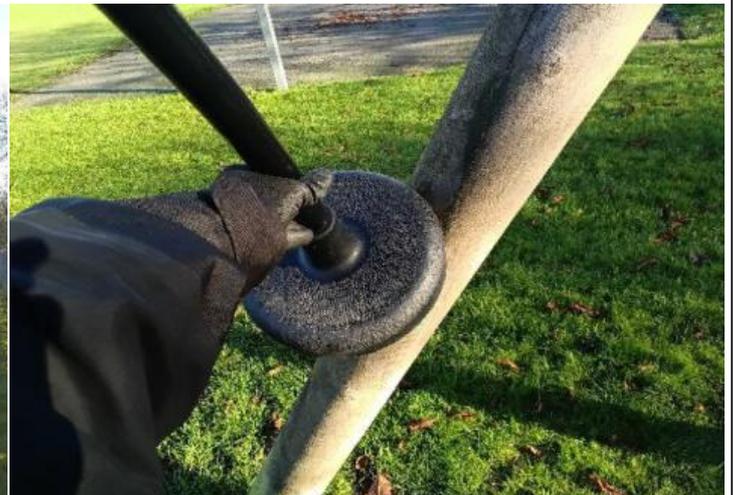
Item: Other - Cable Runway
Manufacturer: Not Identified

Finding: The seat is less than 2.0 metres from the post when extended at 45 degrees at the end of the area of travel and does not meet the requirements of BS EN 1176 Part 4

Action: Adjust the cable stop position to ensure the minimum distance is maintained

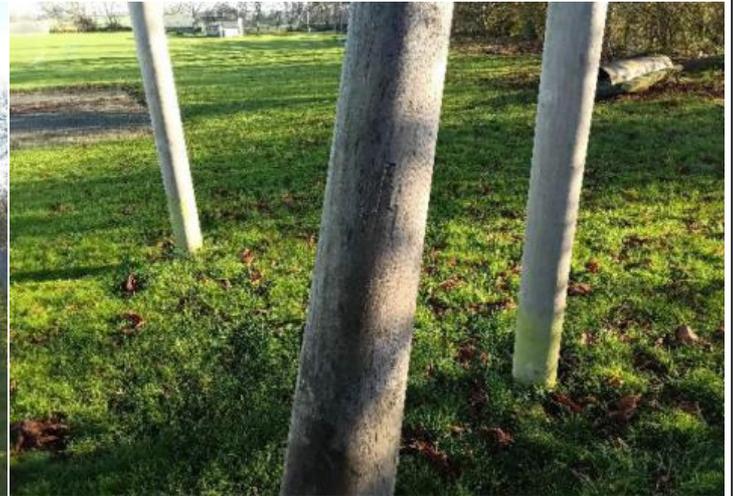
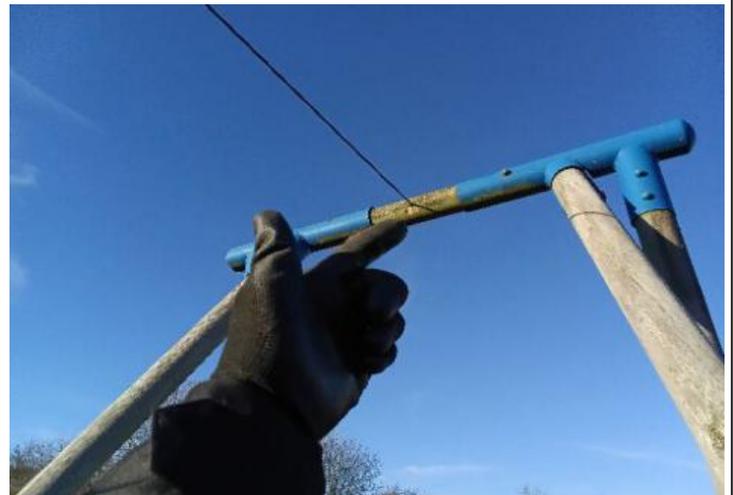
Item: Other - Cable Runway
Manufacturer: Not Identified

Finding: Parts of the timber are rough or splintered

Action: Remove all rough or sharp edges

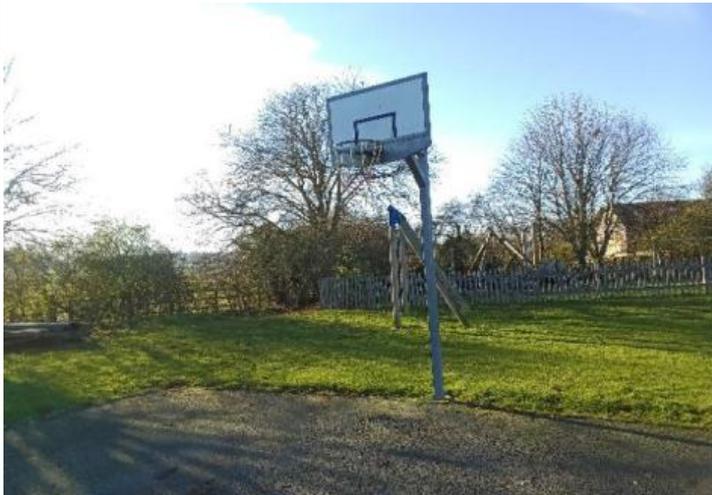
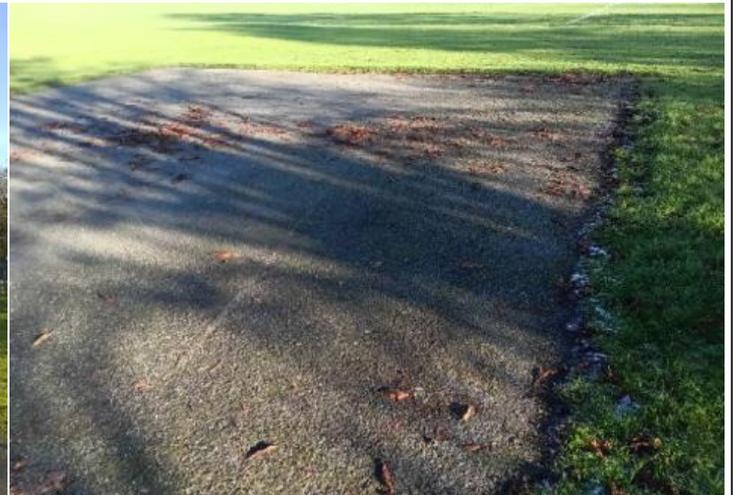
Item: Multi Use Games Area - Basketball Post
Manufacturer: Carr

Finding: There is some tree debris on the surfacing

Action: Remove and maintain
